Forest Audit Program

2012-13 AUDIT OF HARVESTING AND COUPE CLOSURE

VW06734 | 7 June 2013

Document title: 2012-13 Audit of harvesting and coupe closure

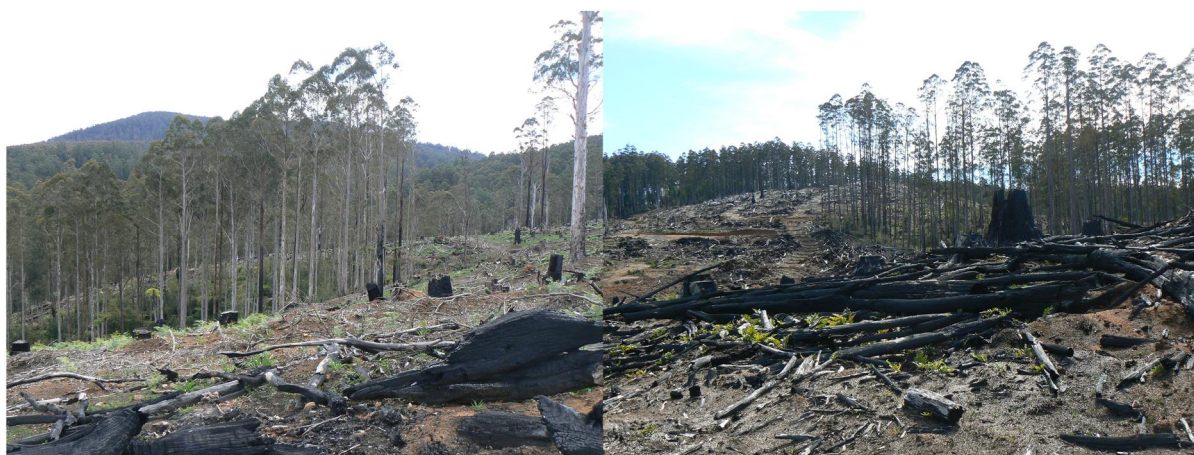
Riparian buffers located in harvest coupes. In general, unharvested buffers along permanent and temporary streams significantly exceeded the minimum required by the Code.

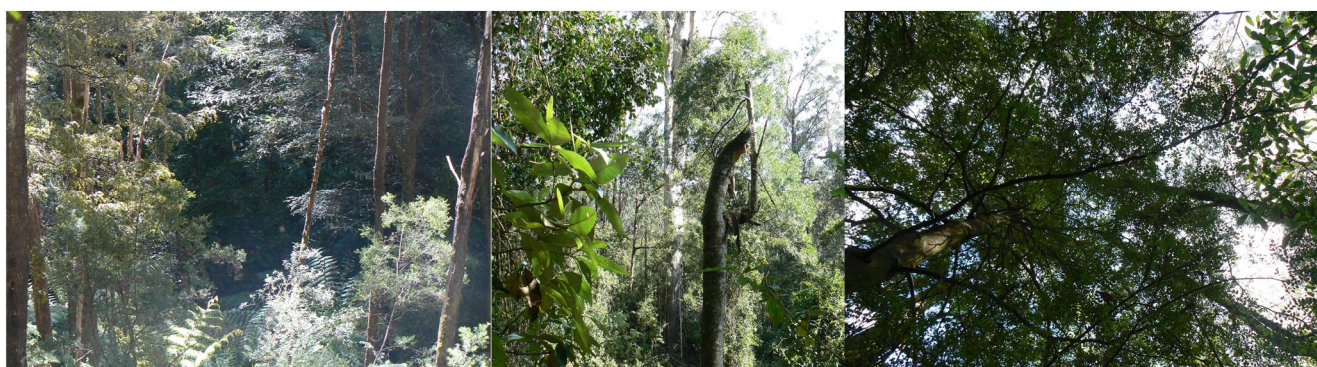
Retained rainforest and undisturbed vegetation within harvest coupes

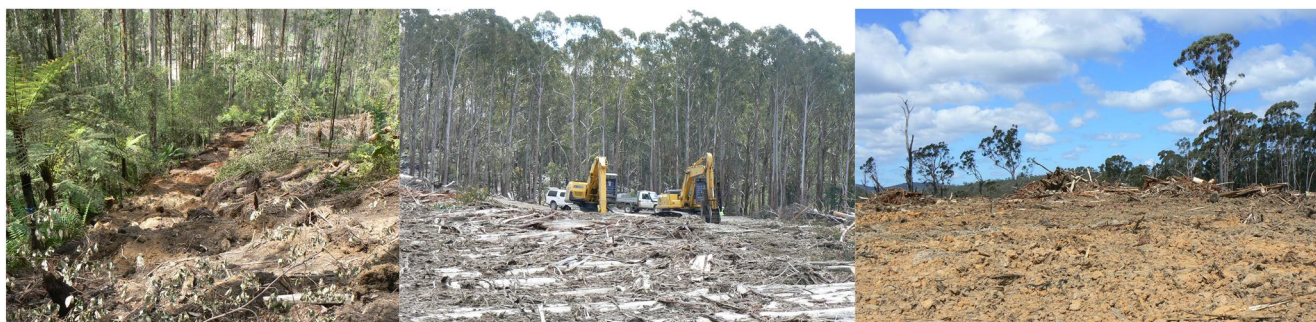
Coupe infrastructure: snig tracks are cross-drained progressively as harvesting proceed; active and rehabilitated log landings.

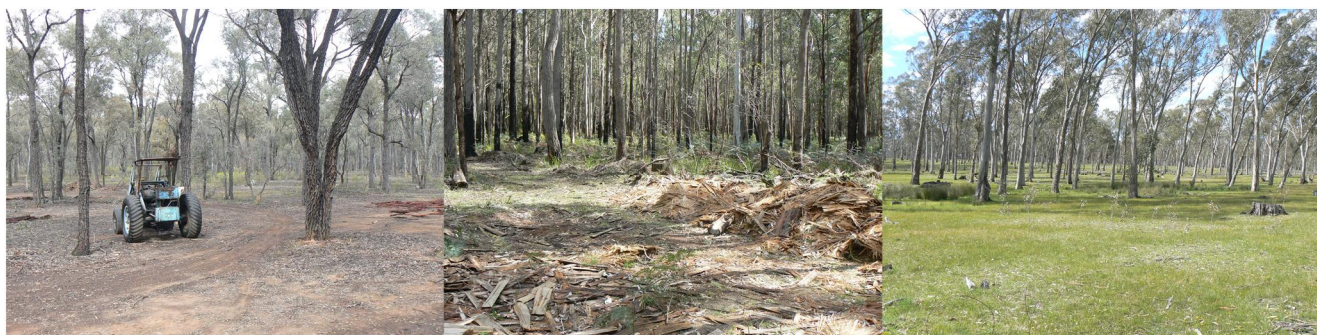
Examples of DPI-managed timber production operations. The audited operations were all low intensity operations, with no formal coupe infrastructure, such as landings and snag tracks. Environmental risk factors were generally lower than for VicForests coupes.
