Forest Audit Program: 2011-12 reporting period
Module 7 audit of coupe regeneration and finalisation

Final report: August 03, 2012

Department of Sustainability and Environment

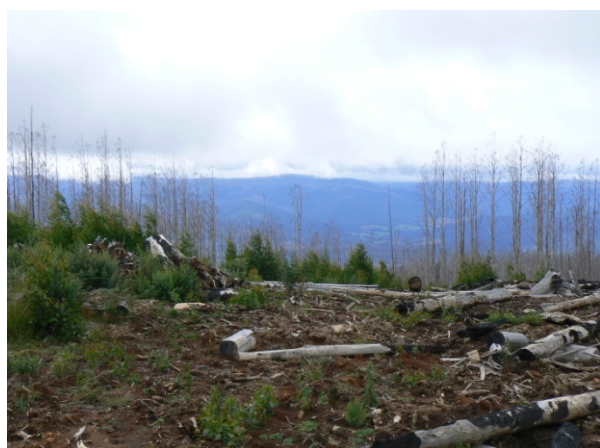
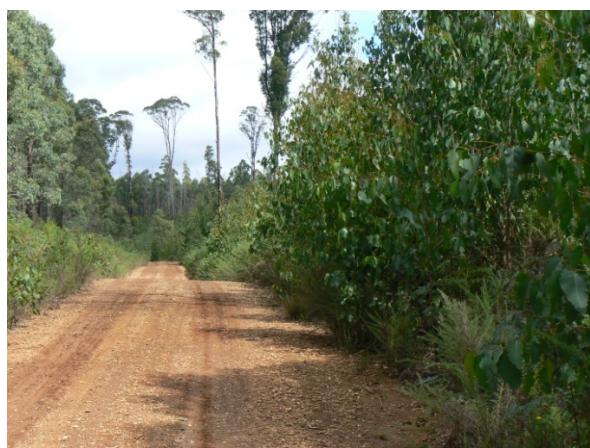
Rehabilitated log landing and successfully regenerated harvesting coupes

Thinning coupe operations

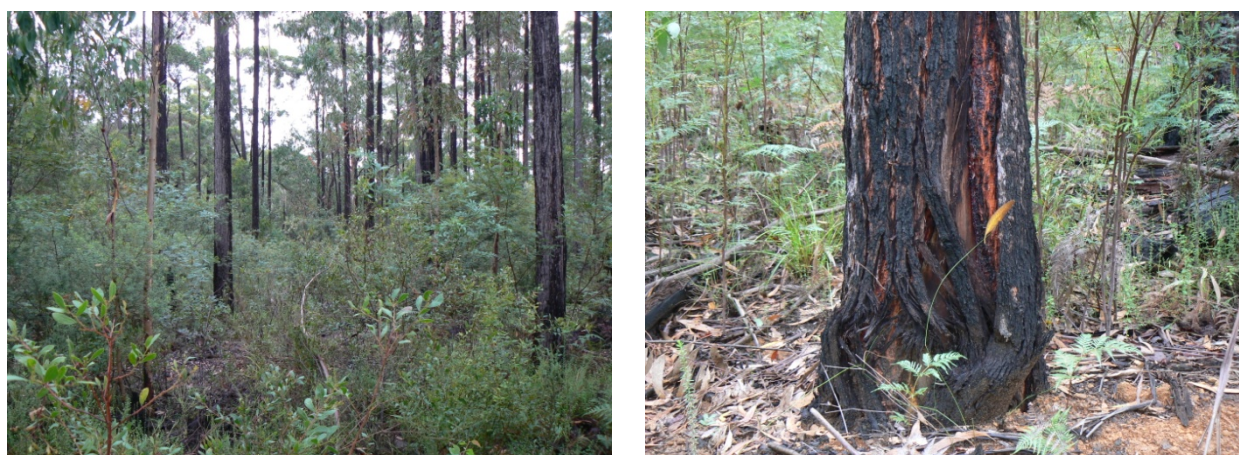
VicForests' reporting shows significant non-compliance of thinning operations with NFSG standards. This is particularly true for the requirement that no more than 50% of live BA is removed. Half of the coupes proposed for finalisation were assessed to have been thinned to a greater extent than the standard, three of them with less than 40% of the original live BA retained (Figure 1). The reported target retained BA in VicForests coupe finalisation reporting was actually less than the 50% standard for 13 of 40 coupes.

VicForests thinning coupe and an example of damage sustained during thinning

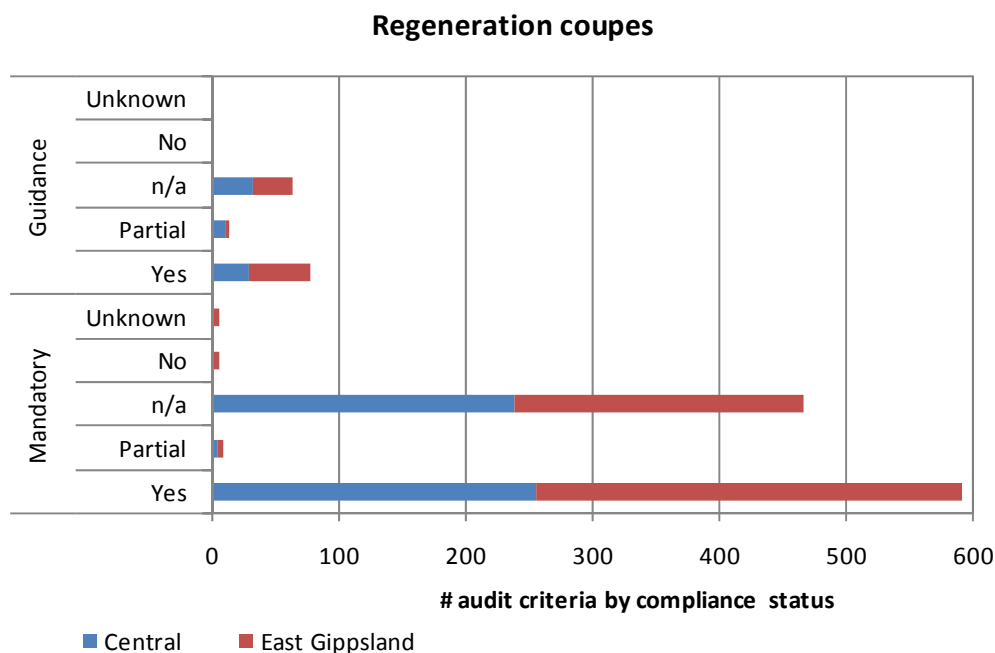
Figure 2 Summary of assessments for compliance against mandatory and guidance audit criteria based largely on the Code of Practice for Timber Production 2007 for selected regeneration coupes in Central and East Gippsland FMAs.

A total of 34 mandatory and five guidance audit criteria were identified in the Code and incorporated into Table 4 of Workbook 7B. Most criteria were assessed from information contained in coupe files or the CIS or FireWeb information systems. Several were based on the field assessments of coupe stocking and other conditions. Summaries of the results of the assessment are given in Figure 2 and Table 5.

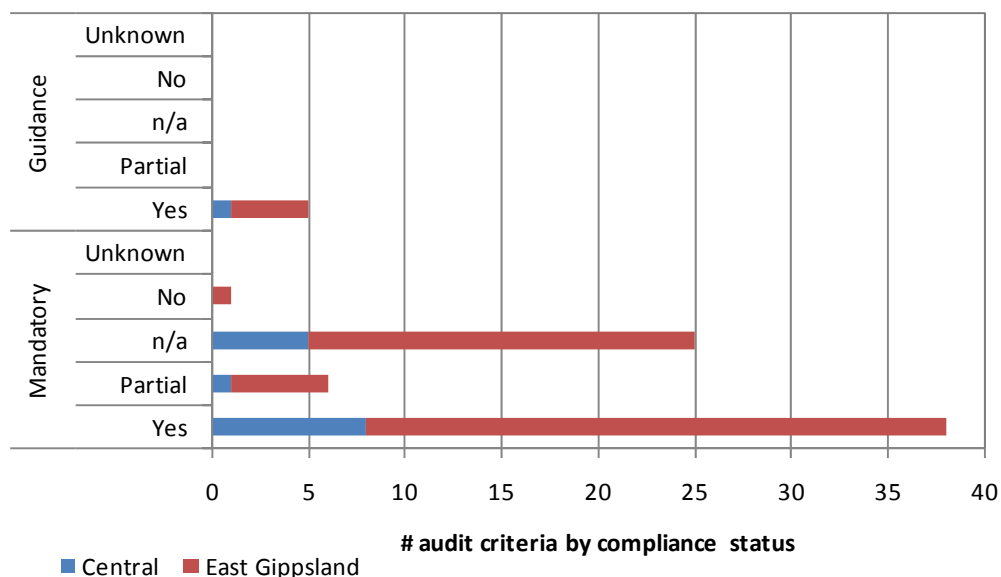
Figure 3 Preliminary summary of assessments for compliance against mandatory and guidance audit criteria based on the *Code of Practice for Timber Production 2007* for selected thinning coupes in Central and East Gippsland FMAs.

As with regeneration coupes, the audits were based on evidence contained in coupe files, VicForests CIS or the field assessment of thinning coupes. Summaries of the results of the assessment are given in Figure 3 and Table 6.

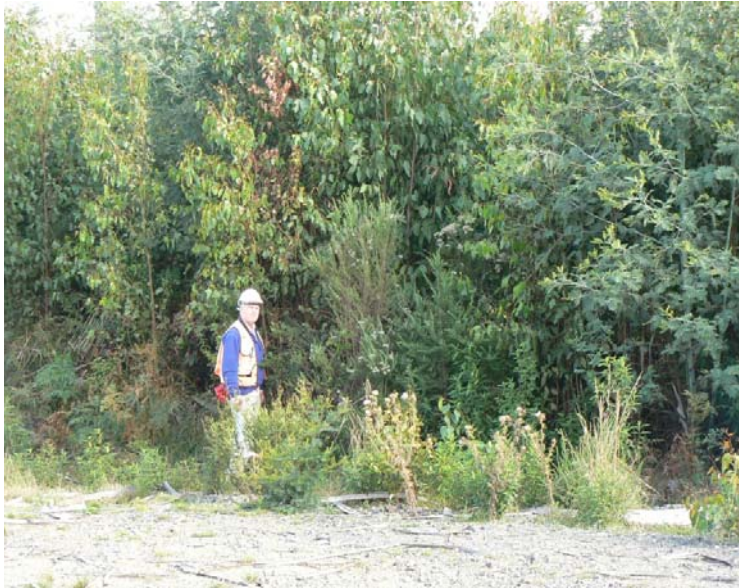
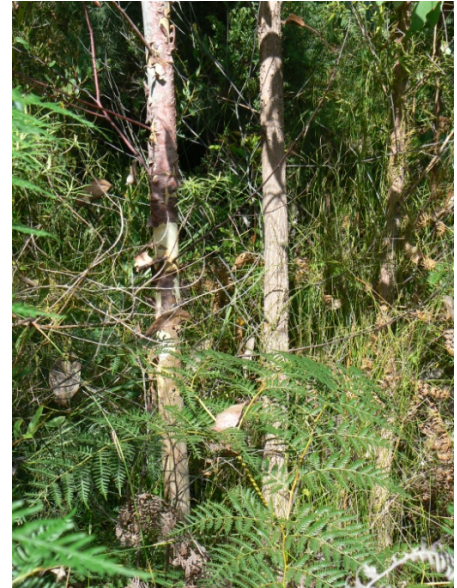
Dense eucalypt, wattle and understorey regrowth, which in some coupes was interspersed with dodder laurel and vines resulted in sampling procedures being modified from that outlined in the revised Module 7 and Workbook 7A

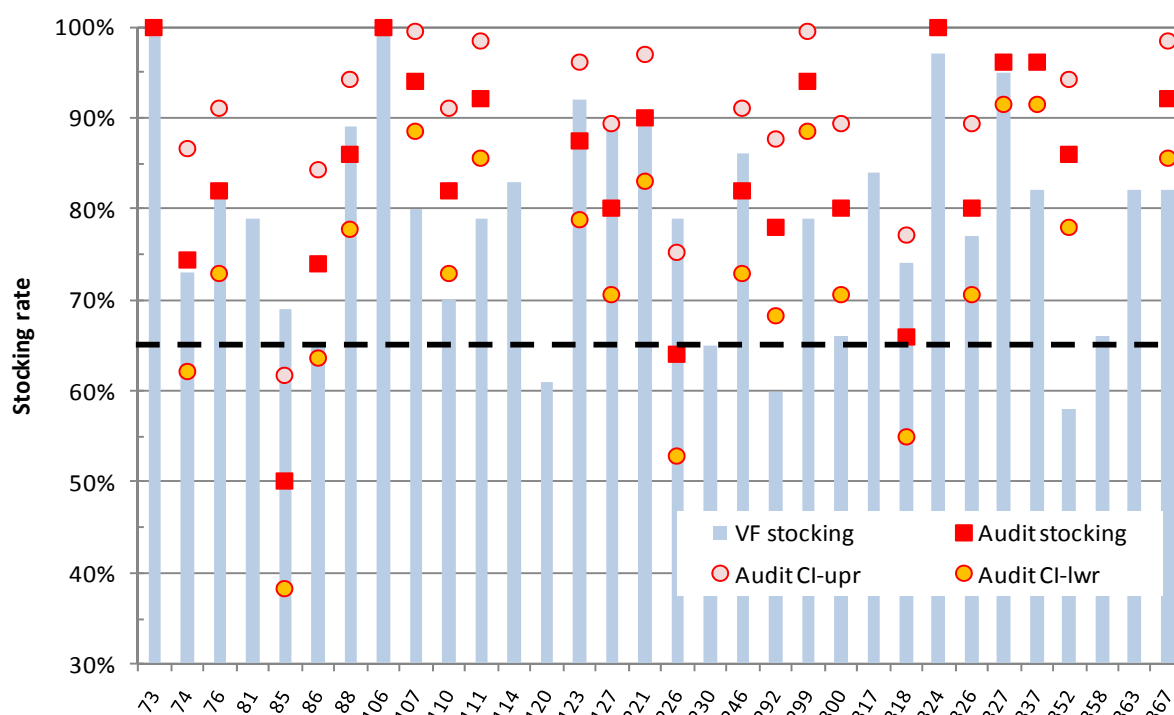
The stocking rate in two of the audited coupes fell short of the 65% standard from NFSG #10. However, in only one of these (coupe 085) was the 65% stocking standard outside the 90% confidence interval for coupe stocking. This coupe in Central FMA was difficult to access (due to safety issues associated with retained stags and extremely dense wattle regrowth) and as a result, sampling tended to be concentrated in a large patch of wattle-dominated regrowth, with poor eucalypt stocking. While the audit stocking survey results suggest below target regeneration, this is most likely an artefact of sampling. VicForests survey identified that an area of over 1 ha in this coupe was unstocked, but that over 65% of stocking survey plots were stocked.

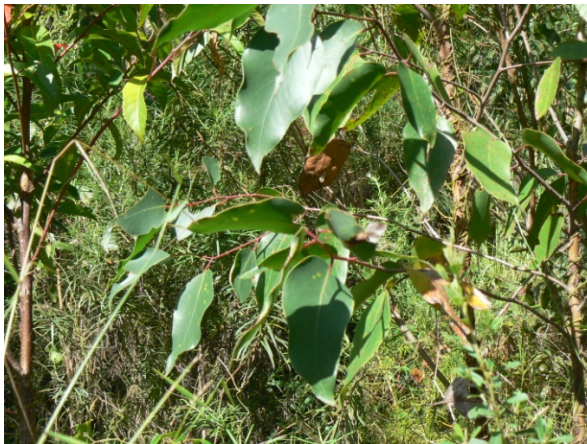
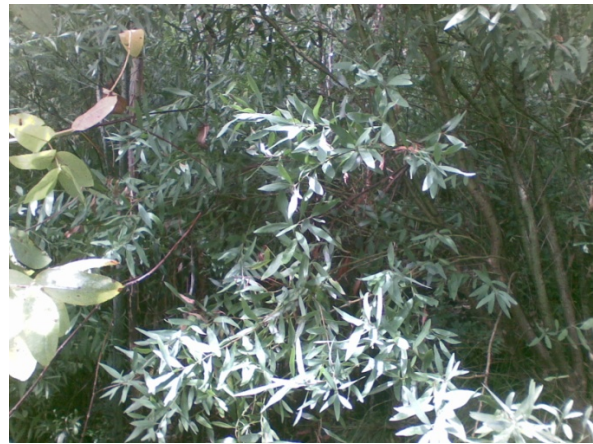
The long delay between regeneration and proposal for hand back for some coupes (up to 7 years) contributed to the advanced development of regrowth (which exceeded 6-8 m in height in some cases) and understorey. It made

coupe access difficult in some instances (exceptionally so at times). Some access roads had also become overgrown or otherwise unusable, thereby hampering or preventing coupe access.

Dense regrowth, difficult terrain and logging debris contribute to physical hazards and slow progress in stocking survey components of field audits
