Audit of timber harvesting operations in Victoria's State forests

Department of Environment, Land, Water and Planning

Report on the 2017-18 Forest Audit Program

IS247800-RP-002 | Final

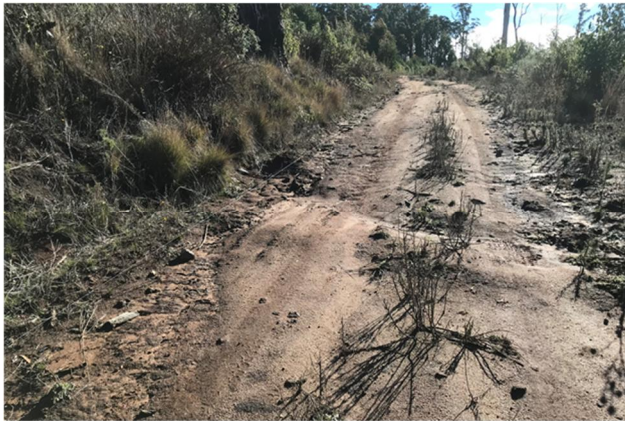
Inadequate maintenance of the in-coupe road from 25 Titanium through adjacent Platinum and Tungsten coupes means that the bypass of cross-drainage structures (on left side of road) by road drainage has not been corrected. Long drainage lengths have allowed the left-hand side of the road to erode. EIA rating: negligible.

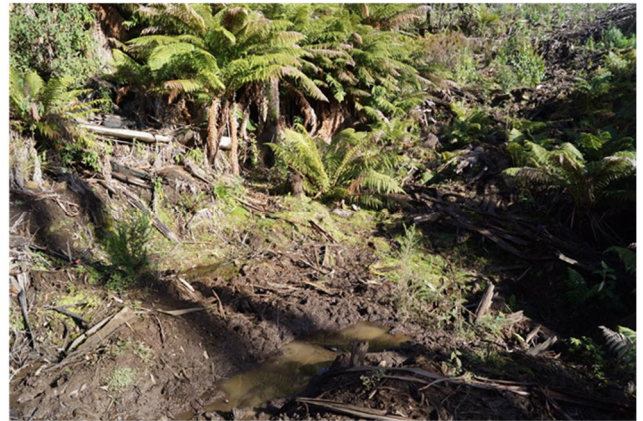
Some logs from High Voltage coupe were snigged across this temporary stream to the adjacent Zap coupe. The snig track waterway crossing was constructed as a log-fill crossing. Removal of the crossing resulted in an unaddressed disturbance to the waterway. EIA rating: moderate.

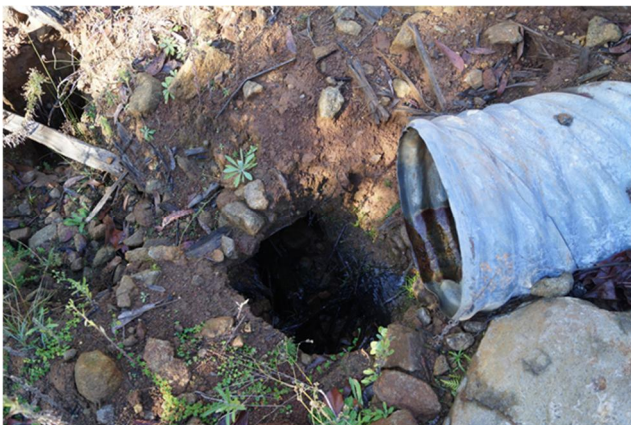
Inappropriately located culvert outlet, 2 High Voltage. The culvert discharges onto unconsolidated sediments on a log-fill crossing and created a point source of erosion. EIA rating: moderate.

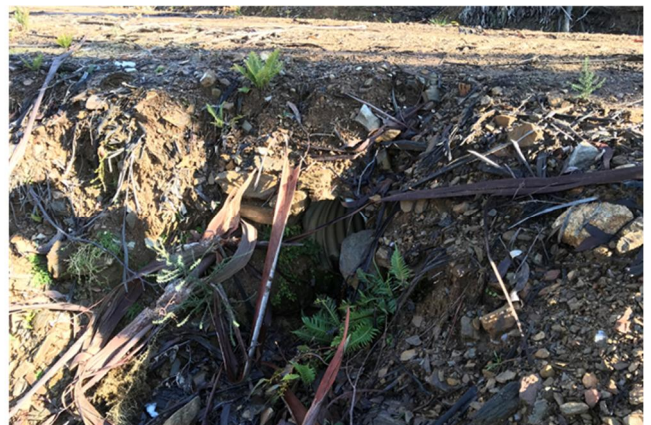
Culvert on 19 Swivel discharges onto the embankment sediments, causing a small amount of erosion. EIA rating: moderate.

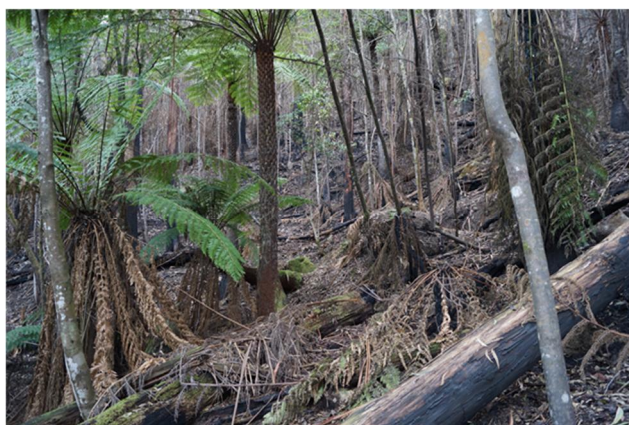
The regeneration burn in 9 Tarzan crossed containment lines more than 100 m (in places) into this area that was planned to remain unharvested. EIA rating: moderate.

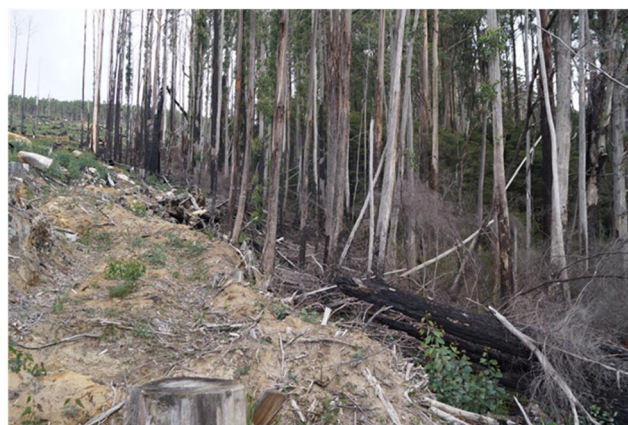
The regeneration burn in 10 You just know crossed containment lines into this riparian buffer area, which was planned to remain unharvested. EIA rating: moderate.

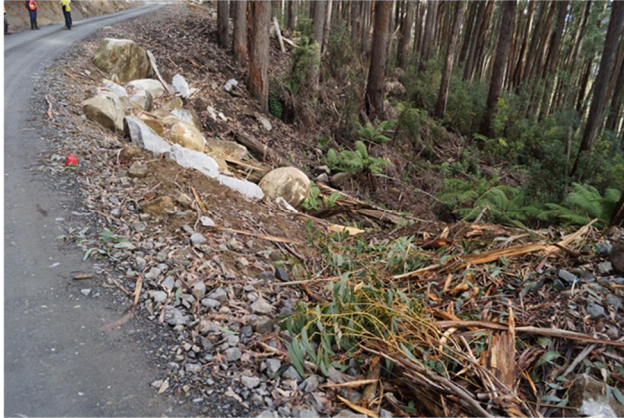
The bases of several live trees were covered by the road embankment for the in-coupe road constructed to access 3 Rocksteady. EIA Rating: minor

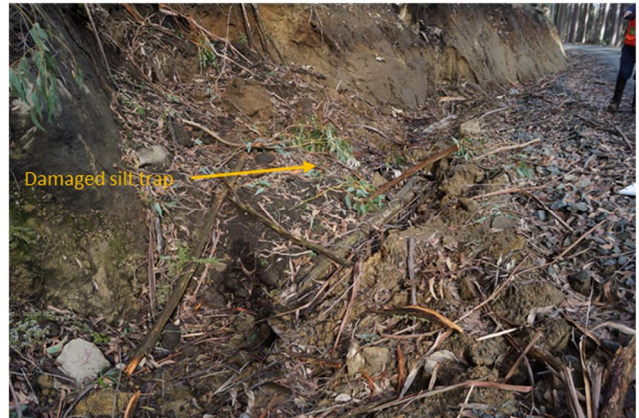
A silt trap was constructed to capture sediment carried by road drainage approaching a waterway crossing on 3 Rocksteady coupe. The silt trap has subsequently been damaged and is no longer effective allowing an extended section of the road to drain directly into the waterway.

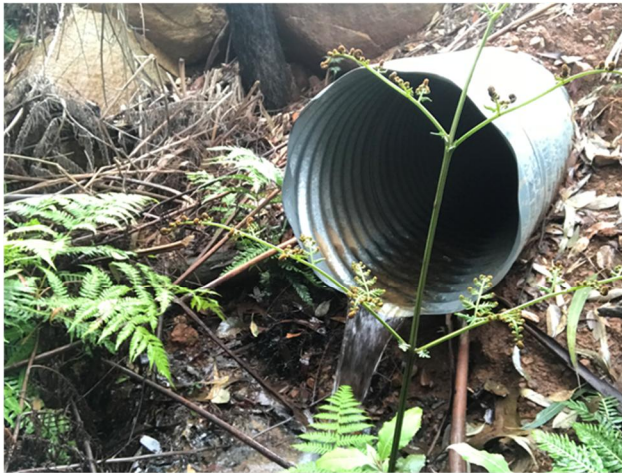
a) Culvert outlet located above the downstream bed of the waterway (1 Bear Grylls)

Recommendation to VicForests	Priority: moderate
V2: As part of its review of the construction of waterway crossings and in-coupe roads and during coupe monitoring, VicForests should ensure culvert outlets comply with regulatory requirements and do not discharge onto unprotected embankments or from above the downstream surface elevation.

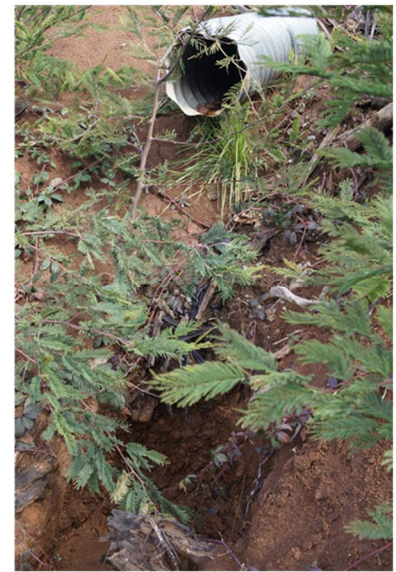
b) Road drainage culvert inappropriately discharging onto embankment materials (Zebra coupe, 2016-17 FAP audit)

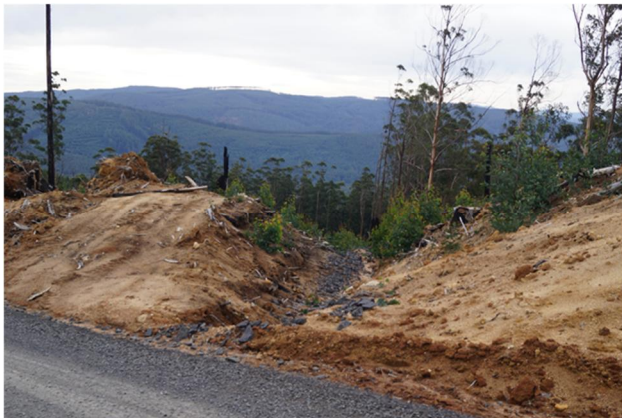
c) Road drainage culvert discharges onto drain across road embankment that has been protected using rock armouring (10 You just know)

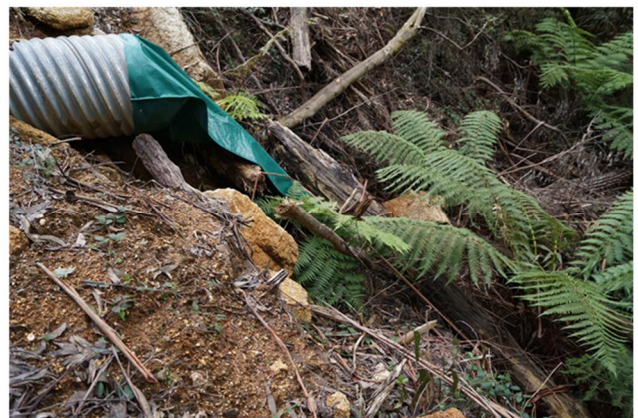
d) Outlet of waterway crossing discharged via a "sleeve" to the waterway. Aquatic fauna passage was not a relevant consideration at this location within the catchment (Hairy Hide coupe, 2016-17 FAP audit)

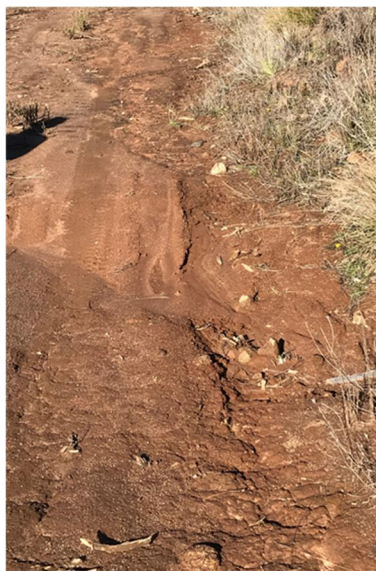
a) Relatively erodible soils on the in-coupe road to 25 Titanium coupe. Erosion has resulted in the cross-drainage structure being bypassed. Water quality risk was assessed by VicForests to be low, which was confirmed as accurate by the auditor.

It is recommended that the soil assessment procedures be reviewed to more appropriately classify erodible, but highly permeable soils.

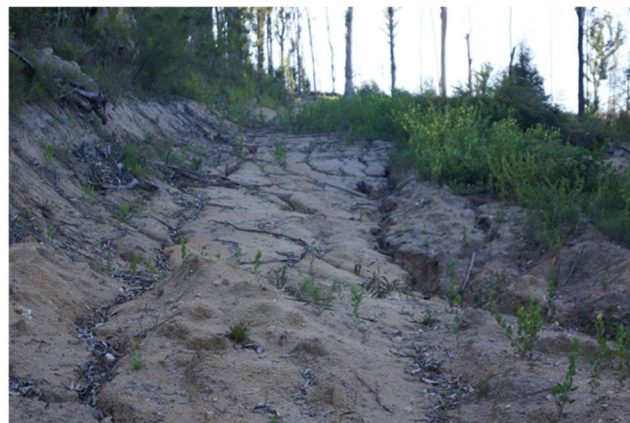
b) Erosion on in-coupe road ~1 year after coupe closure. Coupe was assessed to have low water quality risk by VicForests, an assessment that was confirmed by the auditor (Epiphone coupe, 2016-17 FAP audit)
