Forest Audit Program

2012-13 AUDIT OF COUPE REGENERATION AND FINALISATION

VW06982 | 26 July 2013

Document title: 2012-13 Audit of coupe regeneration and finalisation

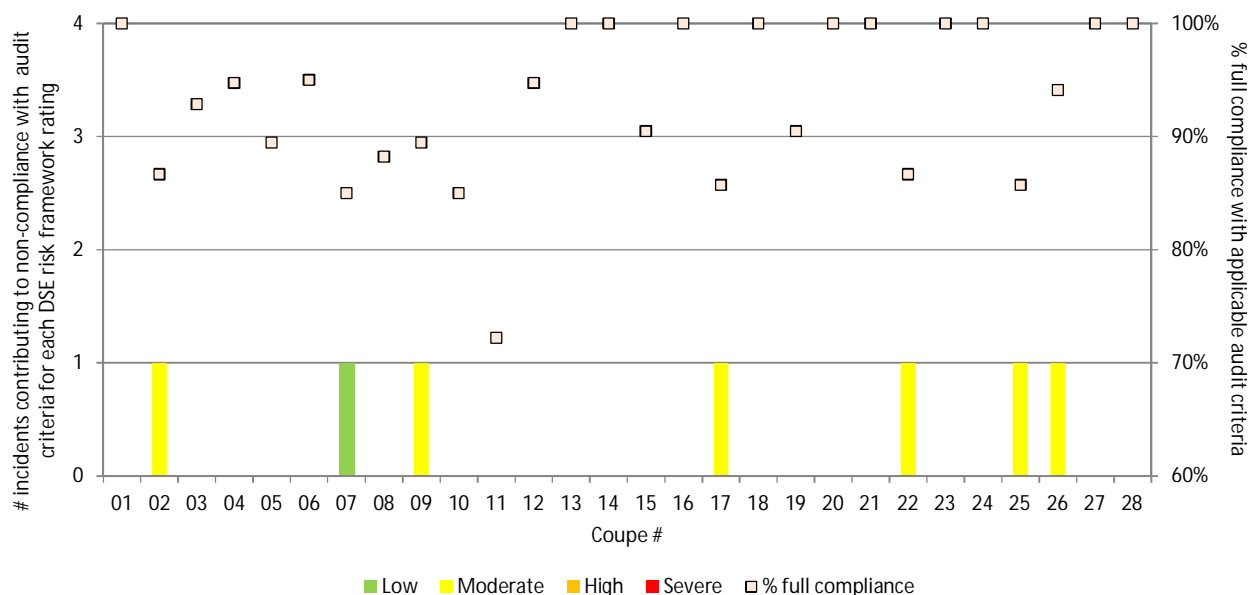
Figure 1 Summary of results from audited regeneration coupes: % full compliance with audit criteria (right vertical axis) and the number of risk ratings (using DSE Risk Management Framework) for incidents leading to non-compliance with audit criteria (left vertical axis).

Overall, the audit found that regeneration coupes fully complied with 93% of applicable criteria (Figure 1). Eleven of the audited coupes complied with all of the applicable criteria. One coupe (coupe 11) complied with less than 80% of applicable criteria.

Note: No non-compliances received the high or severe risk rating. Some non-compliances were not associated with direct environmental risk.

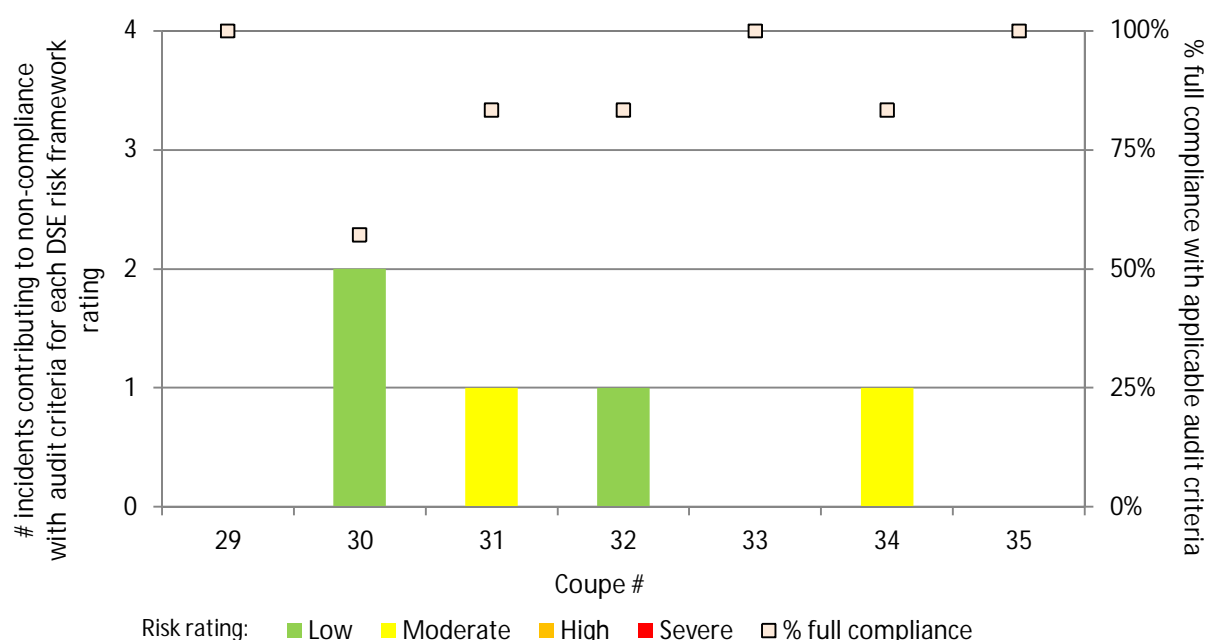
Figure 2 Summary of results from audited thinning coupes: % full compliance with audit criteria (right vertical axis) and the number of risk ratings (using DSE Risk Management Framework) for incidents leading to non-compliance with audit criteria (left vertical axis).

Thinning coupes included in the audit were found to fully comply with 86% of applicable criteria (Figure 2). Three of the audit coupes were found to be fully compliant with all applicable criteria.

Note: No non-compliances received the high or severe risk rating

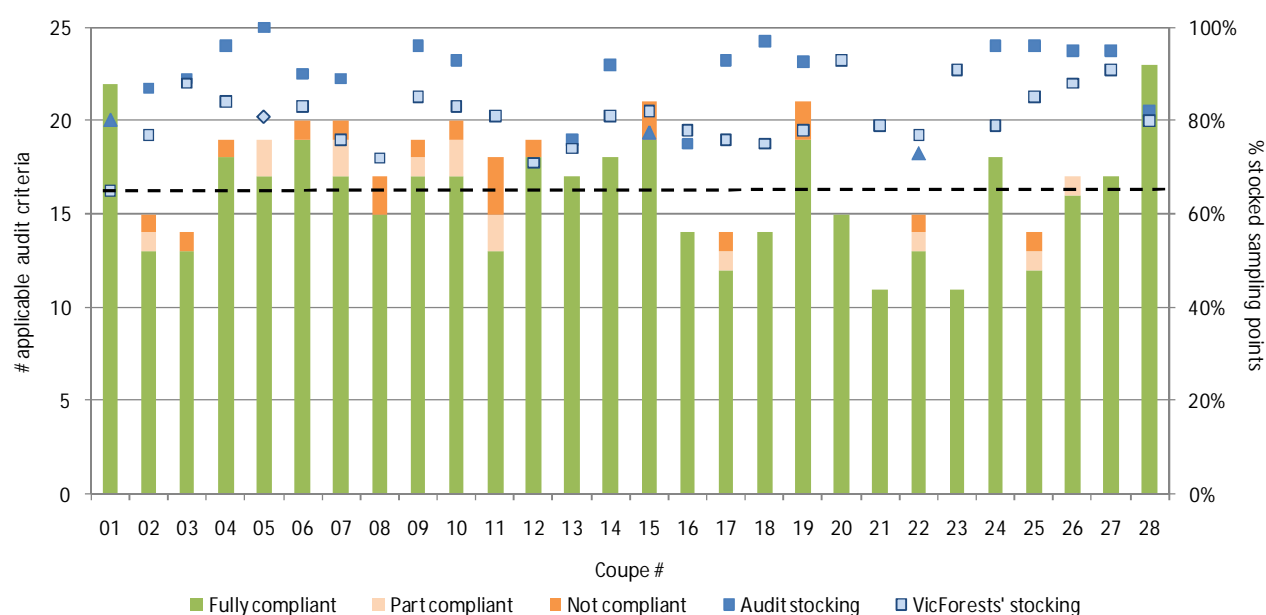
Figure 3 Compliance with audit criteria in regeneration coupes and results from audit and VicForests' stocking surveys.

Compliance with applicable audit criteria varied between coupes (Figure 3). At the extremes, 11 coupes were found to fully comply with all applicable criteria and one coupe complied with less than 80% of applicable criteria (coupe 11). An analysis of criteria for which non or partial compliance was detected is provided in Appendix C.1.

Note: Solid blue triangles flag the audit coupes for which stocking was assessed using a detailed, rather than reconnaissance survey. Reserve and inaccessible coupes in which field assessments were not carried out only have results for VicForests' ESS. All VicForests' ESS results are based on a standard survey (80x20 m grid), with the exception of coupe 05 (diamond symbol). The stocking result for this coupe is based on the results of an intensive ESS (40x20 m grid). The black dashed line represents the minimum acceptable stocking for a regeneration coupe, based on a standard (80x20 m) ESS [11]

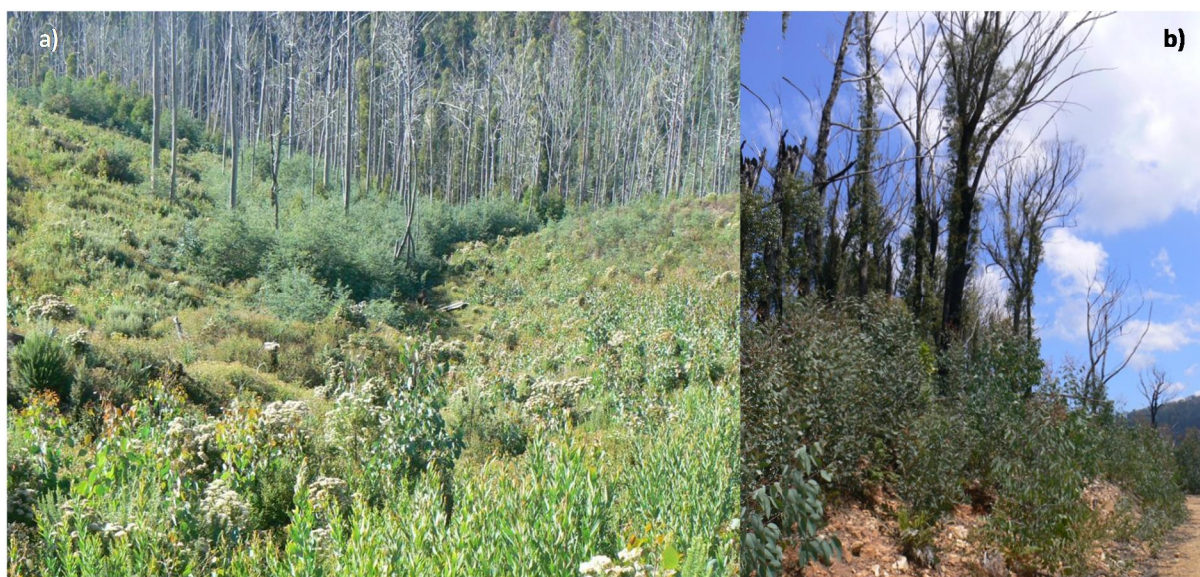
- > Coupe 17: where an attempt was made to rehabilitate the landing, but was not considered to provide suitable conditions for regeneration and regrowth (as required by section 2.5.3 of the Code). While the coupe as a whole has been successfully regenerated, the whole of the landing has not been. A moderate EIA rating was assessed for this incident.

- > Coupe 26: where the regeneration burn caused crown scorch in vegetation along a ridge line that was excluded from harvesting. The affected trees had epicormic shoots and were recovering from the effects of scorch at the time of the field audit. A burn plan was prepared for the coupe, approved by DSE and executed and hence the requirements of the Code (section 2.3.1; that "*all practicable measures must be*

taken to protect all areas excluded from harvesting from the impacts of fire”) were presumably met. However, the intent of the Code that exclusion areas are protected from impacts of regeneration burning has not been satisfied. The major EIA rating for this non-compliance is consistent with the way similar issues were dealt with in the 2012-13 Audit of harvesting and coupe closure [8].

Examples of non-compliance with audit criteria that were assessed to pose material environmental risk: a) placement of a rough heap in the head of a drainage line on coupe 09; b) crown scorch to an unharvested area adjacent to coupe 26 that resulted from planned regeneration burning.

- > Coupe 26: where (as described above) the regeneration burn has scorched the canopy of some trees in an exclusion area along a ridge line that sits above the coupe. Although a burn plan was prepared and executed, the requirement of the Code - to protect areas excluded from harvesting from the effects of fire – has not been fully satisfied.

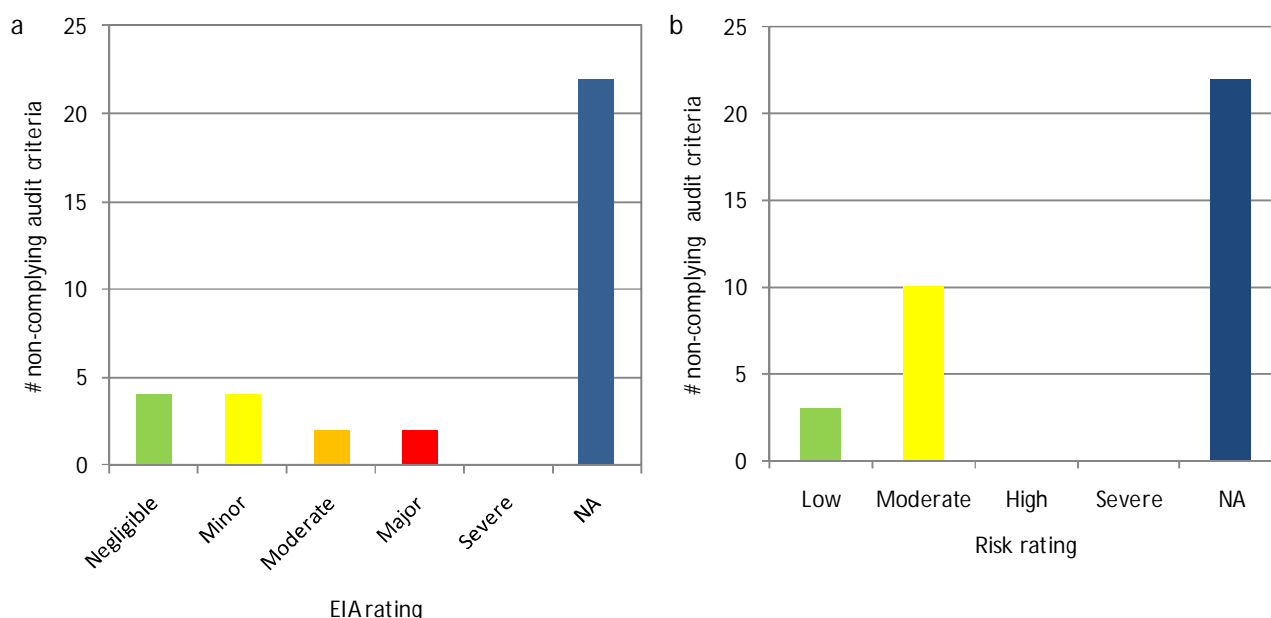
Figure 5 Assessments of environmental risk resulting from non-compliance with audit criteria for regeneration coupes, using a) EIA rating tool and b) DSE's risk management framework.

Seven incidents (sometimes comprising multiple instances of non-compliance with audit criteria) were identified where an EIA rating was applicable. Three of these (each associated with a different coupe) were found to pose a material environmental risk.⁸

The moderate risk ratings applying to the non-compliances observed on coupes 09 and 26 are considered to more accurately reflect risk of harm to the environment than the major EIA ratings.

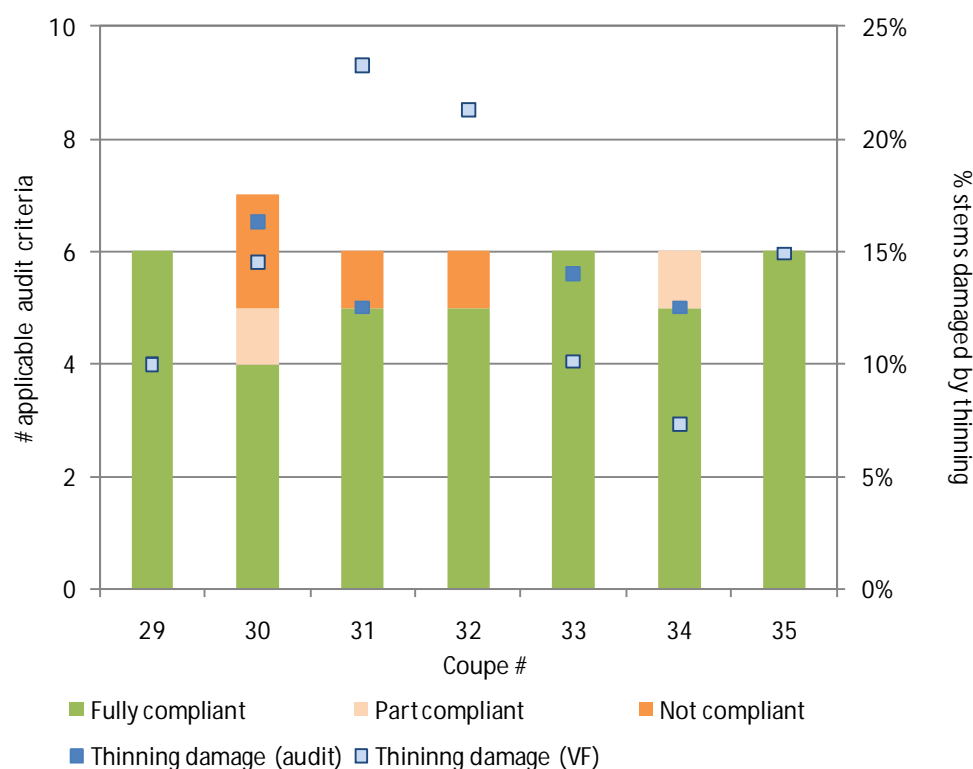
Figure 6 Compliance with audit criteria in thinning coupes and results from audit and VicForests' surveys of damage from thinning operations sustained by retained trees.

were found to fully comply with all applicable criteria. Coupe 30 fully complied with only four of the seven applicable criteria. An analysis of criteria for which non or partial compliance was detected is provided in Appendix C.2.

Note: Coupes 29, 32 and 35 were reserve coupes. No audit assessments of thinning damage were undertaken on these coupes.

- > Coupe 30: the audit found that thinning damage to retained stems was 16.3% and exceeded the acceptable limit of 15% prescribed by NFSG 14 [5]. This was slightly higher than the level of damage detected in VicForests' post-thinning surveys (14.5%), although the difference is within sampling uncertainties.
- > Coupe 31: the coupe was found to have experienced excessive damage as a result of the thinning operation (criterion 3). This included damage sustained by retained trees due to the thinning operations, as well as post-thinning windthrow of retained trees. VicForests' post-thinning survey found that 23.3% of retained stems had been damaged by thinning operations. The rate of damage identified during the audit was less (12.5%) and within the prescribed level. However, much of the coupe could not be sampled during the field assessment due to the extensive windthrow of retained trees.

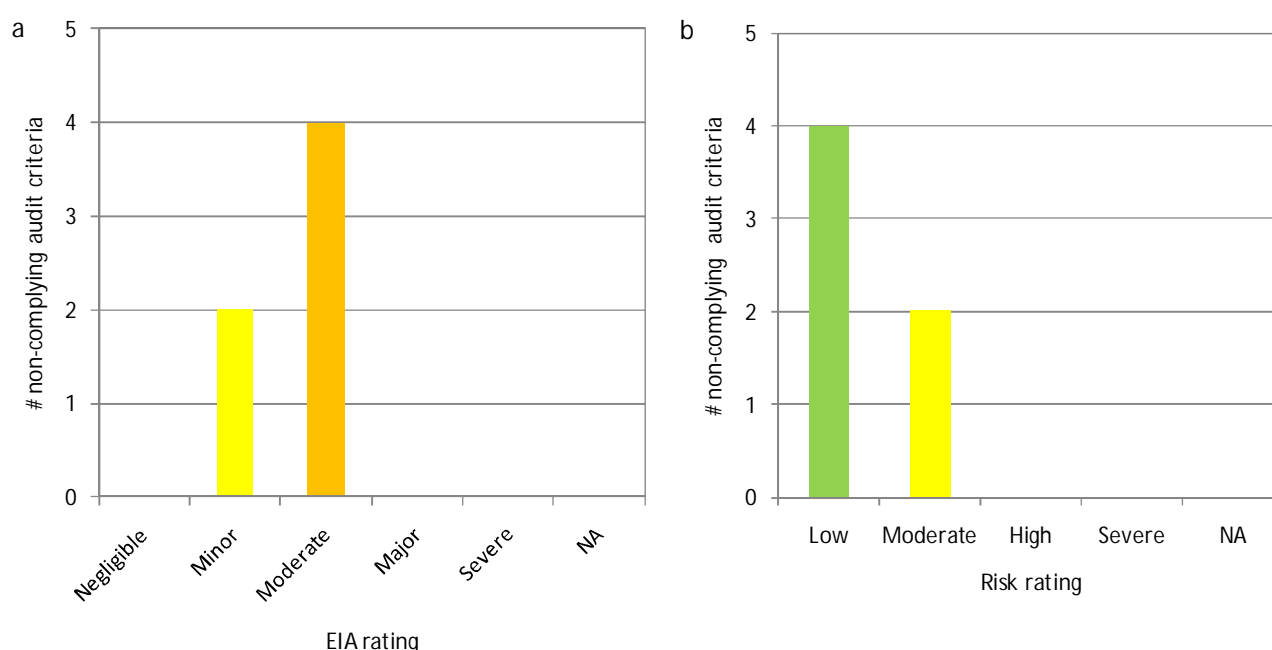
Figure 7 Assessments of environmental risk resulting from non-compliance with audit criteria for thinning coupes, using a) EIA rating tool and b) DSE's risk management framework.

The former DSE's Risk Management Framework found that only two of the six non-compliances posed a material (in this case moderate) risk of harm to the environment. These related to the incidents referred to (above) on coupes 31 and 34.
