Department of Environment, Land, Water and Planning

Forest Audit Program 2015 Environmental Audit of the Construction & Rehabilitation of Waterway Crossings

Final Report

24 February 2016

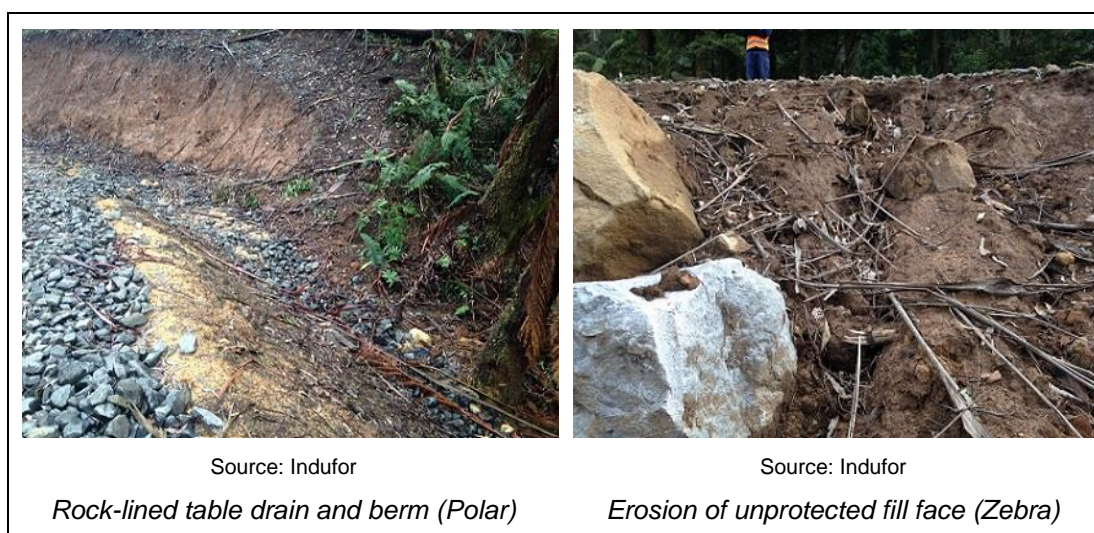
Sources of sediment were most commonly observed from erosion of fill faces from road runoff and pipe discharge, and a lack of or ineffective drainage structures to divert water off the road. In some coupes weaknesses in planning regarding the timing of construction had increased both the risk to and impact on water quality.

Figure 4-2 shows an example of the use of rock and a berm to control water runoff; and resultant erosion in the absence of protection of a fill face from water runoff.

Figure 4-2: Rock-lined table drain and berm; and erosion of an unprotected fill face

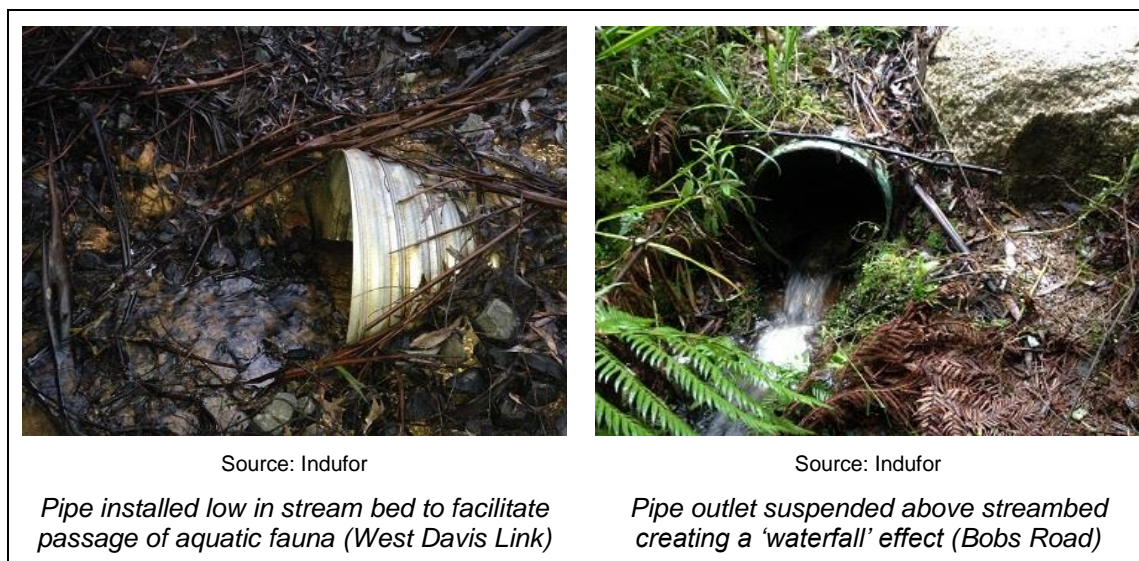
A high proportion of culverts had the pipe suspended above the stream which can potentially inhibit the migration of fish and other aquatic fauna along the waterway. It appeared that several of these culverts would have been compliant at the time of installation, but the non-inclusion of rock armouring of the stream bed at the pipe outlet had resulted in erosion post installation. A similar finding was noted in the 2014 audit report.

Figure 4-3: Pipe outlet positioning at the West Davis Link and Bobs Road coupes

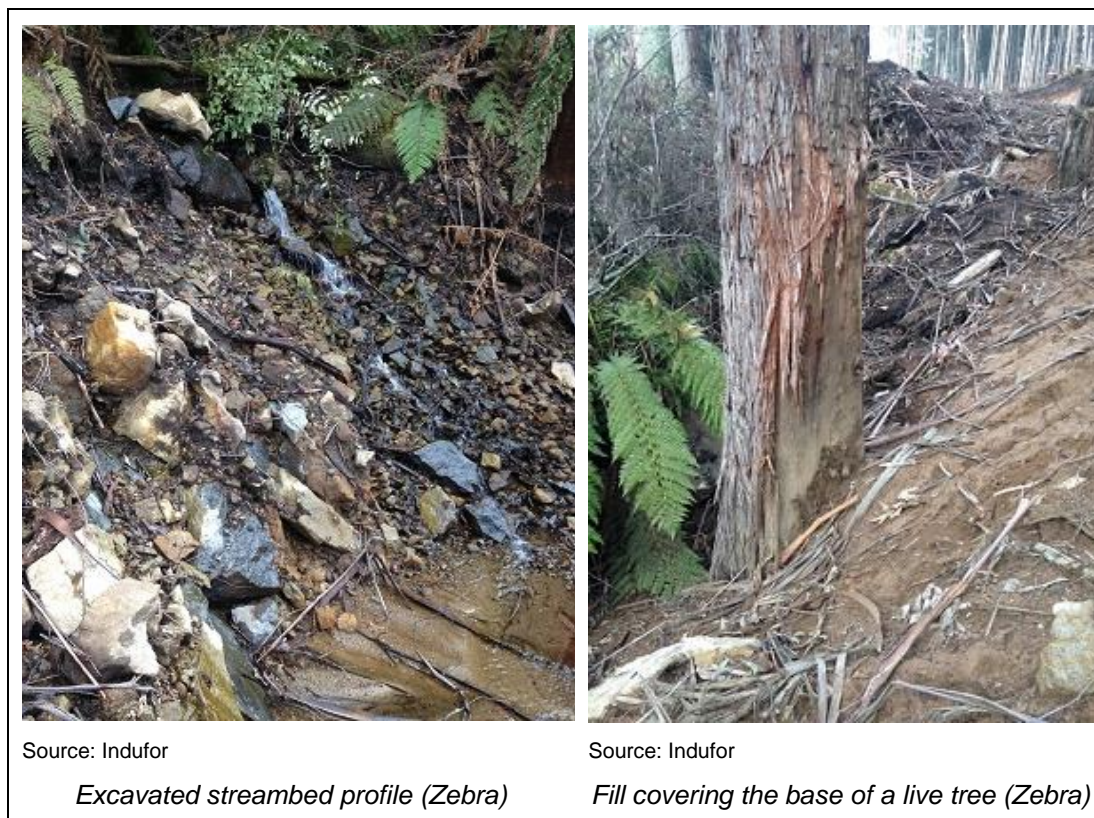
reference to design criteria or records of load design; and two instances of deep excavation established across the profile of the waterway at the culvert inlet in order to balance cut and fill. At two crossings, fill excavated during construction was observed covering the bases of live trees.

Figure 4-5 shows examples of non-compliance issues for which minor environmental risk ratings were determined.

Figure 4-5: Excavated stream bed profile; and fill covering the base of a live tree at the Zebra coupe

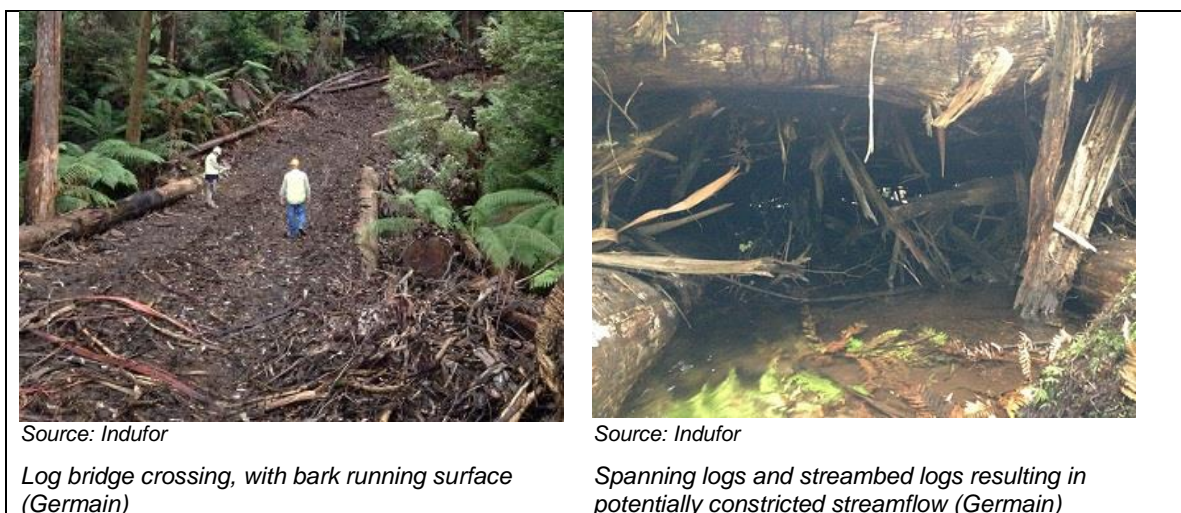
Figure 4-8 shows the bark-lined running surface of the crossing and the stream below the structure.

Figure 4-8: Germain snig track log bridge

Despite not having been constructed to any documented structural standards or in accordance with the DSE Bridge Policy (which is of more relevance to higher traffic road bridges), the crossing appeared to be bearing the traffic loads (harvesting machinery) well at the time of the audit.

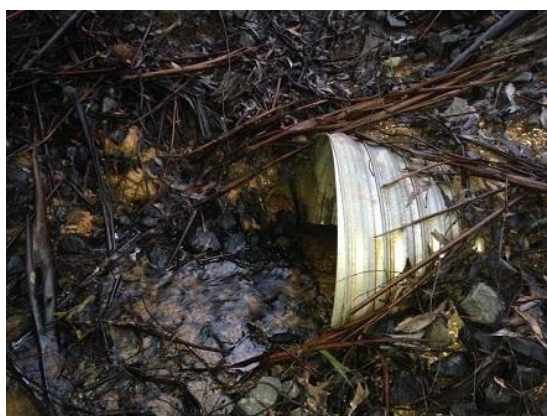
Culvert installed partially below the streambed to improve habitat and facilitate passage of aquatic fauna

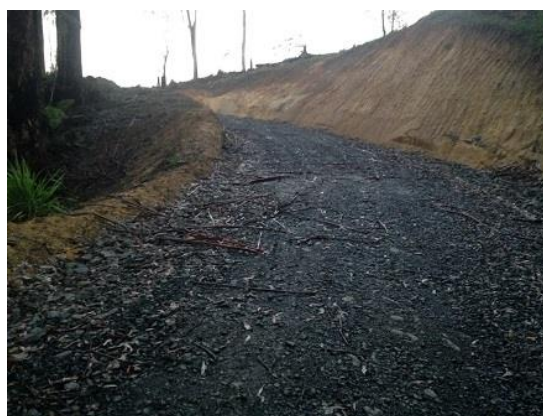
Box cutting and stable subsoil in cut

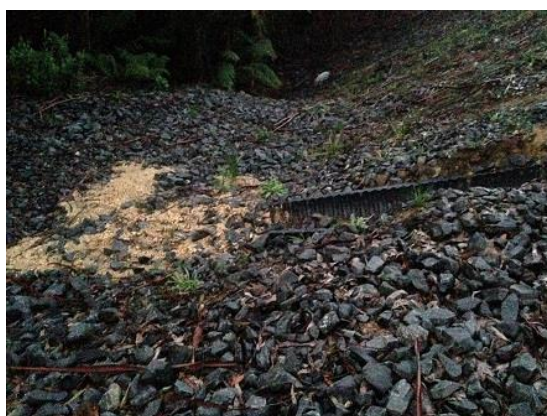
Sediment discharge onto rock beaching adjacent to waterway

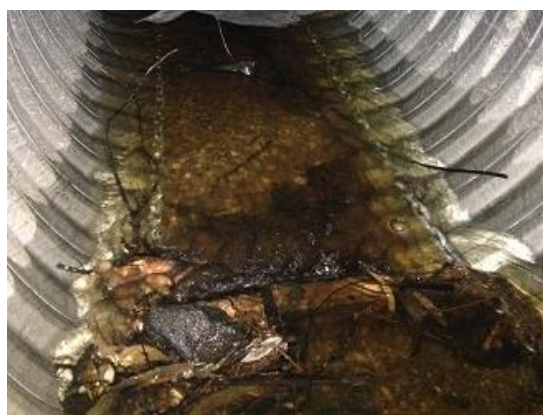
Fish ladder installed in pipe

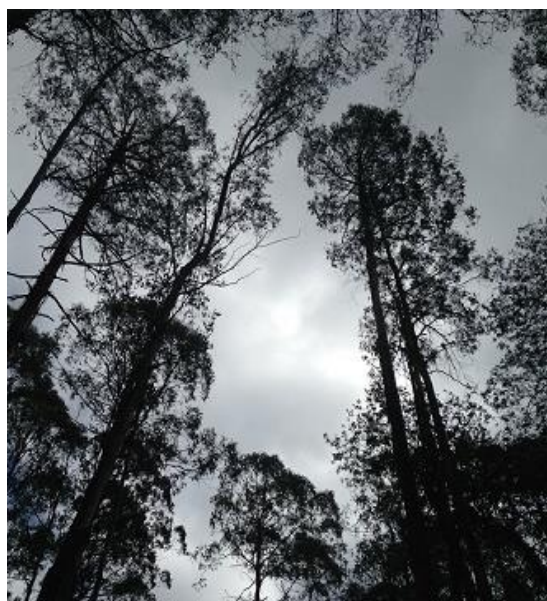
Minimal gap created in the buffer canopy from snig track construction leading to the waterway crossing

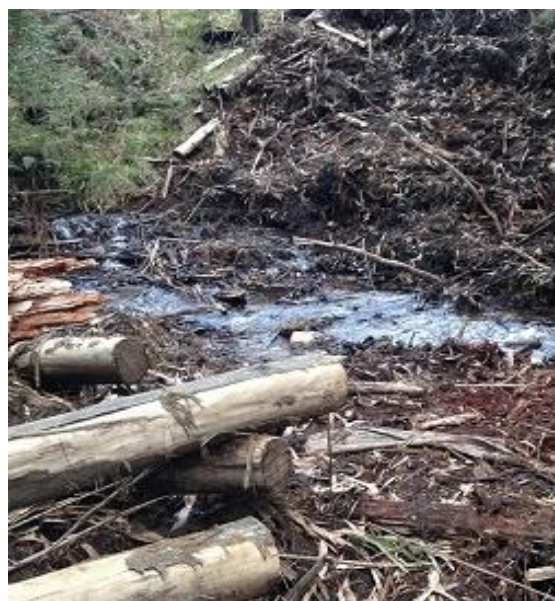
Bed and bank profile reflects that of the undisturbed portion of waterway after crossing removal.

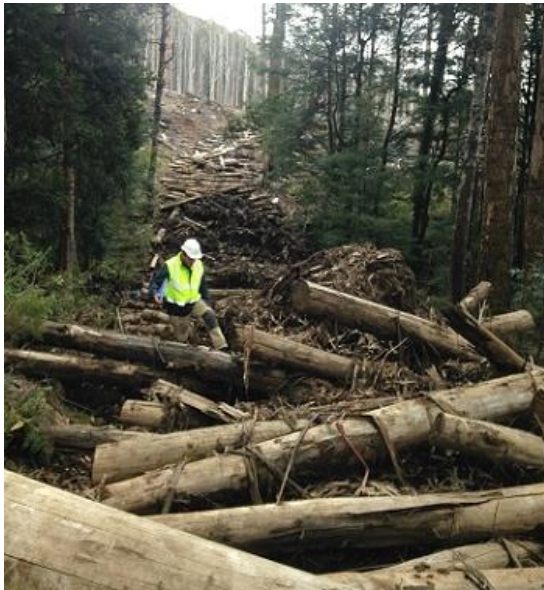
Narrow crossing width in middleground; retained cording in foreground

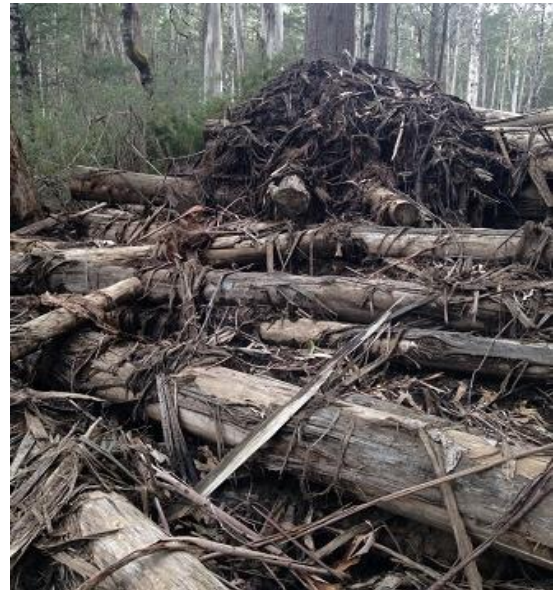
This retained cording will likely inhibit rainforest species from recolonizing for an extended period of time
