Module 1: Harvesting and Closure

Module 3: Regeneration and Finalisation

Environmental Audit Forest Audit Program 2014

Prepared for: Department of Environment and Primary Industries

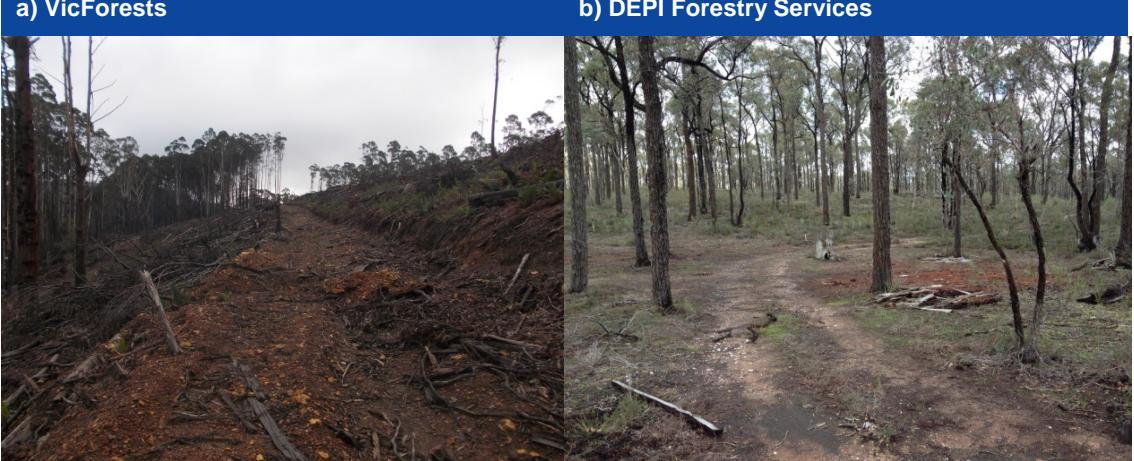
for a) VicForests; and b) DEPI Forestry Services a) VicForests b) DEPI Forestry Services

Typical topography, soil disturbance and harvest intensity of the audited coupes

There were large differences observed in the types of forest, landscapes and harvesting intensity at audited coupes managed by VicForests and those managed by DEPI Forestry Services. Generally the auditor recognised that DEPI Forestry Services managed coupes were less intensive and had lower overall risk of environmental impact. VicForests coupes generally occurred on steeper topography and had more intensive harvesting systems. In addition, the number of criteria applicable to DEPI Forestry Services coupes was significantly lower than those applicable to coupes managed by VicForests; which results in each instance of non-compliance having a larger percentage impact on the overall compliance score than those reported for VicForests.
