Audit of timber harvesting and forest regeneration in State forests in eastern Victoria

Department of Environment, Land, Water and Planning

Report on the 2016-17 Forest Audit Program

IS206000-P2-001 | Rev D

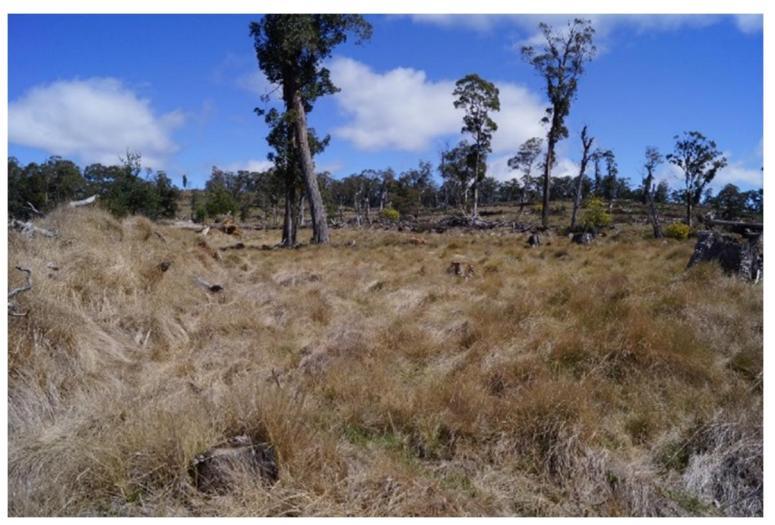
Tom's Track regeneration coupe (717-507-0013). Initial attempts to regenerate the coupe failed. The coupe was subsequently rough-heaped and replanted in a second attempt at regeneration.

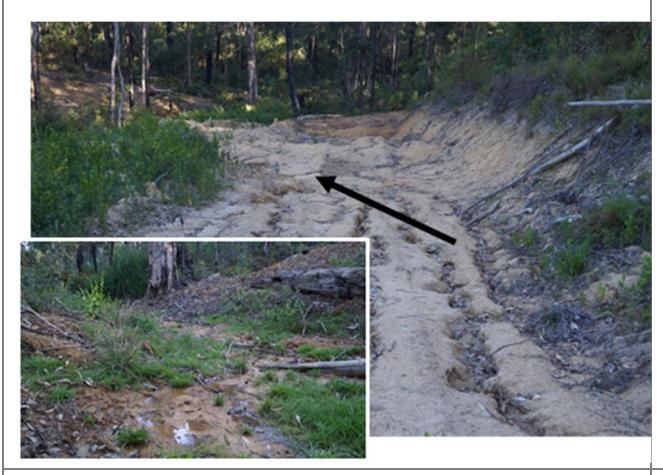
Erosion at the outlet of waterway crossing culverts

This culvert forms part of a crossing of a permanent stream at #7 Mosquito coupe. The culvert exceeds 750 mm in diameter and does not include a fish ladder as is required by the MSPs. While the outlet only drops water only a few centimetres into the downstream bed, it poses a barrier to the movement of aquatic fauna. Flows through the culvert have also led to a small amount of erosion.

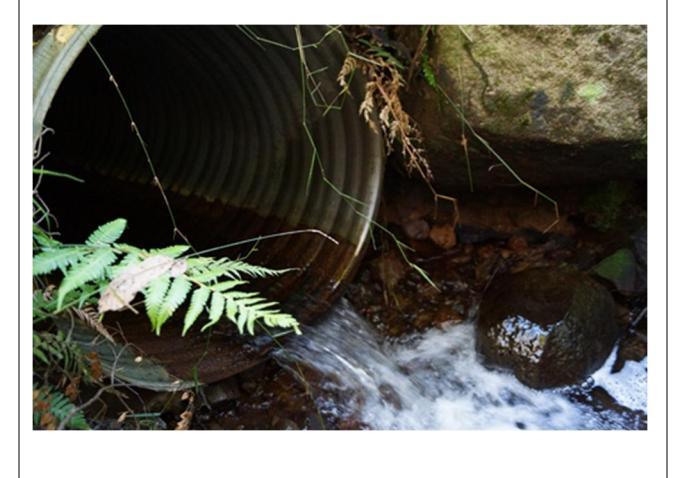
Provision of passage for fish and other aquatic fauna

This culvert was constructed to provide drainage for a crossing of a permanent stream at #4 Hogsmeade coupe. The culvert exceeded 750 mm diameter and its outlet dropped water 10-20 cm into the bed of the waterway.

While the culvert is stable and there is currently no erosion at the outlet, there is no fish ladder as required by the MSP. The culvert prevents all upstream movement of any fish or other aquatic fauna inhabiting the permanent stream.

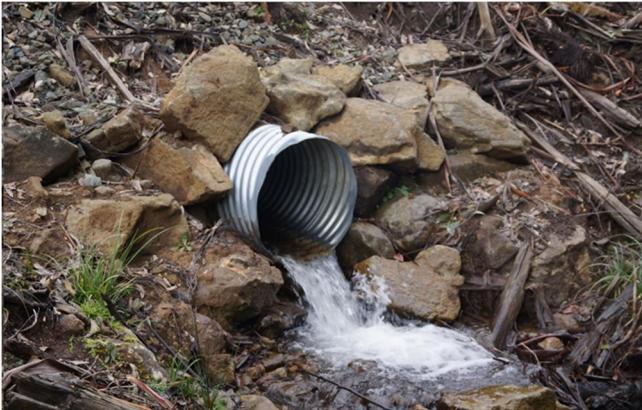
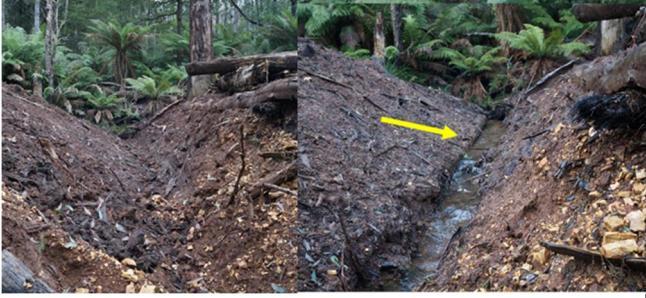
Inadequate rehabilitation of waterway crossing sites following culvert removal

The photographs show a rehabilitated waterway crossing on the approach to #9 Zombie coupe. The site was inspected in Phase 1 of the audit (in June 2017, left) and again in Phase 2 (in September 2017, right). Much of the embankment was left in place after the culvert was removed. Winter flows along the waterway have mobilised sediment from the embankment and deposited it downstream of the crossing.

In the September photograph, a log is observed to define the left hand stream channel (arrow). This was not visible in the June photograph. While the provides some protection against further erosion, it is clear that a significant volume of soil have been eroded by the temporary stream.

Inadequate rehabilitation of a crossing site following culvert removal: the culverts installed into waterway crossings on the entry to two of the audited coupes had been removed prior to the audit. In neither case was the embankment treated to reduce the entry of sediment into the waterway or to prevent sediment from being mobilised during higher flow events (see Box 1). This was considered to be inconsistent with the requirement (MSP 6.4.1.2, Code 2.2.1.7) to restrict soil movement and habitat disturbance following the removal of a culvert of log fill crossing and attracted a major environmental impact assessment.

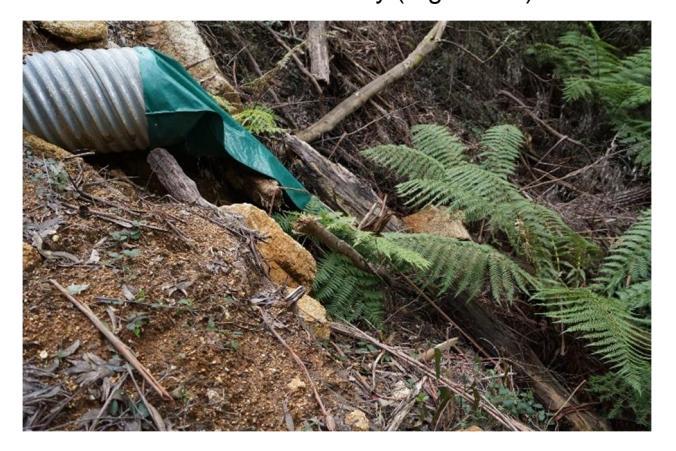
Figure 4.4 Waterway crossing culvert for temporary stream, #11 Hairy Hide coupe. The heavy duty plastic sleeve carries drainage flows to the waterway bed and minimises potential for erosion at the culvert outlet when this cannot be laid on the downstream bed of the waterway.

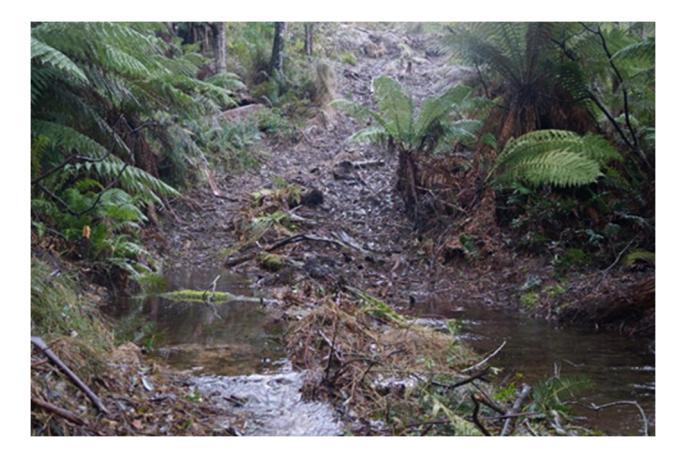
Figure 4.6 Construction of a path and crossing on a temporary stream at the entry to #9 Zombie coupe. This occurred following the removal of the waterway crossing on the nearby in-coupe road.

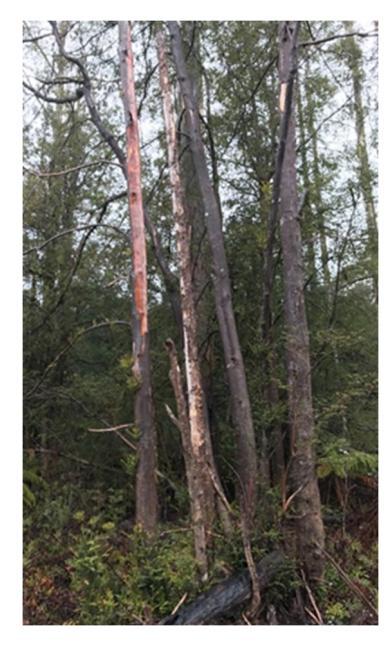
This latter situation was encountered in two coupes, #16 Ghee and #18 Tropical. Myrtle Beech trees adjacent to one of the coupe boundary tracks within #16 Ghee coupe were observed to have sustained damage which could enable Myrtle Wilt entry (e.g. damage to bark), although this was most likely due to damage from post-harvest windthrow and not harvesting (Figure 4.7). An area of Myrtle Beech trees within a riparian buffer on #18 Tropical coupe were killed by fire during the regeneration burn (Figure 4.7). While this is an unsatisfactory outcome, because the trees have been killed they are unlikely to host any outbreak of Myrtle Wilt. No non-compliance was recorded in either case.

#16 Ghee coupe – damage sustained by Myrtle Beech trees following harvesting

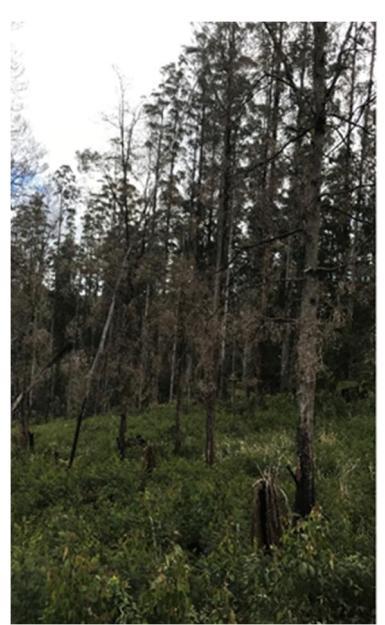
#18 Tropical coupe – damage caused by escaped regeneration burn.

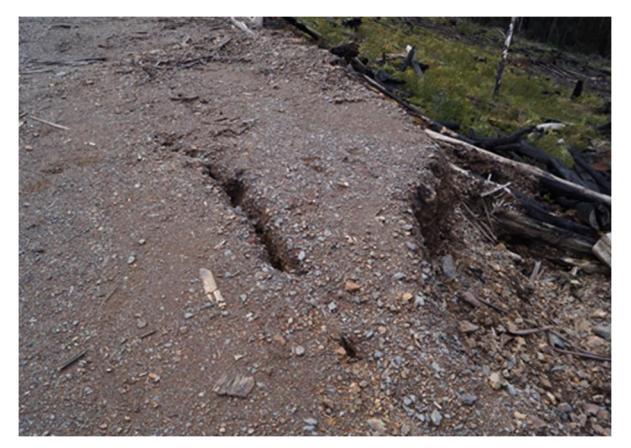
Sections of road or landing embankments on two coupes (#6 Zebra, #19 Turkey Neck) were found to be collapsing (Figure 4.9) at the time of the audit. It is not clear if this reflects a failure to develop a specific engineering design for the embankment or shortcomings in construction. As embankment failures were all located well away from sensitive riparian environments, the assessed environmental impact associated with non-compliances were negligible or minor.

#6 Zebra coupe: collapsing landing embankment. The landing is well removed from the nearest waterway.

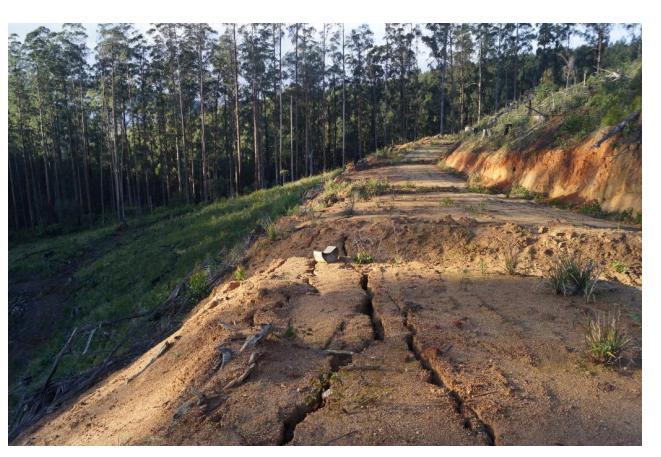
#19 Turkey Neck coupe: collapsing road embankment. This section of in-coupe road is located well away from waterways.

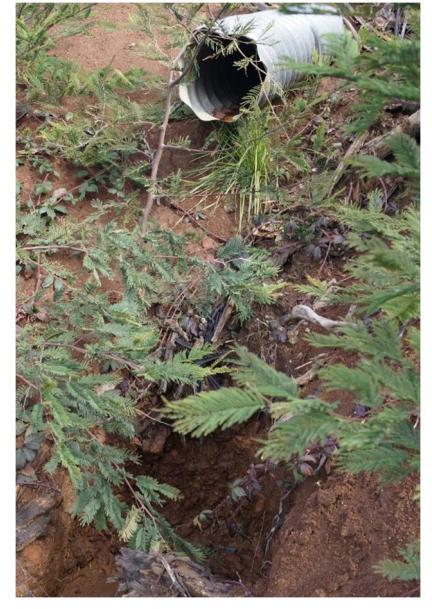
The outlet of the culvert drops water ~1.5 m onto unprotected embankment soil. Sediment from the eroding embankment does not reach a waterway.

Figure 4.10 Example of poor culvert construction, #6 Zebra coupe.

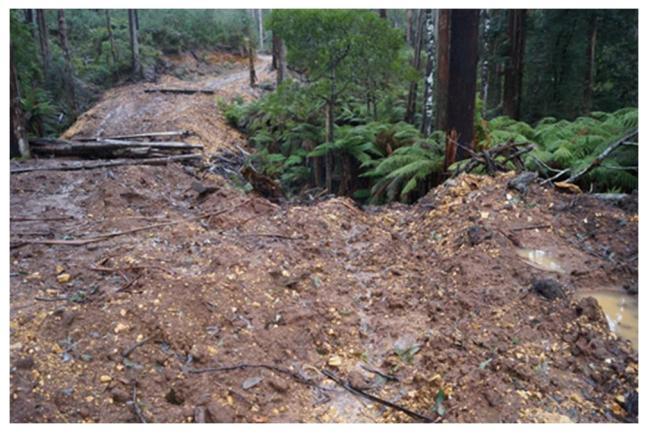
On the two coupes whose crossings were removed (#9 Zombie, #23 Epiphane), drainage from the final section of the (former) in-coupe road ran over disturbed soil directly into the waterway (Figure 4.12) and most likely picked up further sediment. Despite the inappropriate drainage construction, sediment from both roads appeared to have mostly been intercepted by vegetation along the drainage line.

#9 Zombie coupe: drainage flows across highly disturbed soil before entering the temporary stream.

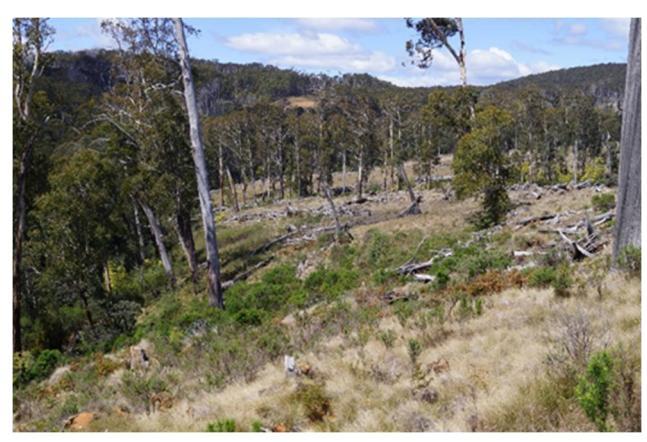
#31 Toms Track North coupe, view across coupe towards #32 Toms Track coupe. Both coupes are dominated by alpine grasses and non-eucalypt regeneration

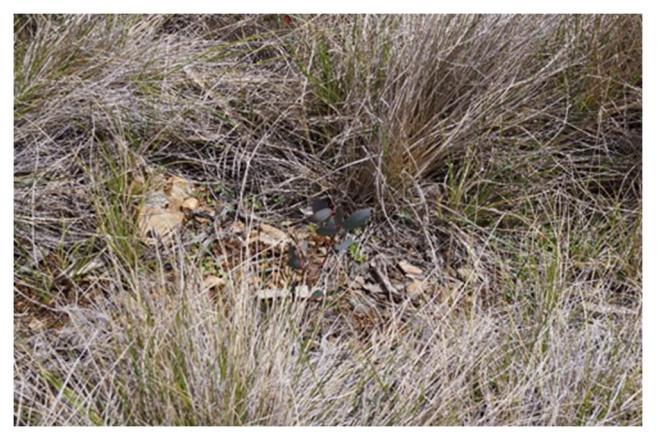
Eucalypt seedling, #32 Toms Track coupe. This seedling is <20 cm tall and is not "acceptable" for the purposes of a regeneration survey (MSP 9.1.1.5). Similar seedlings were distributed at relatively low density across coupes #31 and 32.

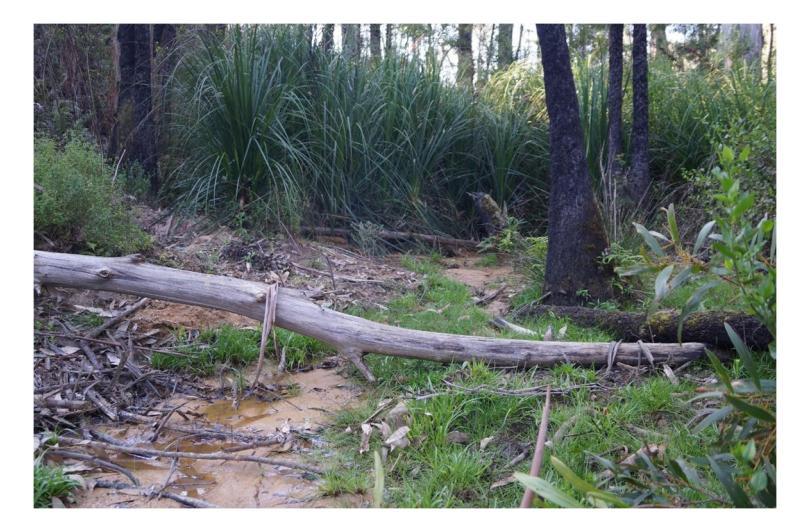
Sediment in temporary stream on the entrance to #23 Epiphone coupe.

Sediment deposited into this temporary waterway results from non-compliant drainage of the in-coupe road and poor rehabilitation of the waterway crossing following removal of the culvert. Several non-compliance incidents were identified on this coupe with the crossing with moderate environmental impact.

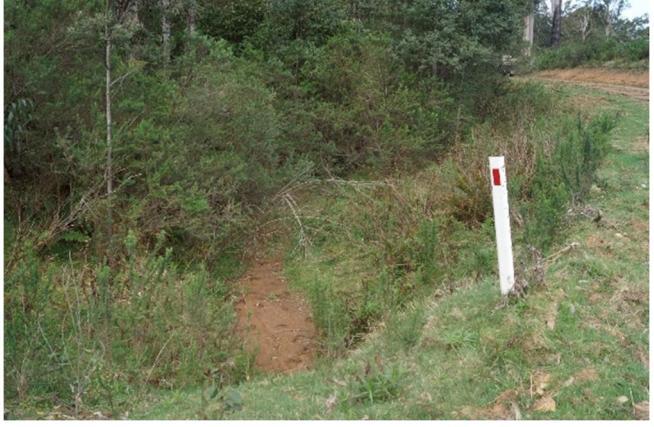
The audit assessed sections of the permanent forest road network adjacent to two of the selected coupes (#21 Net Set Go, #25 Last Minute). These roads were used to haul logs from these and nearby coupes. Drain spacings for the road adjacent to #21 Net Set Go were not compliant with MSP requirements (for the slope and soil erosion hazard). VicForests upgraded the road surface²⁸, but did not correct the drainage so that it was compliant with MSP requirements. Over 100 m of road drained directly into a drainage line waterway crossing adjacent to #21 Net Set Go. There was no sediment trap and as a result, significant quantities of sediment were deposited in the waterway (Figure 5.2).

Photograph shows sediment from a permanent road deposited in outlet of a drainage line waterway crossing. The culvert also did not comply with MSP requirements for diameter and cover (at inlet).
