Forest Audit Program 2015: Audit of In-coupe Roads

Environmental audit of the construction and maintenance of in-coupe roads

IS112500-010 | V2.3

02/03/2016

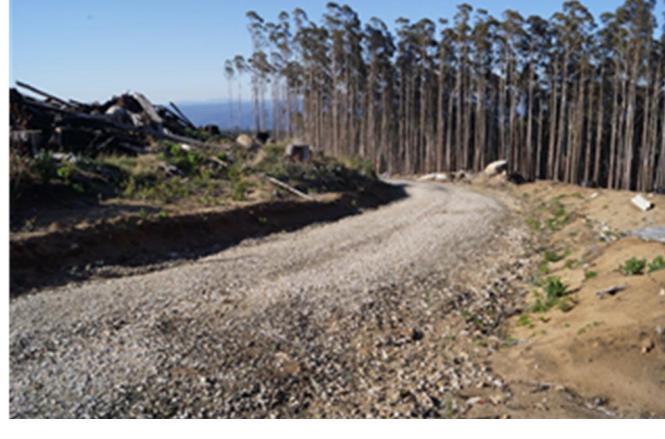
Example of in-coupe road used to access Superstop (480-508-0007) and several other coupes over a period of several years. While this road was generally very well-constructed, some sections were not effectively drained on both sides. There were no observable environmental impacts associated with this.

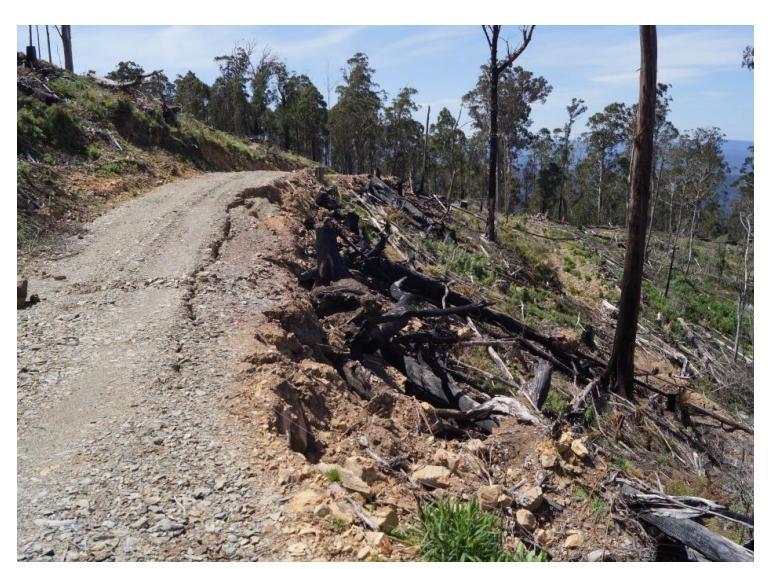
The assessed environmental impact ranged between negligible and moderate, with the latter assessed on one coupe (Staff [526-502-0007]) in which a large embankment across a steep slope had begun to fail.

Road through a steeply sloping wet area on Staff coupe (526-502-0007). The embankment has begun to fail and further mass soil movement is likely.

- *VF-02:* VicForests should be more proactive in seeking engineering advice on the design and construction of in-coupe roads where they will traverse areas of steep slope and require deep side cuts and/or large fill embankments to be constructed. The precise limits for seeking engineering advice prescribed by the MSP (i.e. 30°/25° for areas with lower/higher soil erodibility) are not necessarily consistent with the limited accuracy of available topographic mapping, digital elevation models or field measurement. It is recommended that engineering advice is sought in these higher risk areas, based on the possibility (>50% chance) that:

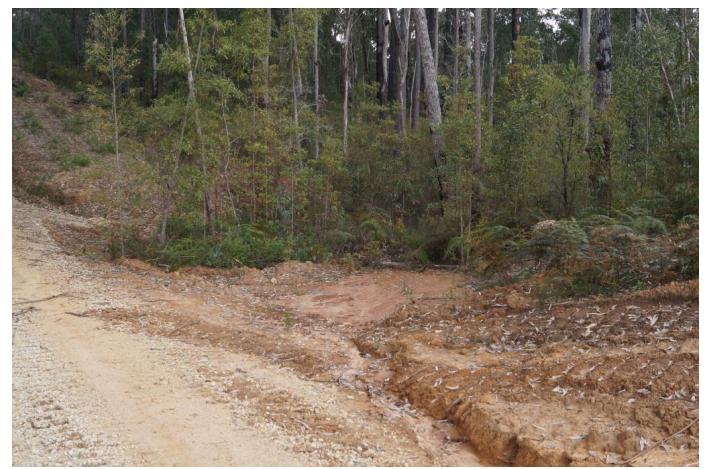
Figure 4.4 Waterway crossing at the boundary of Lumpy coupe (#24). The road did not have the necessary drainage diversion structures and consequently sediment has entered the drainage line.

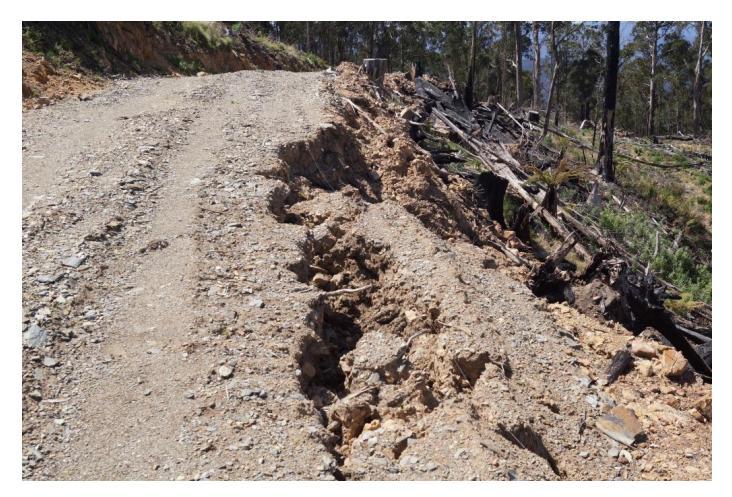
Figure 4.5 Road in Funfair coupe (#7) traversing a steep slope. The embankment failed due to water movement below it and is likely to continue to collapse. Engineering advice on construction was not sought. EIA rating is currently moderate, but the environmental impact may worsen as the embankment continues to fail.

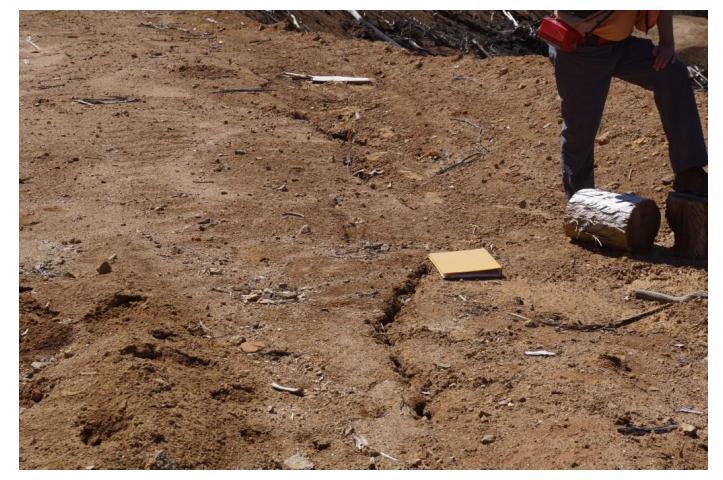
Figure 4.8 Cracking in a landing embankment located on a steep slope in Dapples Creek coupe. It is likely that part of the landing will fail, resulting in mass soil movement down slope. No evidence that engineering advice was sought for the construction of this landing was found during the audit.

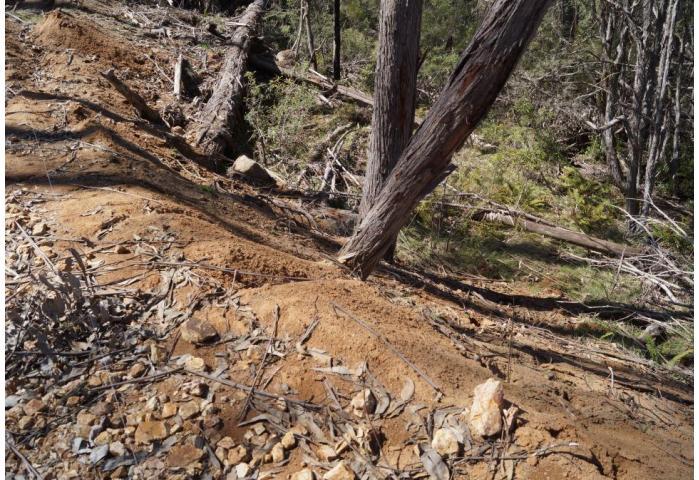
Figure 4.11 Fill batter covering the bases of live trees outside the harvest area of Dapples Creek coupe.

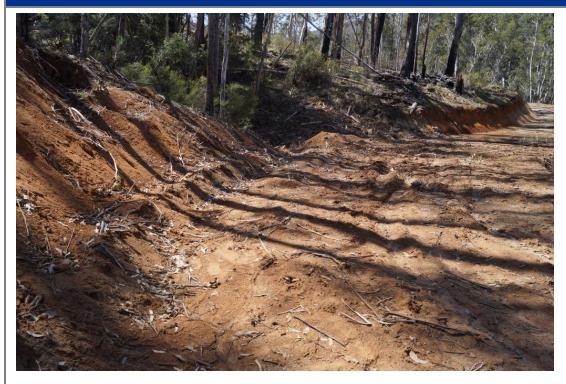
Case study #1 Dapples Creek coupe: Four waterway crossings. EIA rating for non-compliance issues: up to major.

Road drainage delivered directly to waterway and culvert entrance.

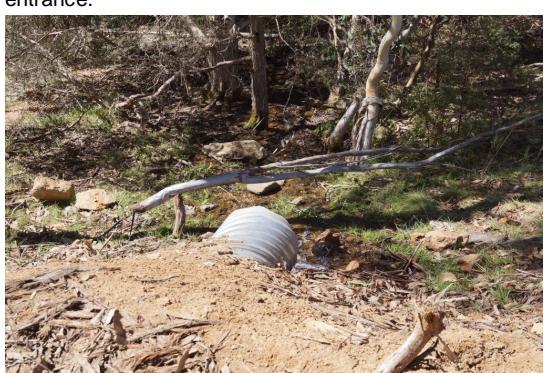
Culvert discharging water from above the base of the waterway crossing embankment.

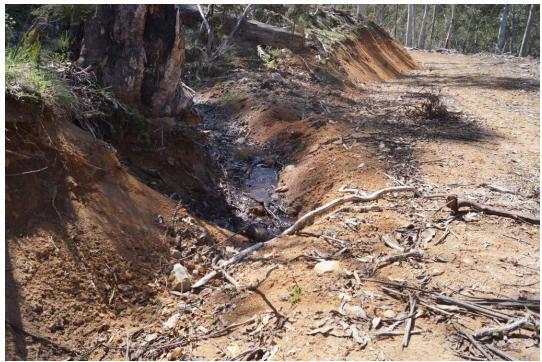
Soil from embankment has been used to divert flow towards the culvert entry.

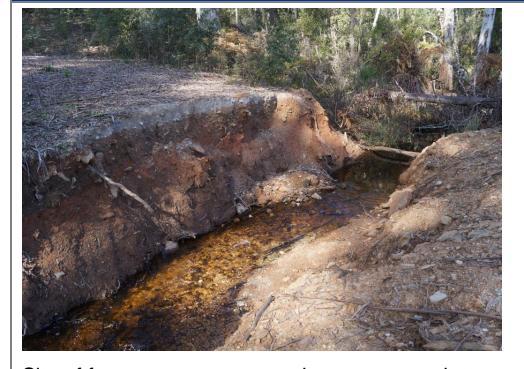
Case study #2 Buttons coupe: Single waterway crossing. EIA rating for non-compliance issues: up to major.

Site of former waterway crossing on approach to Buttons coupe. No remedial work had been undertaken to stabilise the embankment following removal of the culvert.

- *DE-03:* Given the significant non-compliance issues which were observed for waterway crossings in the 2015 FAP, DELWP should maintain a focus on waterway crossings in the 2016 audit program.
- *DE-04:* DELWP should include a mandatory action in the MSP to ensure that VicForests and its contractors take appropriate action to stabilise former waterway crossing sites following the removal of culverts.

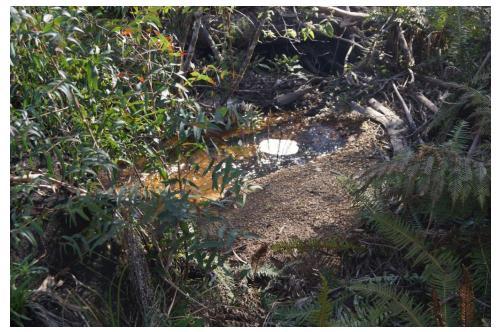
Sediment deposited in the waterway, downstream of the former crossing.

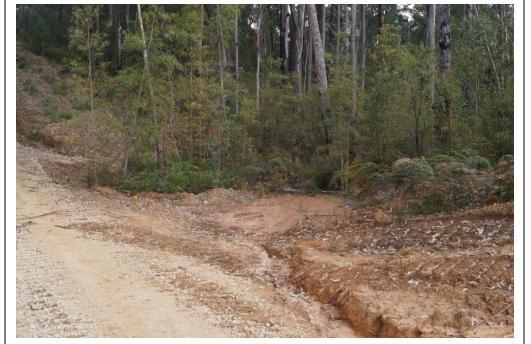
Case study #3 Lumpy coupe: Single waterway crossing. EIA rating for non-compliance issues: up to moderate.

Sediment delivery into the downstream side of the waterway crossing.

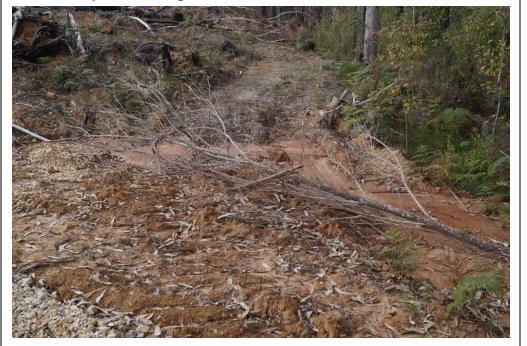
Sediment delivery into the upstream side of the waterway crossing.

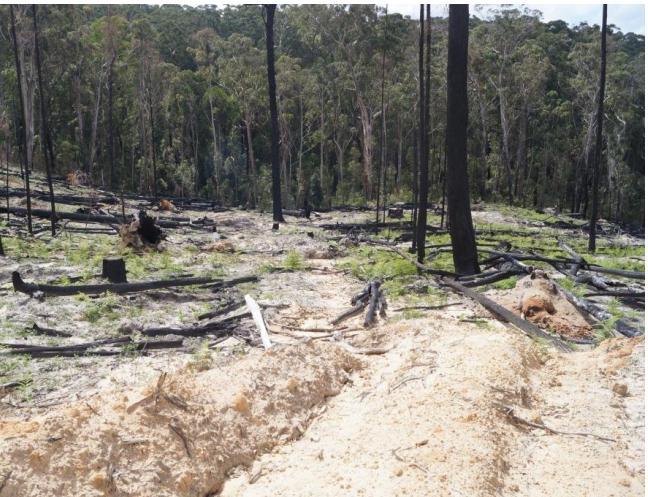
Figure 4.15 Sediment from road drainage in Lumpy coupe was observed to run for up to 50 m during the regeneration period, when groundcover is limited. In-coupe roads are typically sufficiently remote from waterways that sediments are not discharged into them. Sediment transport distances quickly decline as the understorey regenerates.

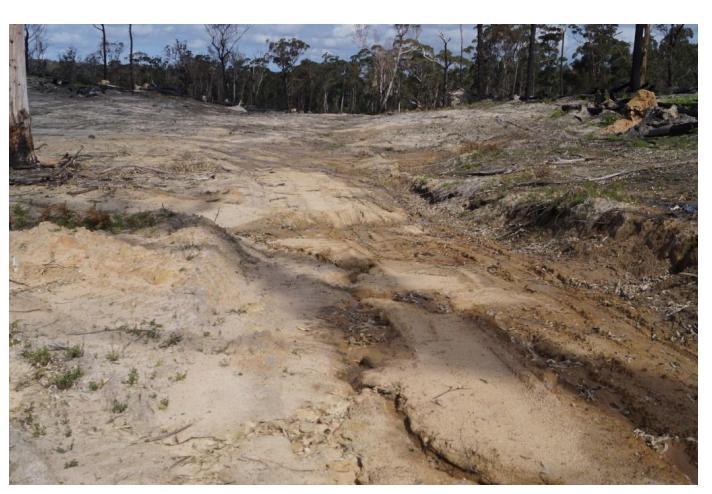
Figure 4.17 Failure of cross drains in Donkey coupe. Cross drains

VicForests should explore the more widespread use of rollovers or similar, trafficable cross-drainage structures for in-coupe roads. This type of structure has been observed to be used effectively by VicForests in some settings and by other Victorian forestry operators. They are also widely used in forest and rural roading in tropical and sub-tropical regions of Australia. Rollover structures reduce the need for culverts and, if properly constructed, should function effectively through and following harvesting. They are generally more stable and resilient to damage by post-harvest traffic than traditional "bar and breach" cross drainage structures.
