Forest Audit Program

2012-13 AUDIT OF HARVESTING AND COUPE CLOSURE

VW06734 | 7 June 2013

Document title: 2012-13 Audit of harvesting and coupe closure

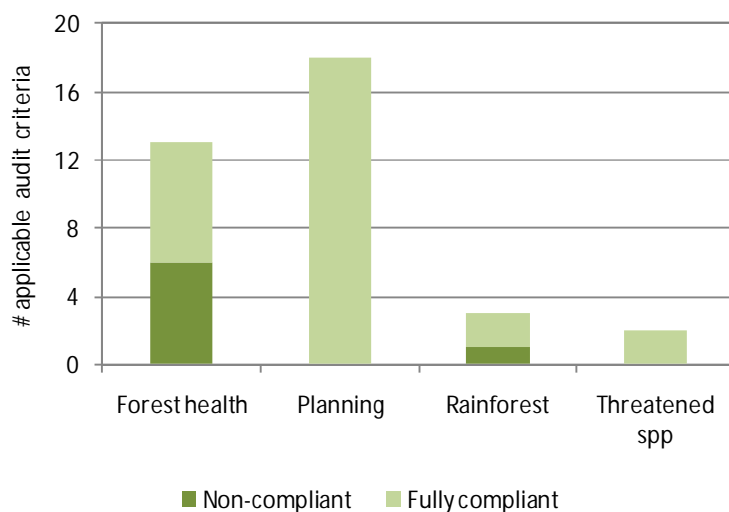
The extent of compliance with audit criteria varied between themes in the biodiversity conservation workbook (Figure 15). Non-compliances were only recorded for forest health and rainforest criteria. EIA ratings were only applicable to non-compliances in relation to forest health criteria (and were minor or negligible; Figure 14).

Figure 15 Compliance with main themes for workbook 5C: forest health; planning and management; rainforest; and threatened species. Non-compliant includes non and partial compliance with audit criteria.

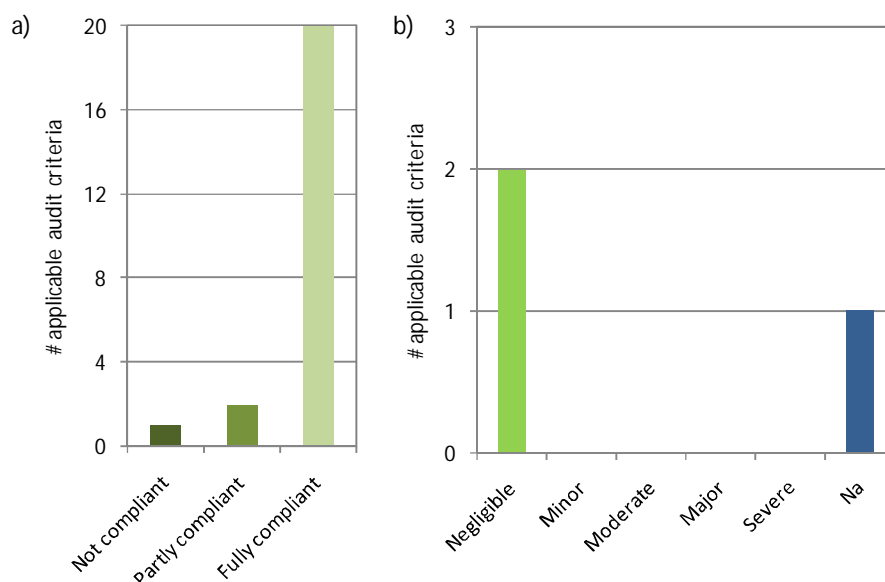
Workbook 5D for operational provisions includes 18 compliance elements (Appendix A) relating to the management of harvesting operations. The audit found that 87% of applicable audit criteria were fully satisfied and that a further 9% of applicable audit criteria were partly satisfied (Figure 16).

Figure 16 Overview of compliance with operational provisions audit criteria for coupes managed by DPI. a) Instances of non, partial and full compliance with applicable audit criteria; b) Number of non or partly compliant audit criteria to which EIA ratings have been applied or were not applicable.

Non-compliance was identified for three individual audit criteria. The EIA rating tool was applied to two of these and was negligible in both instances of non-compliance (Figure 16). Detailed comments on non-compliances are given in Appendix D.4.

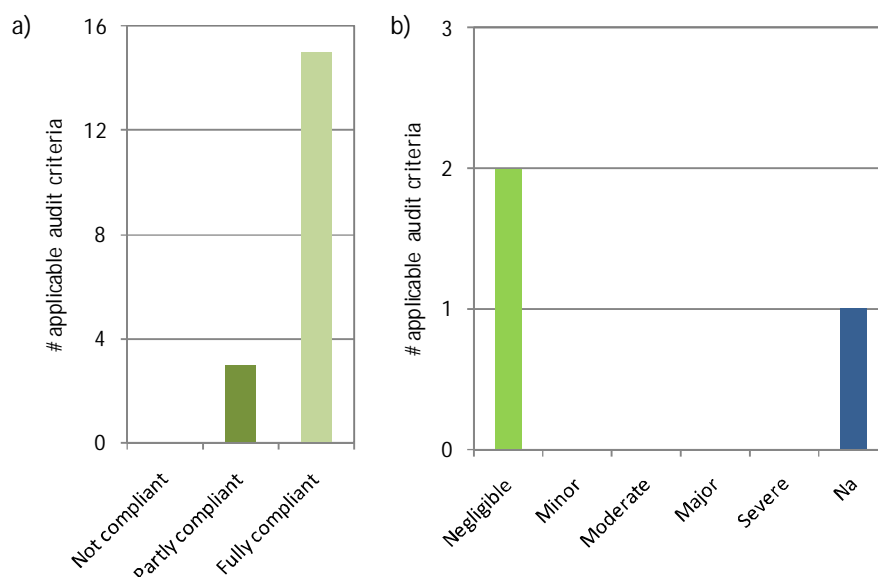
The audit found that 80% of applicable audit criteria were fully satisfied and that a further 7% were partly satisfied (Figure 17). EIA ratings were applicable to two of the three criteria for which non-compliance was assessed. EIA ratings were negligible in both instances. Detailed comments on non-compliances are given in Appendix D.5.

Figure 17 Overview of compliance with roading audit criteria for coupes managed by DPI. a) Instances of non, partial and full compliance with applicable audit criteria; b) Number of non or partly compliant audit criteria to which EIA ratings have been applied or were not applicable.

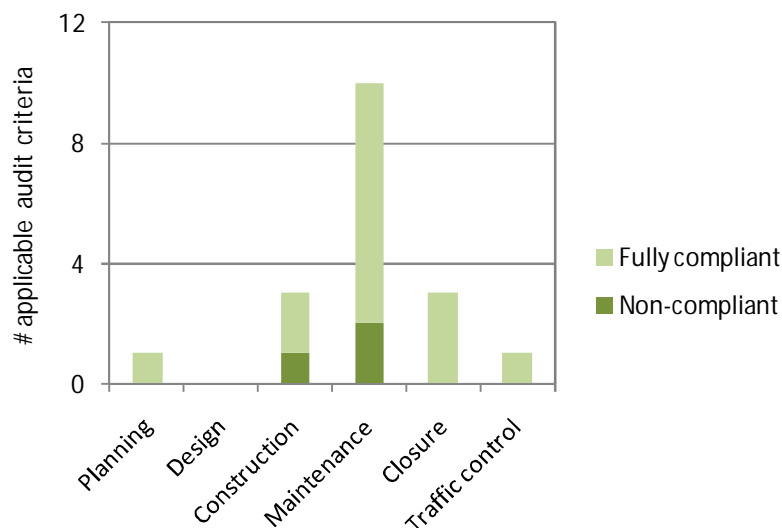
The extent of compliance with audit criteria varied between themes in the roading workbook (Figure 18). Non-compliances were only recorded for three criteria, one in the construction theme and the other in the maintenance theme. None of the road design criteria were applicable to the audited coupes.

Figure 18 Compliance with main themes for workbook 5E: road planning, design, construction, maintenance and closure and traffic control. Non-compliant includes non and partial compliance with audit criteria.

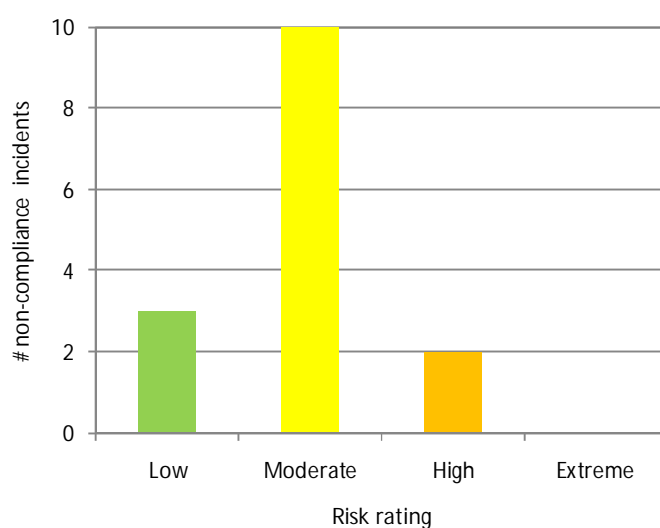
A further risk assessment was undertaken for each of these incidents using the former DSE's Risk Management Framework (Appendix B.2). This second assessment was undertaken to place the environmental risk resulting from non-compliance with management prescriptions and the required management response in the context of other risks faced by DSE. Details of the assessment are provided in Appendices E.1 for VicForests' operations and E.2 for the former DPI's operations. The results are summarised in Figure 19. Risk was assessed to range between low and high. Ten of the 16 incidents were rated as moderate risk. The two incidents assessed to be in the high risk category (Figure 19) were:

- > Coupe 12: where almost the entire gross coupe area was harvested. When combined with disturbance from follow up burning and rough heaping to assist in regeneration, the coupe retained no long-lived understorey elements within the harvestable area, as is required by the Code. A moderate EIA rating was assigned to this incident. This issue is addressed by recommendation 3.7
- > Coupe 33: where part of the road into the coupe drained back into a permanent stream, without opportunity for drainage water to be diverted into and filtered through natural vegetation or constructed features. Sediment and gravel from the road was observed to have been deposited in the stream, although not in large quantities. A major EIA rating was assigned to this incident. This issue is addressed by recommendations 3.8 and 5.1.

Figure 19 Summary of assessment of risk of harm to the environment assessed using the former DSE's Risk Management Framework. Only incidents leading to non-compliance with audit criteria and EIA ratings of moderate or major were included in the risk assessment.

Details of other incidents included in the analysis are provided in Appendices E.1 and E.2 and can be cross-referenced with detailed descriptions in sections 3 and 4. The two low risk incidents received major and moderate EIA ratings (coupes 27 and D, respectively). Incidents in the moderate risk category received either moderate (8 incidents) or major (8 incidents) EIA ratings.

That VicForests undertake an audit of existing stream crossings along coupe driveways, roadline coupes and other coupe access roads it has constructed to assess the compliance of road design and construction with Code and MP prescriptions aimed at protecting water quality from road drainage. Any non-compliant road drainage should be rectified where this is practicable and will not adversely affect water quality.
