Module 1: Harvesting and Closure

Module 3: Regeneration and Finalisation

Environmental Audit Forest Audit Program 2014

Prepared for: Department of Environment and Primary Industries

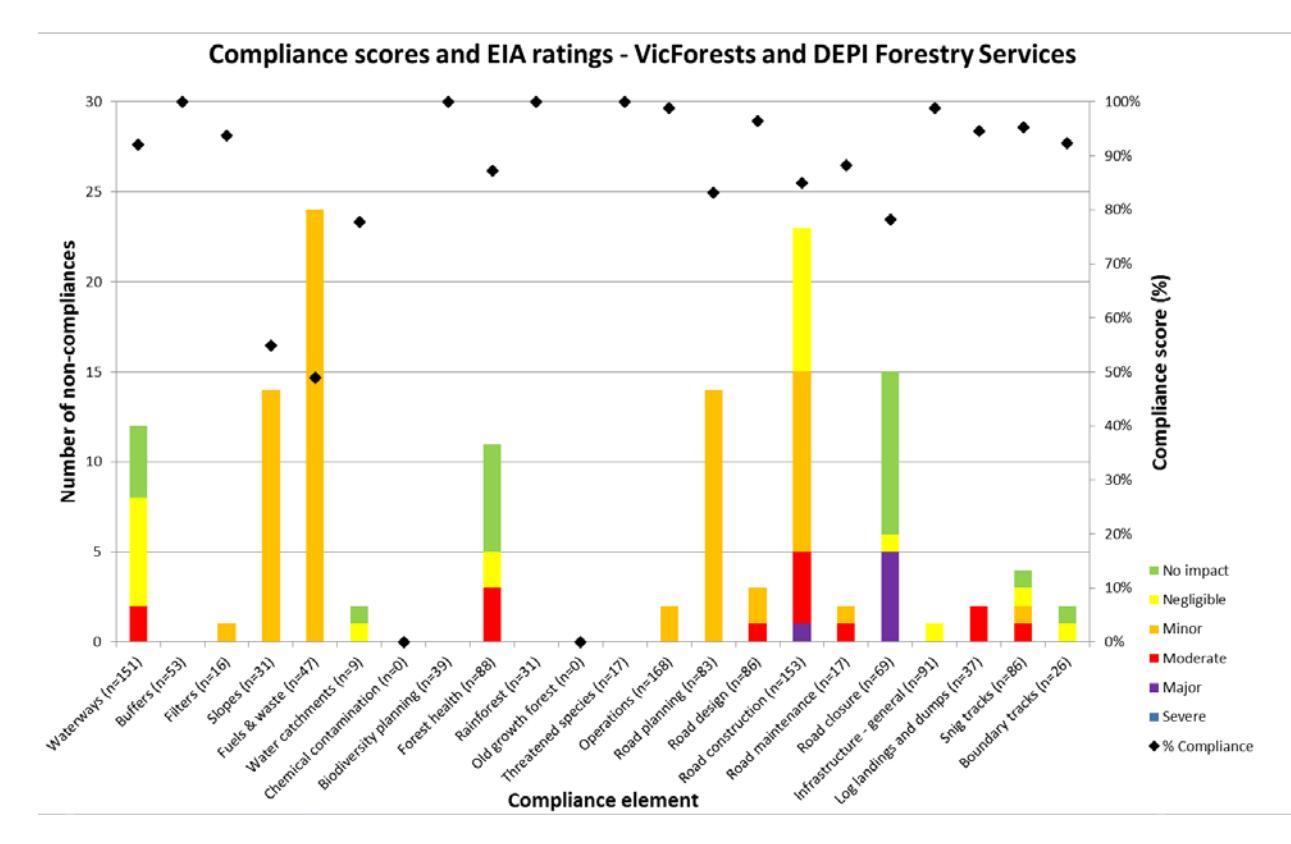
Figure 4-1 Compliance levels and EIA risk ratings for identified non-compliances for each compliance element

Figure 4-1 graphically summarises the level of compliance and EIA risk ratings for noncompliances identified for each compliance element (VicForests and DEPI Forestry Services combined).

Below is a summary of the findings of the EIA scores for each non-compliance. Details of each non-compliance are included in Section 4.3 of this report.
