Audit of timber harvesting operations in Victoria's State forests

Department of Environment, Land, Water and Planning

Report on the 2017-18 Forest Audit Program

IS247800-RP-002 | Final

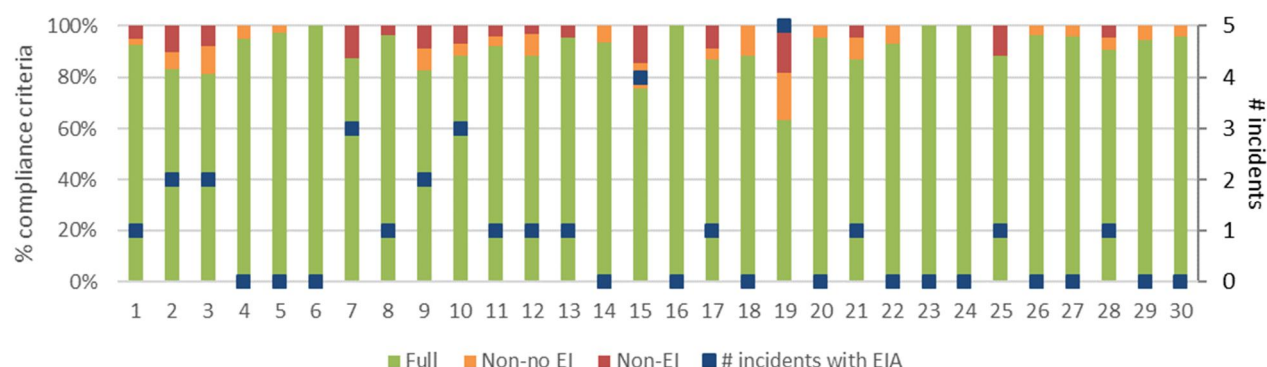
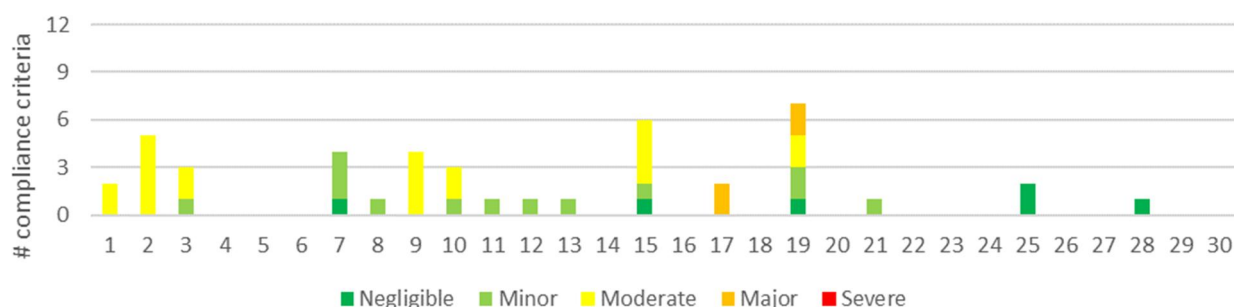
Figure 4.1 Overall compliance results and assessed potential environmental impact for instances of non-compliance. The horizontal axis in both graphs refers to the coupe numbers, as per Table 3.2.

The overall level of full compliance with applicable audit criteria⁹ ranged between 63% (19 Swivel) and 100% (6 Liverpool, 16 Tatong Heights, 23 Boxed Chook, 24 Running Creek; Figure 4.1). The average level of full compliance with applicable criteria across the 30 audited coupes was 91%. Non-compliances with environmental impact were recorded on 16 of the 30 audited coupes (Figure 4.1).

a) Level of compliance with audit criteria and number of non-compliance incidents with assessable environmental impact. Compliance definitions (Full, Non-no EI, Non-EI) as per Table 3.3.

b) Number of compliance criteria with assessable environmental impacts and the assessed level of impact for each instance of non-compliance.

The EIA tool (Appendix C) was used to assess the potential environmental impact associated with each non-compliance incident¹¹. These assessments ranged between negligible and major (Figure 4.1). Non-compliances that were assessed to have major environmental impact were detected in two of the 30 audit coupes. These were associated with harvesting in what were intended to be riparian buffers.

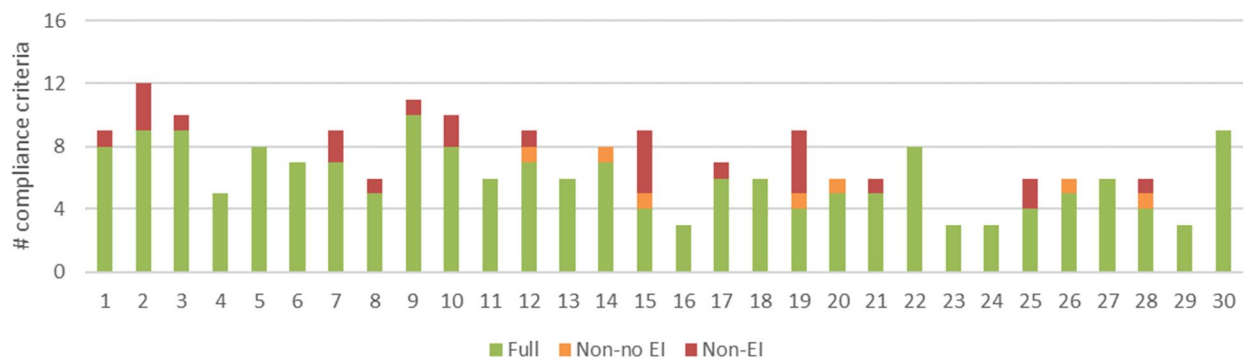
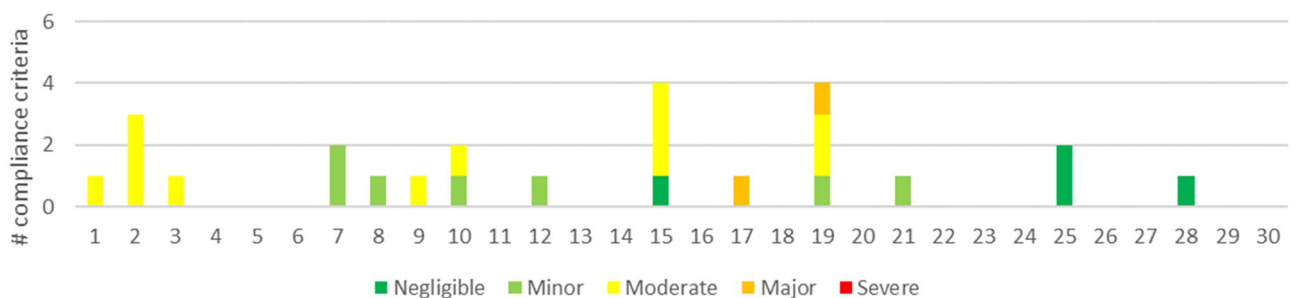
Figure 4.3 Compliance findings and assessed environmental impact for instances of non-compliance for criteria applicable to the protection of forest soils. The x-axis refers to the coupe numbers, as per Table 3.2.

A total of 19 audit criteria were relevant to the protection of forest soils, of which three were not applicable to any of the target coupes. The average level of full compliance with applicable criteria was found to be 87%, with the level of compliance ranging between 44% (15 Jonnie and Jackie, 19 Swivel) and 100% (12 coupes; Figure 4.3). The assessed environmental impact associated with non-compliances ranged between negligible and major (Figure 4.3).

a) Level of compliance with audit criteria. Compliance definitions (Full, Non-no EI, Non-EI) as per Table 3.3.

b) Number of compliance criteria with assessable environmental impacts and the assessed level of impact for each instance of non-compliance.

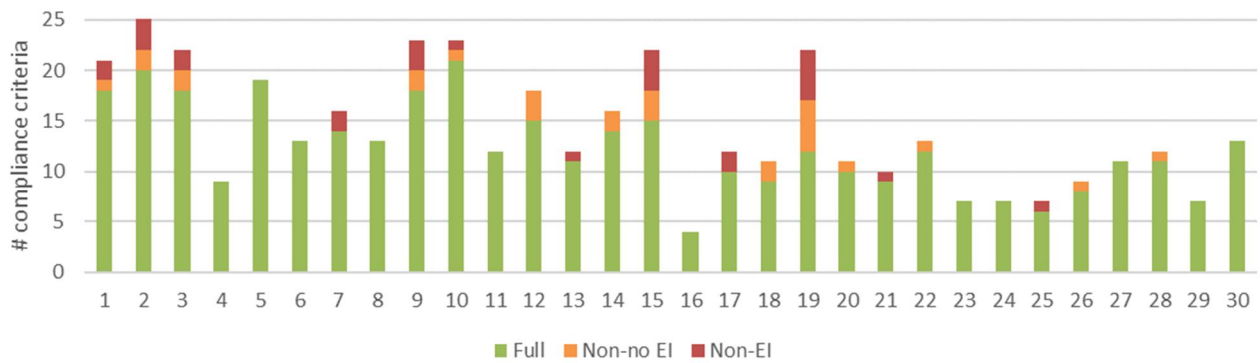
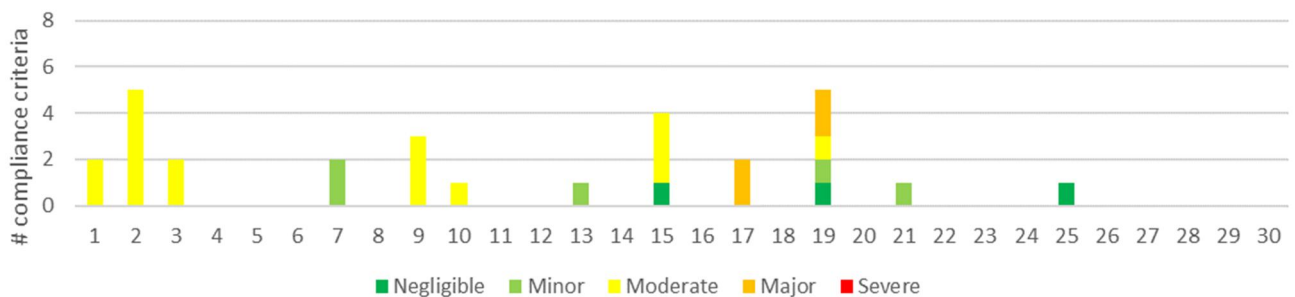
Figure 4.4 Compliance findings and assessed environmental impact for instances of non-compliance for criteria applicable to the protection of water quality, flows and river health. The x-axis refers to the coupe numbers, as per Table 3.2.

a) Level of compliance with audit criteria. Compliance definitions (Full, Non-no EI, Non-EI) as per Table 3.3.

b) Number of compliance criteria with assessable environmental impacts and the assessed level of impact for each instance of non-compliance.

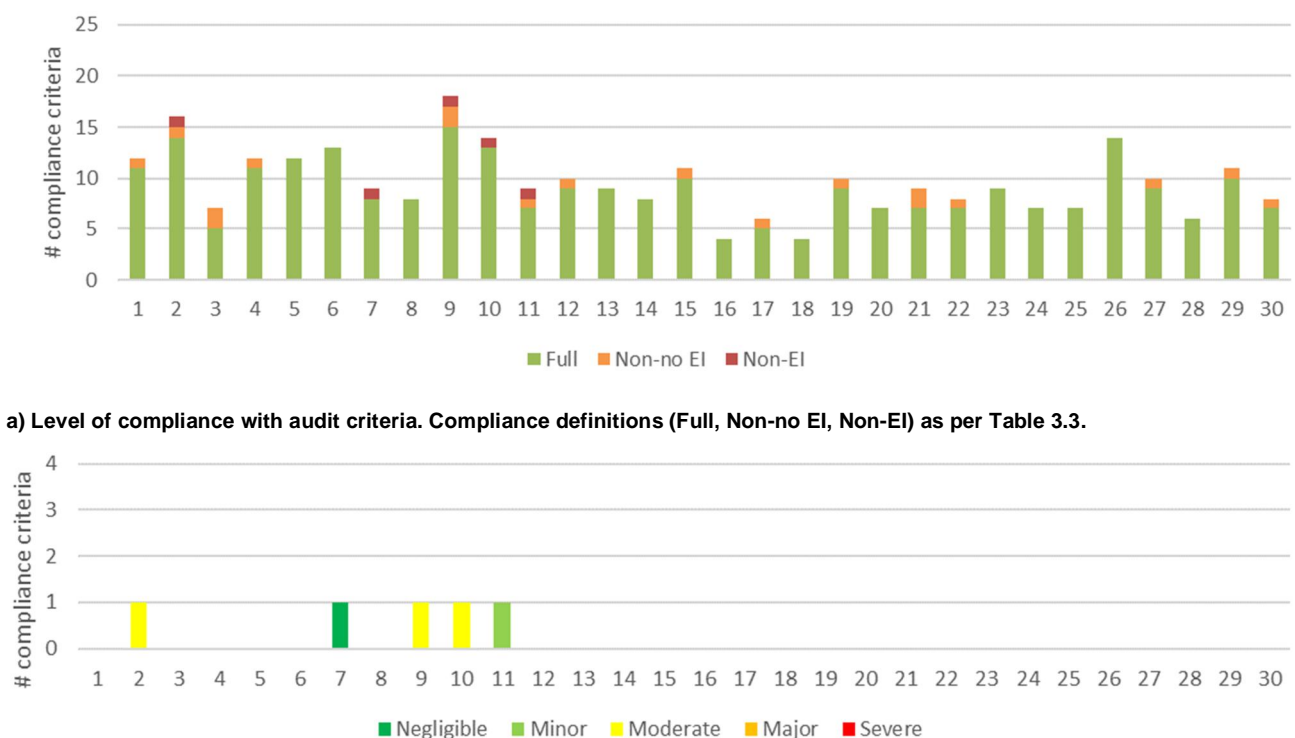
Figure 4.6 Compliance findings and assessed environmental impact for instances of non-compliance for criteria applicable to the protection of biodiversity values. The x-axis refers to the coupe numbers, as per Table 3.2.

The average level of full compliance with applicable criteria was found to be 92%, with the level of full compliance ranging between 71% (3 Rocksteady) and 100% (13 coupes; Figure 4.6).

Non-compliances with environmental impact were observed on five of the 30 coupes. The assessed environmental impact ranged between negligible and moderate (Figure 4.6), with the latter identified on three coupes (2 High Voltage; 9 Tarzan, 10 You just know). These were associated with disturbance to riparian habitats when an alternative existed (High Voltage¹⁵) and damage to unharvested vegetation during regeneration burning (Tarzan, You just know¹⁶; Figure 4.7). Damage to unharvested vegetation was sustained during regeneration burning on one other coupe (7 Machikichori), but the EIA rating was assessed as negligible in this case.

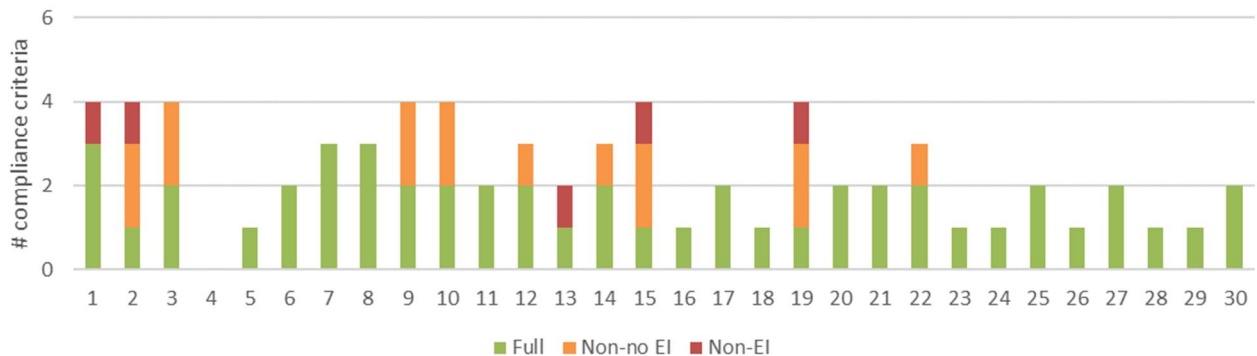
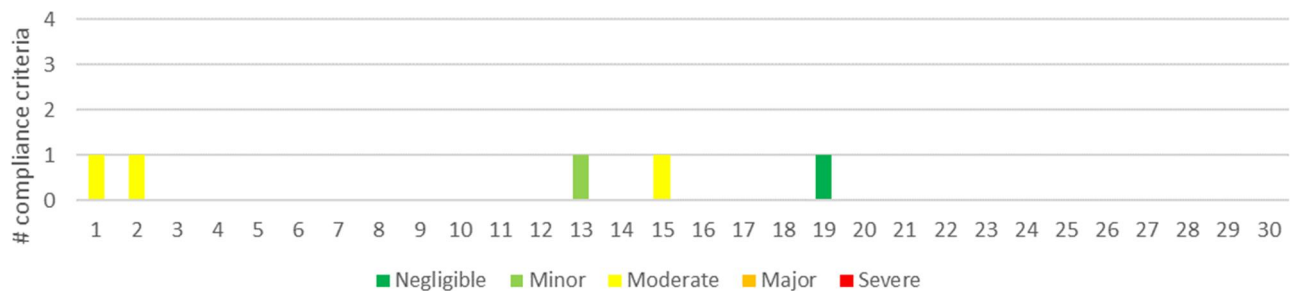
Figure 4.8 Compliance findings and assessed environmental impact for instances of non-compliance for criteria applicable to the road design. The x-axis refers to the coupe numbers, as per Table 3.2.

The average level of full compliance with applicable criteria was found to be 81%, with the level of compliance ranging between 25% (2 High Voltage, 15 Johnnie and Jack, 19 Swivel) and 100% (18 coupes; Figure 4.8).

- Having no recorded engineering basis for design for larger embankments or waterway crossings (e.g. MSPs 6.2.2.3, 6.2.5.4; Code 2.4.2.4)
- Having no specific evidence that the culvert size is consistent with flow requirements in a 10% annual exceedance probability (AEP) rainfall event (MSP 6.2.5.3).

Non-compliances with environmental impact were recorded for one criterion (10.1; Appendix B¹⁷). The assessed environmental impact associated with these ranged between negligible and moderate (Figure 4.8). Each instance assessed to have moderate environmental impact (1 Bear Grylls, 2 High Voltage, 15 Johnnie and Jack) was associated with a culvert design (and subsequent construction) that resulted in water discharging directly onto embankment materials without any erosion control measures (see Figure 4.5).

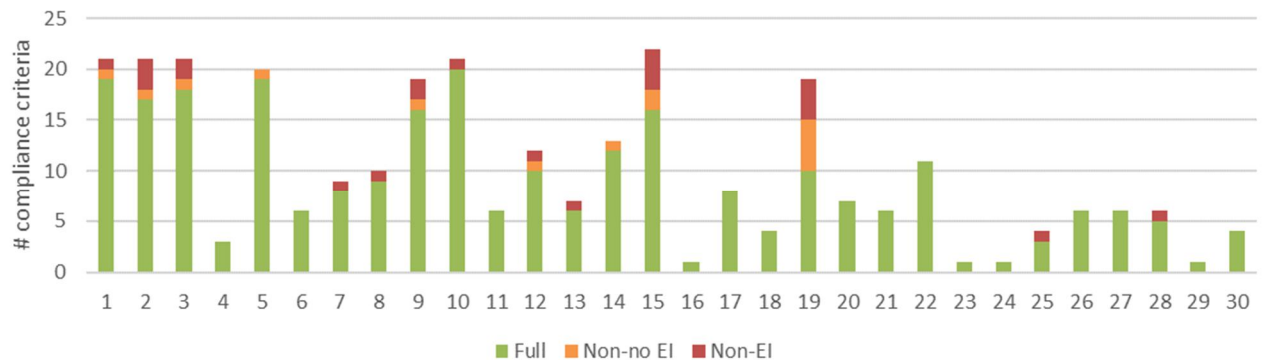
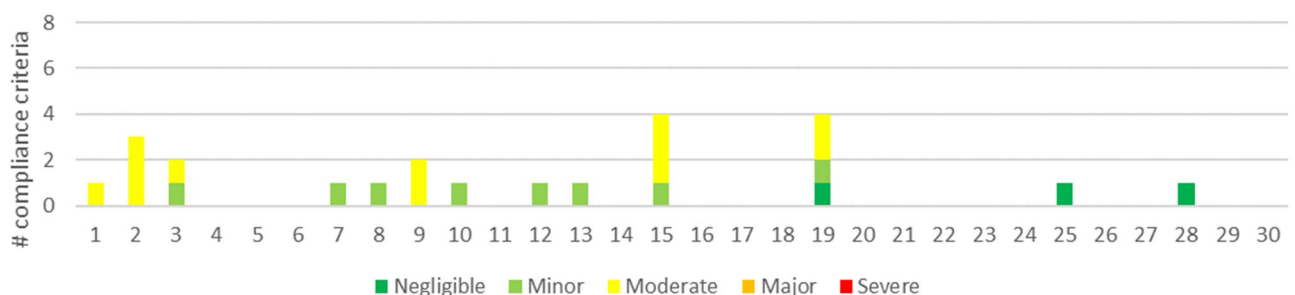
Figure 4.9 Compliance findings and assessed environmental impact for instances of non-compliance for criteria applicable to the road construction. The x-axis refers to the coupe numbers, as per Table 3.2.

The 33 compliance elements relevant to this theme¹⁸ (Appendix B), like those for road design, largely seek to protect soil and water values from risks associated with the construction of road embankments and waterway crossings. The average level of full compliance with applicable criteria was found to be 92%, with the level of compliance ranging between 53% (19 Swivel) and 100% (15 coupes; Figure 4.8). The level of assessed environmental impact associated with non-compliances ranged between negligible and moderate.

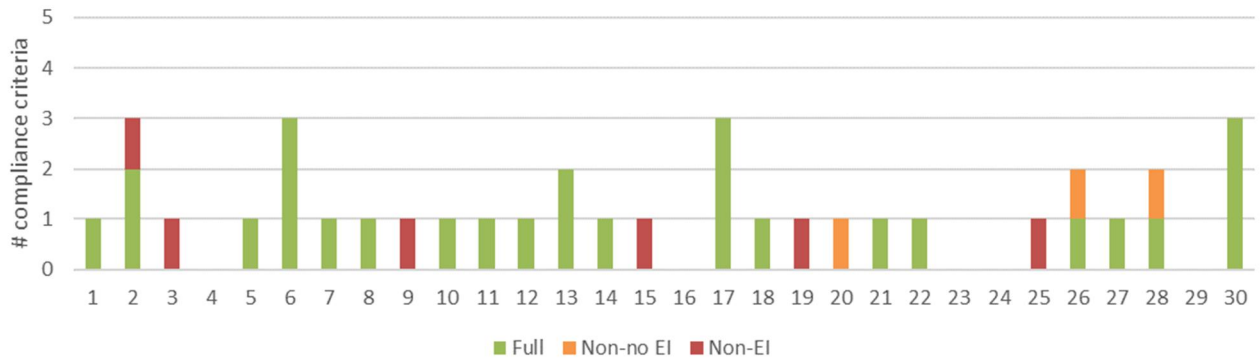
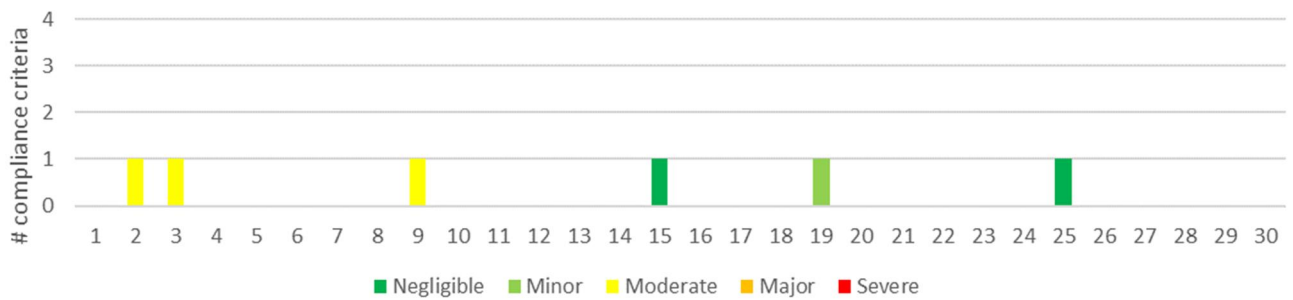
Figure 4.11 Compliance findings and assessed environmental impact for instances of non-compliance for criteria applicable to the road maintenance and closure. The x-axis refers to the coupe numbers, as per Table 3.2.

Only five compliance criteria relevant to road maintenance or closure were considered in this audit (Appendix B), all of which were applicable to at least some coupes. Like compliance elements for road design and construction, they are largely concerned with protecting soil and water values from risks associated with the use of in-coupe roads and their closure following the completion of harvesting operations. The average level of full compliance with applicable criteria was found to be 71%, with the level of compliance ranging between 0% and 100% (Figure 4.11).

- *Remove crossings using techniques that minimise soil and habitat disturbance (Code 2.2.1.7):* removal of a snig track crossing in 2 High Voltage resulted in what the auditor considered to be excessive disturbance (Figure 4.2), with potential to exacerbate the movement of sediment into a temporary stream.

- *Maintain roads in a manner that minimises erosion and protects water quality (Code 2.4.4.2):* two incidents were observed where important road drainage features had not been maintained, increasing opportunities for road sediments to enter waterways. In 3 Rocksteady (Figure 4.10), a silt trap on a drain entering a temporary stream had been left in a damaged state and operating ineffectively. In 9 Tarzan, a roadside sump, which was used to capture sediment in road drainage had been bypassed as a result of traffic damage to the road surface, with the result that road sediment could directly drain into a waterway. Both deficiencies should have been identified and rectified as part of road maintenance.

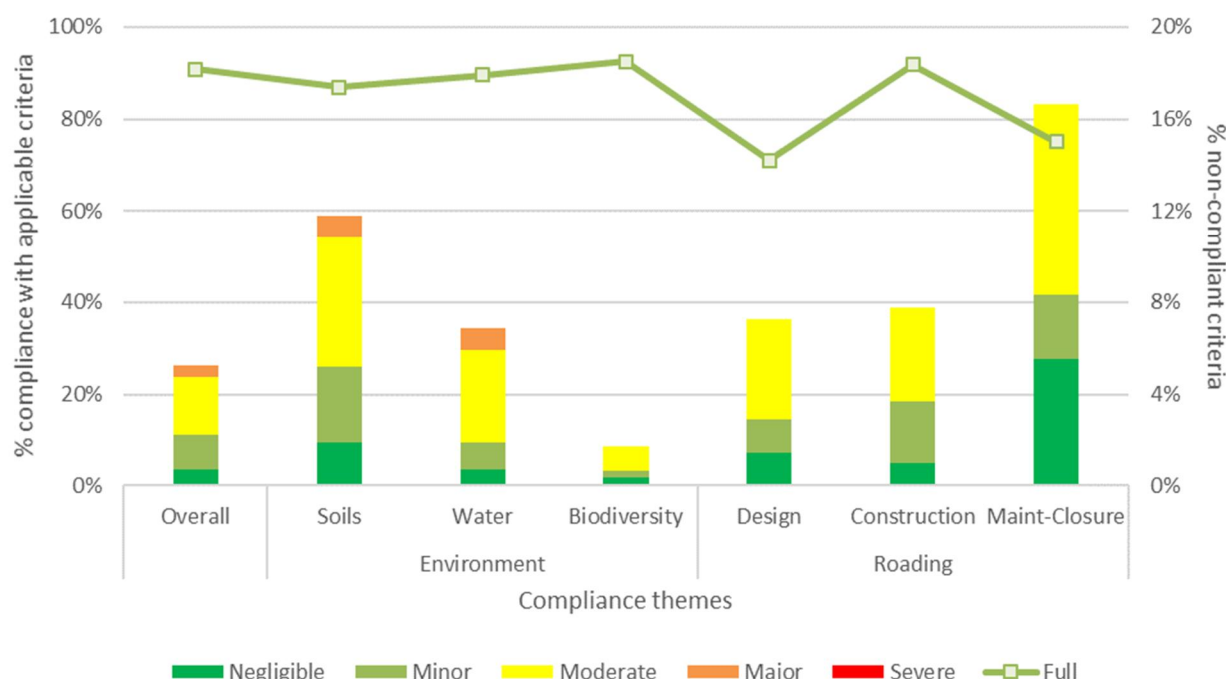
Figure 5.1 Summary of overall audit findings for regulatory compliance and risk of environmental impact from non-compliance with the regulatory framework.

The overall level of full compliance with audit criteria which were applicable to the respective coupes (Figure 5.1) was assessed to be 91%, with average compliance for the various themes varying between 71% (road design) and 92% (biodiversity, road construction). Non-compliances with direct environmental impact were associated with 30 individual incidents on 16 coupes. One of these was associated with a section of the permanent forest road network used in timber haulage (12 Whitelaws Ramble).

Overall, environmental impacts were assessed for 15 of the 105 audit criteria, with almost all of these rated as moderate or lower (Figure 5.1). As noted in Section 5.1.1, non-compliant road drainage, including on the approaches to waterway crossings, was the main source of non-compliance incident with environmental impact (Table 5.1). These were all rated as moderate or lower.
