Audit of timber harvesting and forest regeneration in State forests in eastern Victoria

Department of Environment, Land, Water and Planning

Report on the 2016-17 Forest Audit Program

IS206000-P2-001 | Rev D

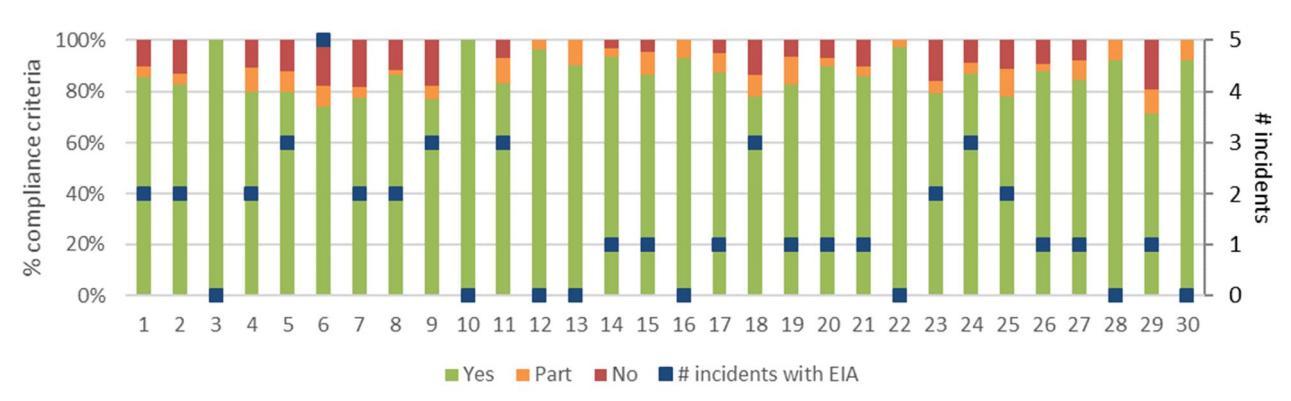
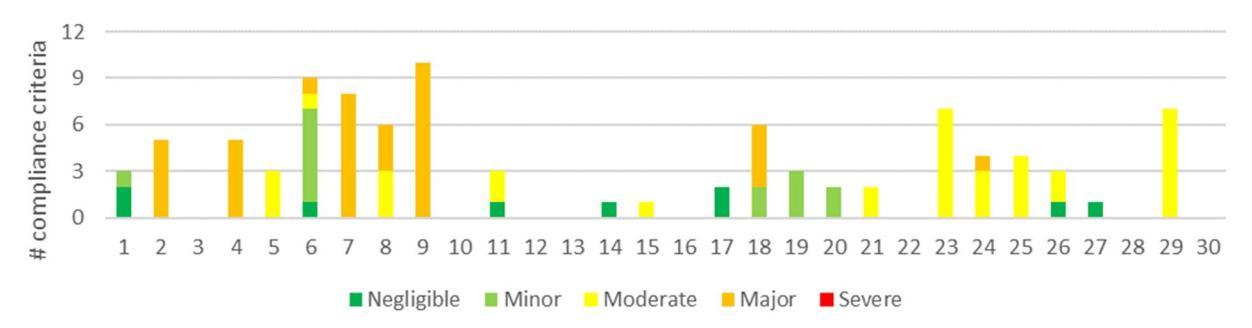
The overall level of compliance with applicable audit criteria ranged between 71% (#29 Cream Bun¹²) and 100% (#3 Low Down, #10 Swinglow), with the average being 86% (Figure 4.1). "Part" non-compliance, where there was no actual or potential environmental impact¹³, was assessed for a further 6% of applicable criteria. Of the 30 coupes included in this component of the audit, eight coupes had no non-compliances with potential for environmental impact.

a) Level of compliance with audit criteria and number of non-compliance incidents with assessable environmental impact.

b) Number of compliance criteria with assessable environmental impacts and the assessed level of impact for each instance of non-compliance.

Figure 4.1 Overall compliance findings and assessed environmental impact for instances of non-compliance. The x-axis refers to the coupe numbers, as per Table 3.1

The (revised) EIA tool (Appendix B) was used to assess the potential environmental impact associated with each (full) non-compliance incident¹⁵. This ranged between negligible and major (Figure 4.1). Non-compliances which were assessed to have major environmental impact were detected in eight of the 30 harvest coupes. These mostly related to issues with waterway crossings.

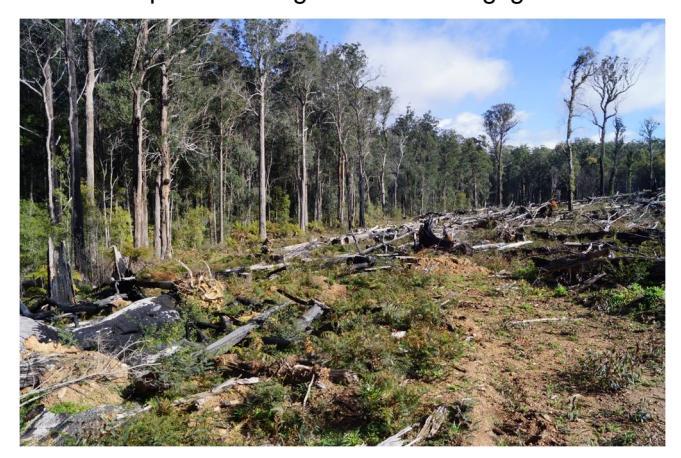
Compliant riparian buffer, #29 Cream Bun coupe.

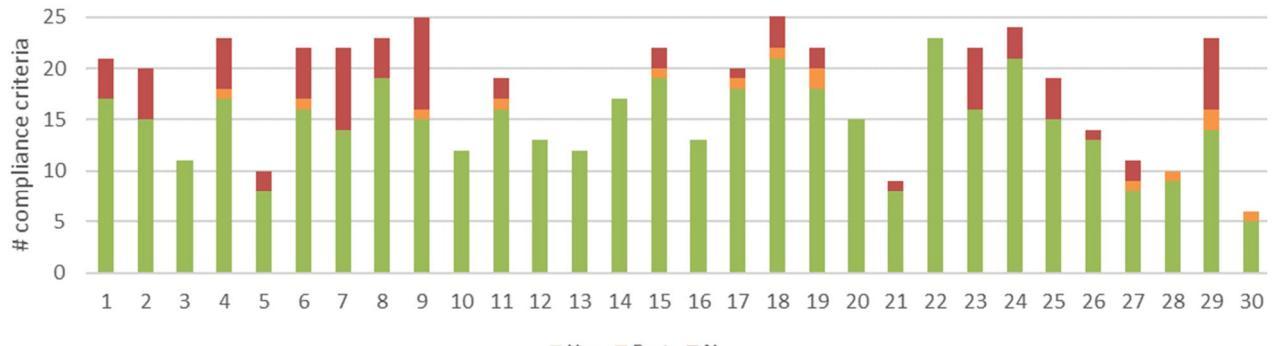
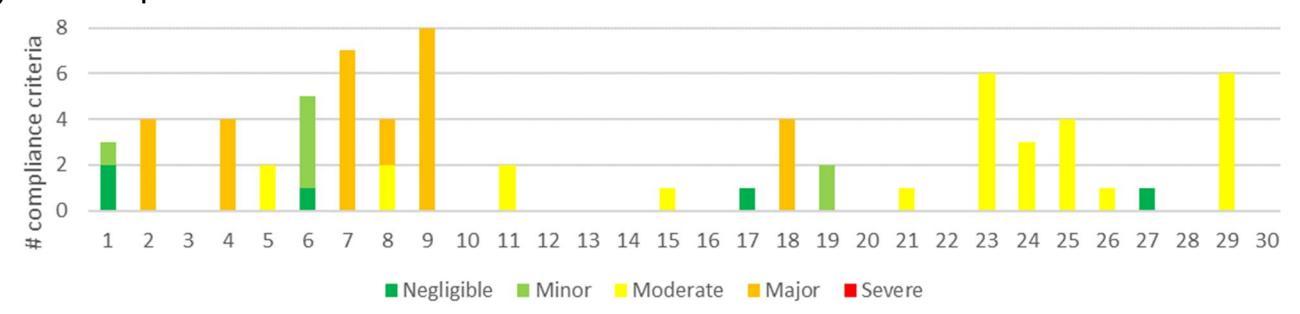
The average level of compliance with applicable criteria was found to be 85%, with the level of compliance ranging between 60% (#9 Zombie) and 100% (eight coupes; Figure 4.3). The assessed environmental impact associated with non-compliances ranged between negligible and major (Figure 4.3). Non-compliances which were assessed to have major environmental impact were identified on eight coupes. All of these related to waterway crossings. Most non-compliances assessed to have moderate environmental impact were also associated with defective waterway crossings.

a) Level of compliance with audit criteria.

b) Number of compliance criteria with assessable environmental impacts and the assessed level of impact for each instance of non-compliance.

Figure 4.3 Compliance findings and assessed environmental impact for instances of non-compliance for criteria applicable to the protection of water quality, flows and river health. The x-axis refers to the coupe numbers, as per Table 3.1.

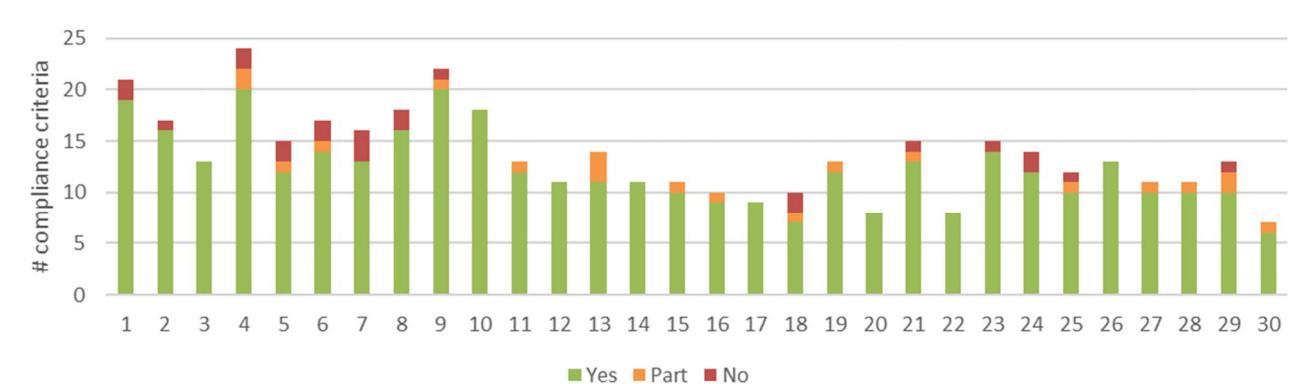
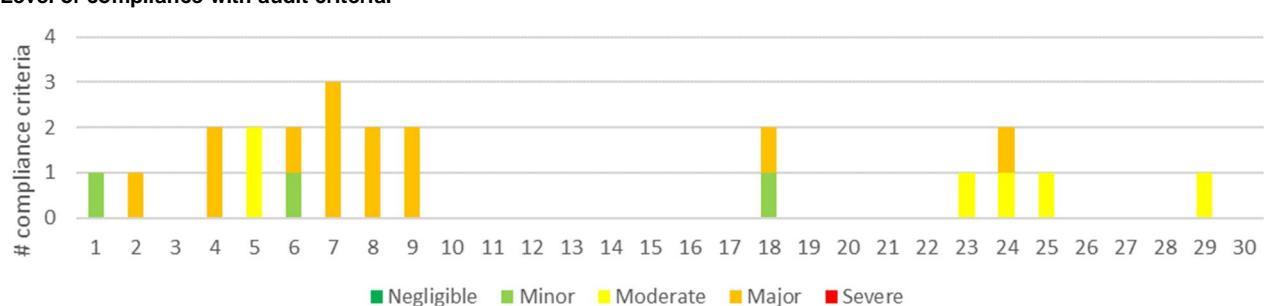
The average level of compliance with applicable criteria was found to be 90%, with the level of compliance ranging between 70% (#18 Tropical) and 100% (8 coupes; Figure 4.5¹⁷). A further eight coupes were assessed to have non-compliances without potential environmental impact.

a) Level of compliance with audit criteria.

b) Number of compliance criteria with assessable environmental impacts and the assessed level of impact for each instance of non-compliance.

Figure 4.5 Compliance findings and assessed environmental impact for instances of non-compliance for criteria applicable to the protection of biodiversity values. The x-axis refers to the coupe numbers, as per Table 3.1.

The assessed environmental impact associated with non-compliances ranged between minor and major (Figure 4.5), with the latter identified on eight coupes. Non-compliances on seven of these coupes related to

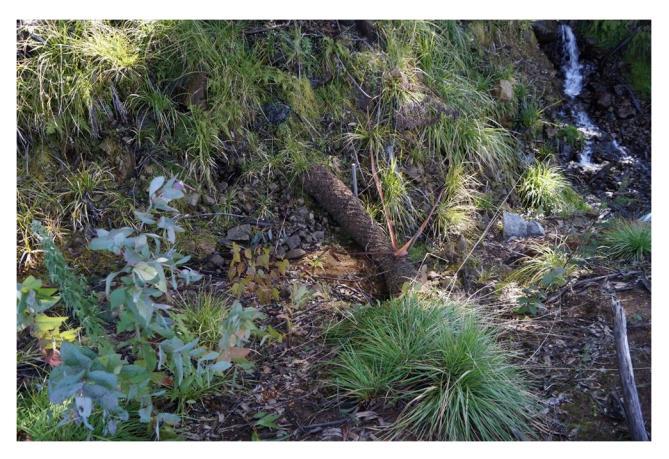
Figure 4.11 Use of a sediment trap to intercept road drainage prior to entry to a permanent stream, #6 Zebra coupe.

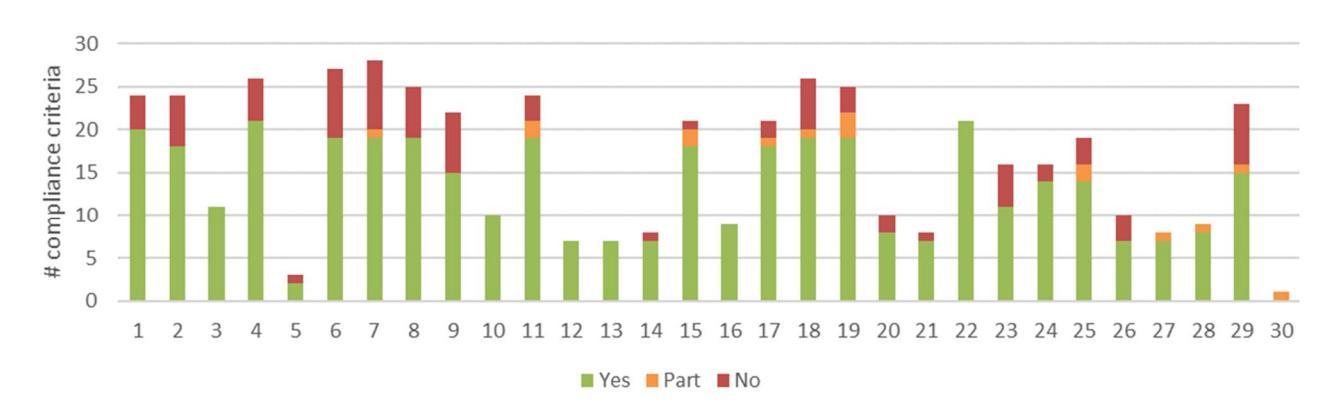
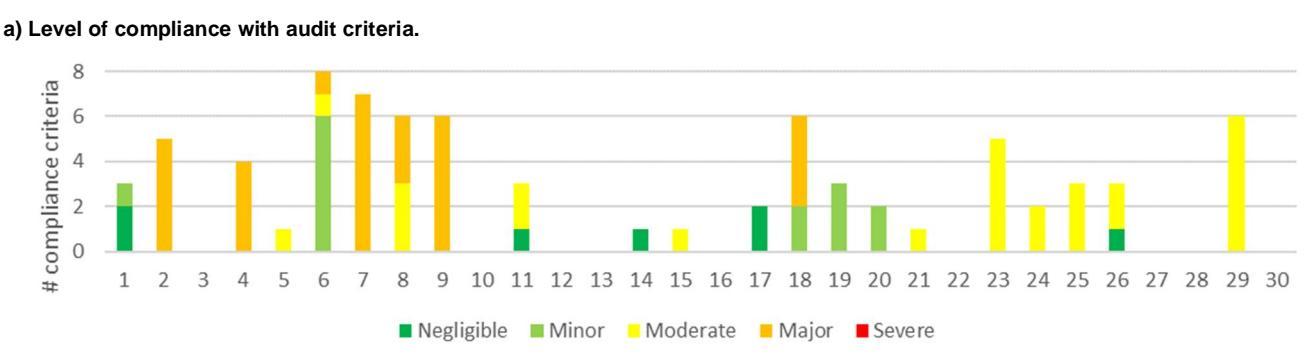
b) Number of compliance criteria with assessable environmental impacts and the assessed level of impact for each instance of non-compliance.

Figure 4.13 Compliance findings and assessed environmental impact for instances of non-compliance for criteria applicable to the road construction. The x-axis refers to the coupe numbers, as per Table 3.1.

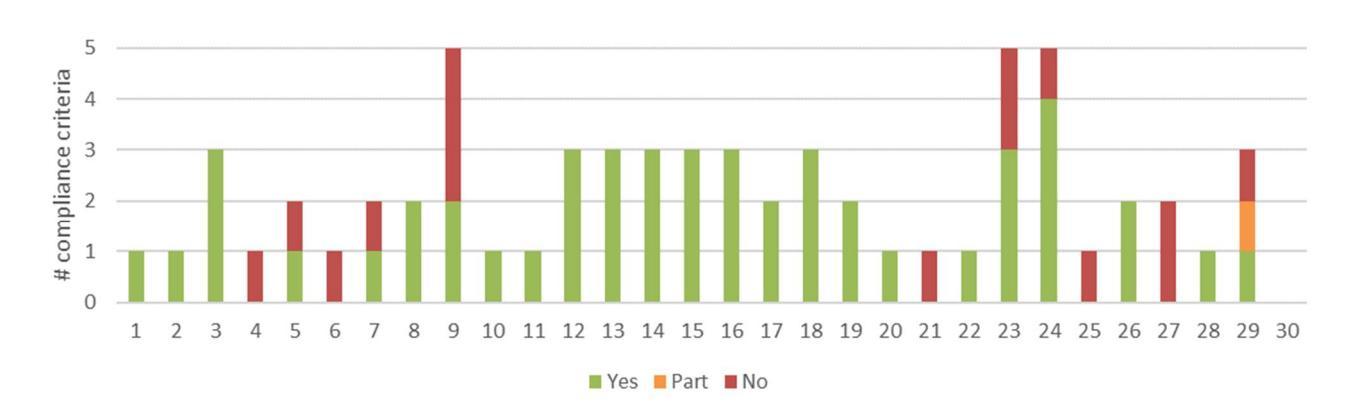
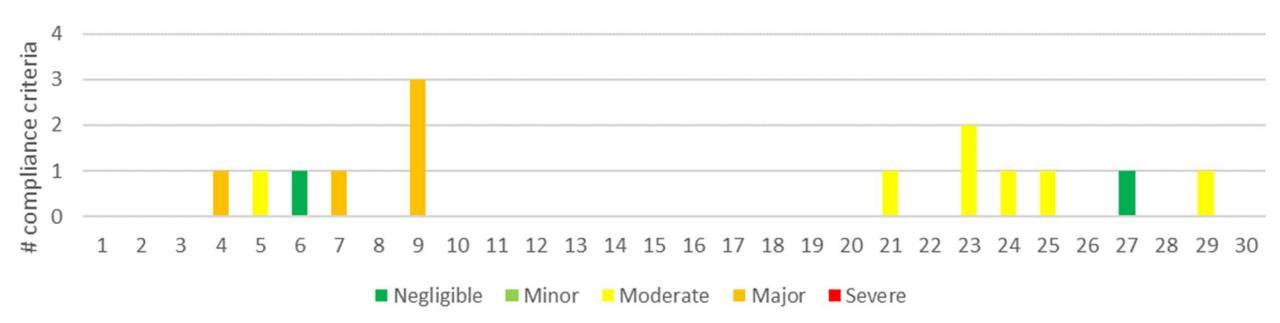
Only five compliance criteria relevant to road maintenance or closure were considered in this audit (Appendix A). Like compliance elements for road design and construction, they are largely concerned with protecting soil and water values from risks associated with the use of in-coupe roads and their closure following the completion of harvesting operations. The average level of compliance with applicable criteria was found to be 73%, with the level of compliance ranging between 0% (non-compliance for one or two applicable criteria) and 100% (Figure 4.14).

a) Level of compliance with audit criteria.

b) Number of compliance criteria with assessable environmental impacts and the assessed level of impact for each instance of non-compliance.

Figure 4.14 Compliance findings and assessed environmental impact for instances of non-compliance for criteria applicable to the road maintenance and closure. The x-axis refers to the coupe numbers, as per Table 3.1.

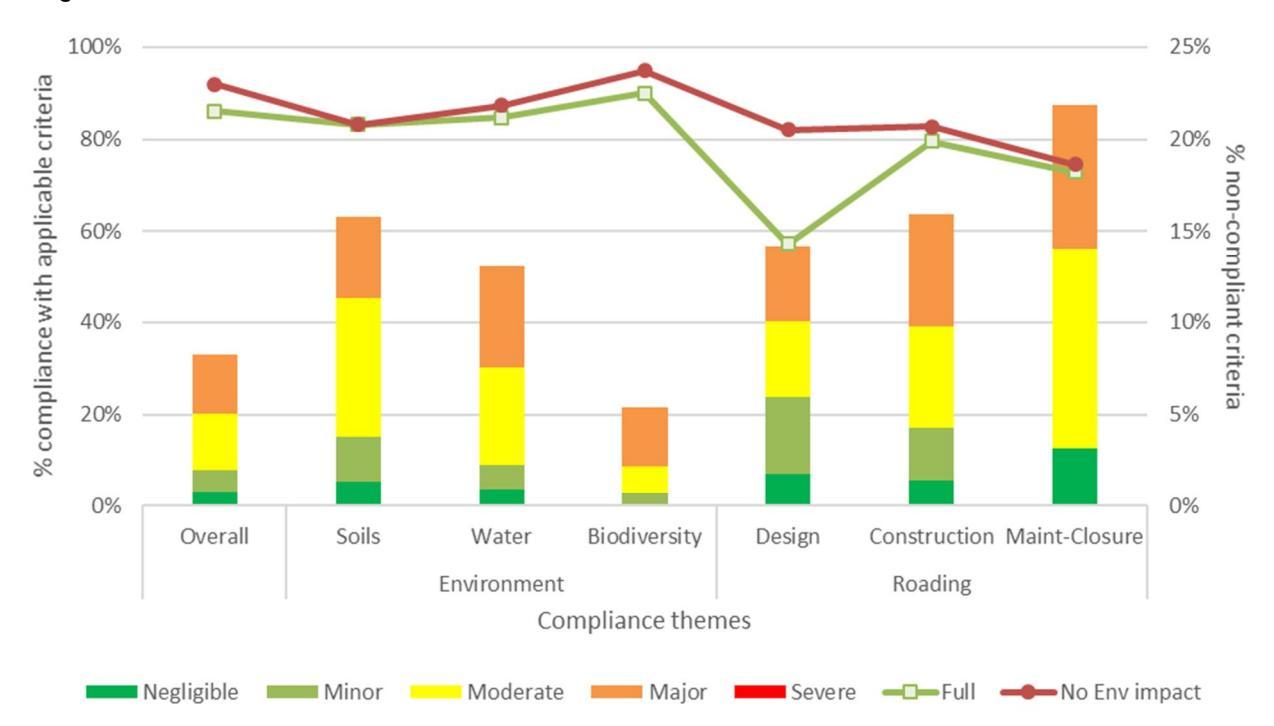
Overall compliance with audit criteria which were applicable to the respective coupes (Figure 5.1) was assessed to be 86%, with compliance for the various themes varying between 57% (road design) and 90% (biodiversity). Including criteria with "part" compliance – meaning all assessments were that there was no direct risk to the environment – the compliance rate increased to 92% overall and ranged between 75% for road maintenance and closure and 95% for biodiversity (Figure 5.1).

Full – % applicable criteria for which full compliance was recorded; No env impact - % applicable criteria with full or part compliance and no direct risk of environmental impact. Compliance is referenced in the left y axis and EIA ratings are referenced on the right y axis.

Figure 5.1 Summary of overall audit findings for regulatory compliance and risk of environmental impact from non-compliance with the regulatory framework.

Overall, environmental impacts were assessed for about 8% of the applicable criteria, with the majority of these rated as moderate or major (Figure 5.1). Waterway crossings were the main source of non-compliance incidents overall and the main source of those with assessments of major potential environmental impact. While this most likely overstates the severity of impact of many waterway crossing non-compliances, it highlights the sensitivity of the locations at which these non-compliances occurred.
