Department of Environment, Land, Water and Planning

Forest Audit Program 2015 Environmental Audit of the Construction & Rehabilitation of Waterway Crossings

Final Report

24 February 2016

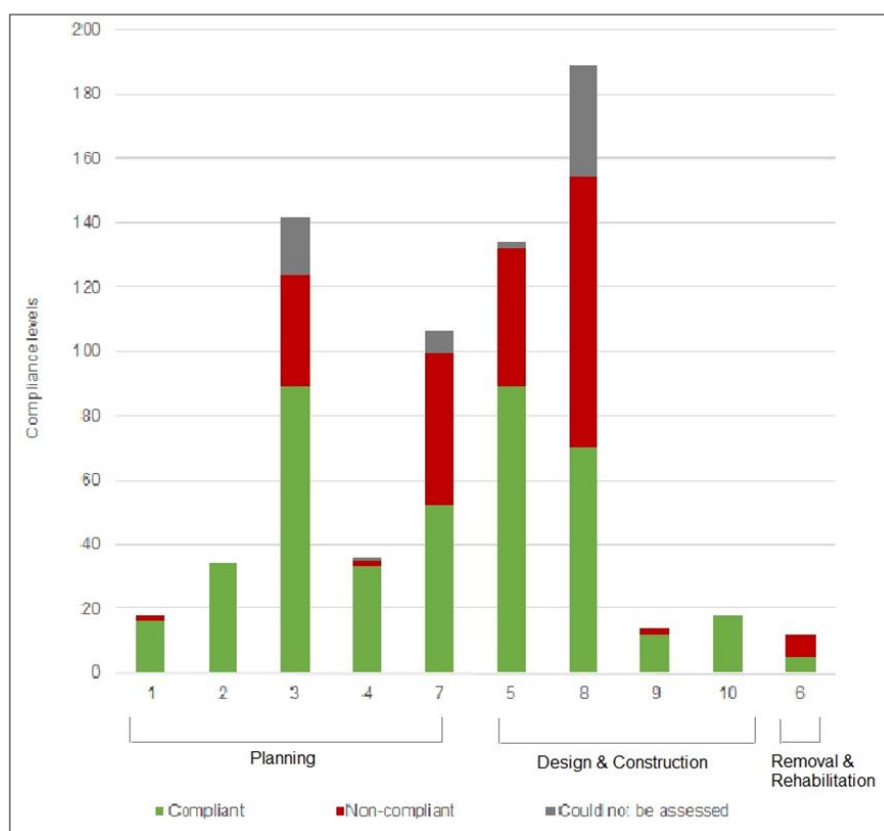
Figure ES 2: Compliance levels for each Code prescription

The compliance score was highest for the *planning for crossings* compliance group (72%). The compliance score was lowest in the *removal and rehabilitation of crossings* compliance group (42%); however, it should be noted that the audit only allowed for assessment of a small number (three) of coupes where the crossings had been removed and rehabilitated. The design and construction of crossings achieved a compliance score of 59%.

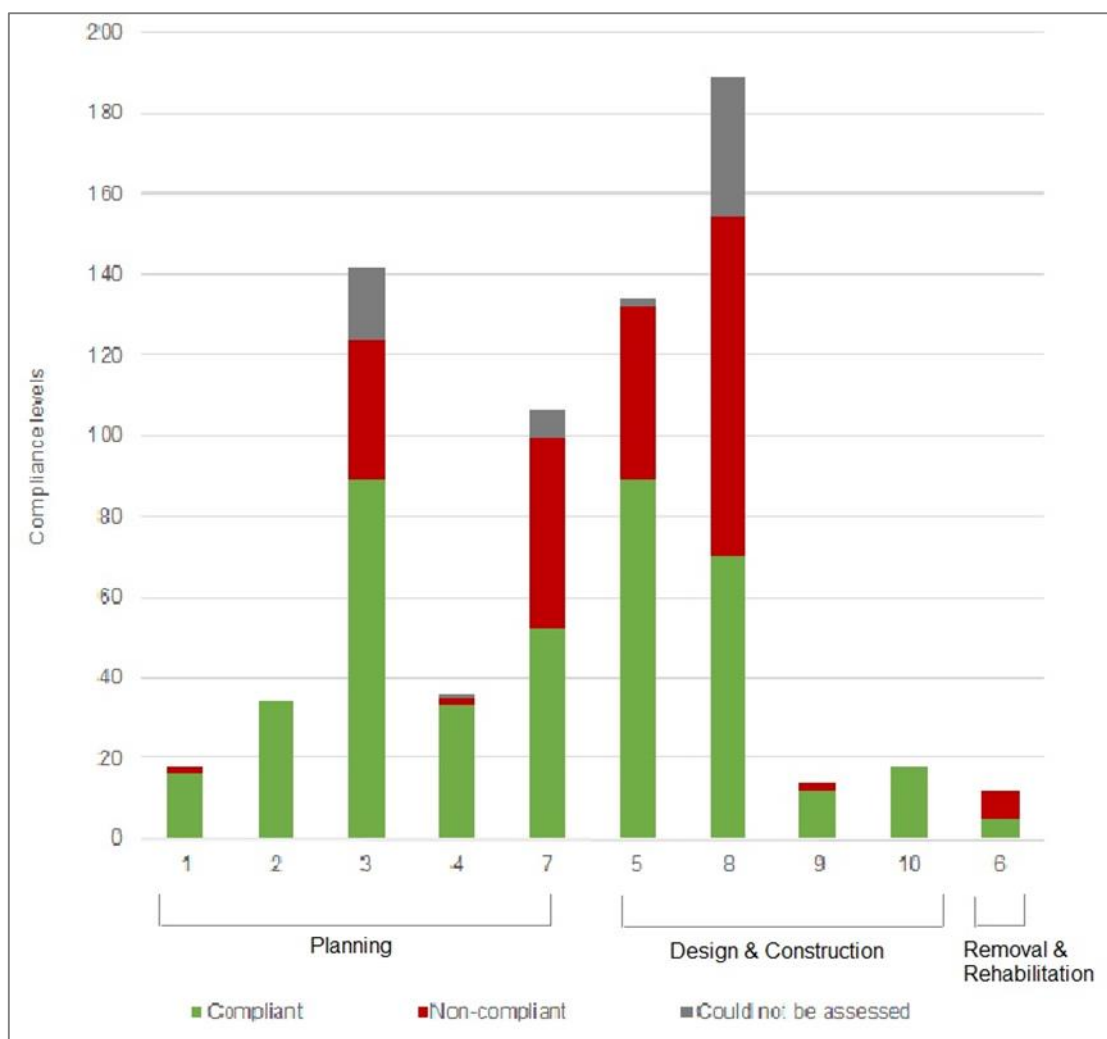
Figure 4-1: Compliance status for each Code prescription across all coupes

The high incidence of non-compliance for Code prescriptions 3, 5, 7 and 8 are influenced by a number of systemic issues across many or all coupes, specifically for:

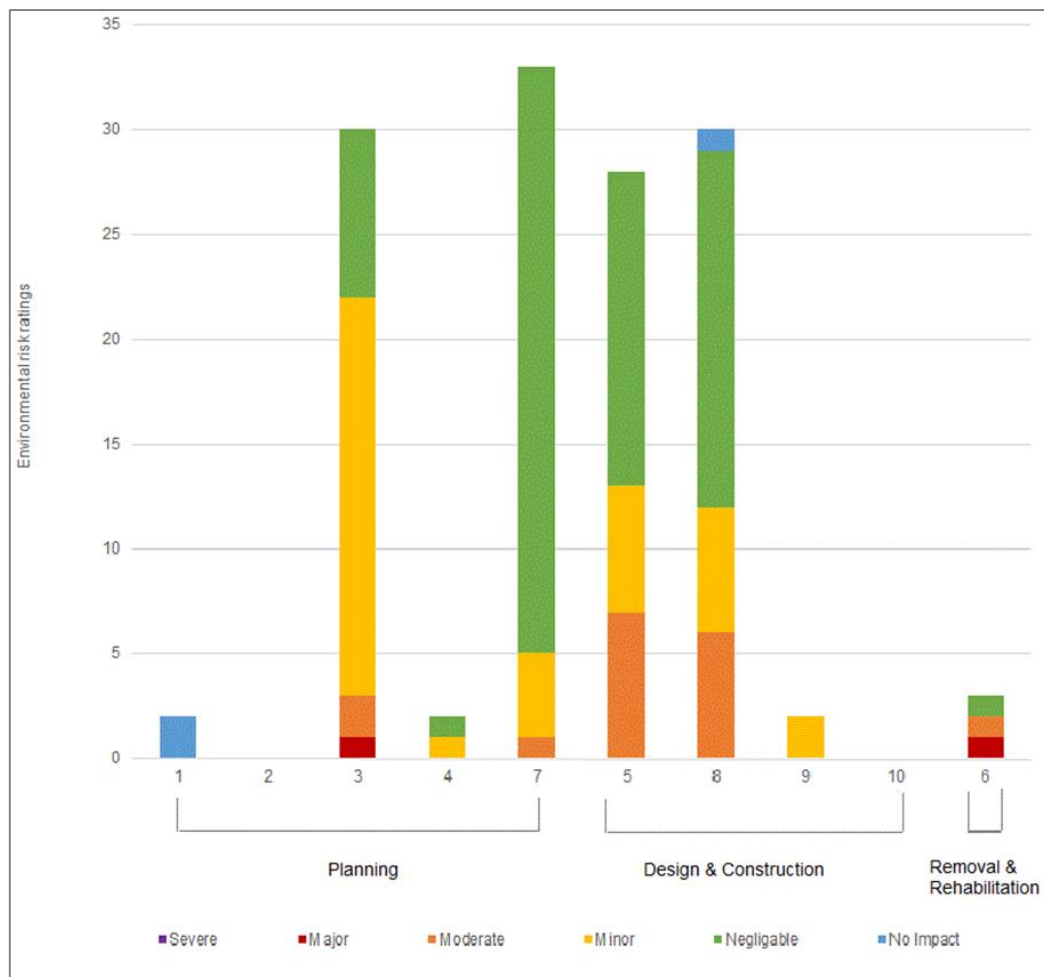
Figure 4-4: Environmental risk ratings for each Code prescription across all coupes

No severe environmental risk ratings were identified during the audit.

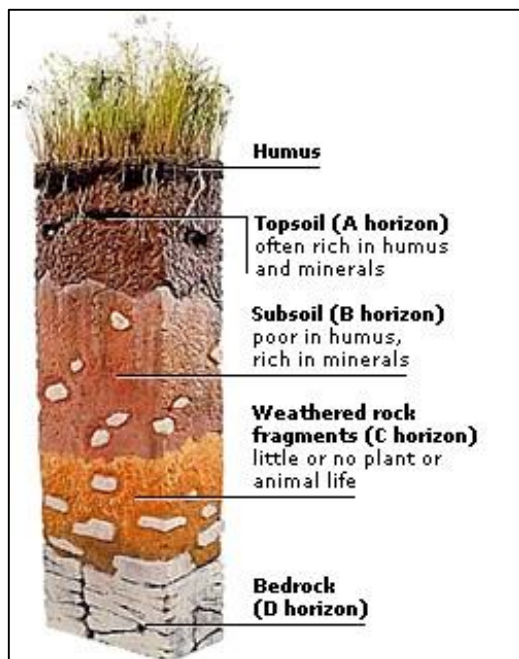
Figure 4-6: Stylised diagram of a soil profile

The auditor noted that VicForests' soil assessments rarely assessed the C horizon⁷, unless a suitable road cutting was available at the time. In one of the audited coupes (West Davis Link roadline) a highly erodible C horizon was identified during road construction (refer to Figure 4-6 for a stylised diagram of a typical soil profile). VicForests responded by reducing the distances between road drainage structures and using more extensive rock armouring. The soil assessment procedure intends that all horizons planned to be exposed during operations should be assessed during planning. However, other than the soil not being fully assessed before construction commenced (which would have likely required the use of a backhoe), the procedure had been followed and drainage designs were adjusted when the C horizon was subsequently

assessed. The auditor considers that in this instance the outcome would not have been significantly different had the C horizon been assessed during planning (environmental risk rating of negligible).

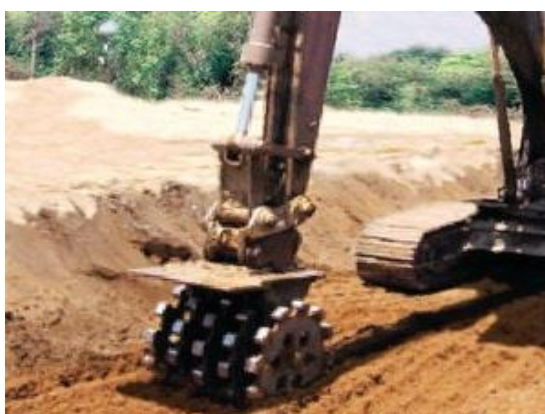
Excavator-mounted sheepsfoot roller compactor

The audit found that the excavator mounted roller had not been approved by an engineer (a towed or self-propelled version had been approved for standard vertical fill compaction, but this equipment was not used by VicForests. Environmental risk rating of negligible) (Refer to Figure 4-9 for images of an excavator-mounted sheepsfoot roller and a self-propelled sheepsfoot roller).

The auditor considers that the current use of the sheepsfoot roller is appropriate for the purpose of consolidating fill faces at crossings; however equally important is the vertical compaction of the crossing fill in thin layers to support the fill face. VicForests stated that fill was compacted by bulldozers, but the auditor was unable to verify whether appropriately thin layers were compacted, as required by the pipe manufacturers' specifications. VicForests also did not mention the use of hand-held compactors required by the specifications for compacting the soil under the haunches of the pipe and up the sides of the pipe, which helps to transfer the load from the pipe to the soil. As there was little evidence of collapsing pipes during visual inspections of the crossings (with the exception of water bypassing the pipe at Mosquito – see findings for Code prescription 8 below), compaction is either adequate and/or the pipe grades used are sufficiently strong without optimal compaction.
