Forest Audit Program 2015: Audit of In-coupe Roads

Environmental audit of the construction and maintenance of in-coupe roads

IS112500-010 | V2.3

02/03/2016

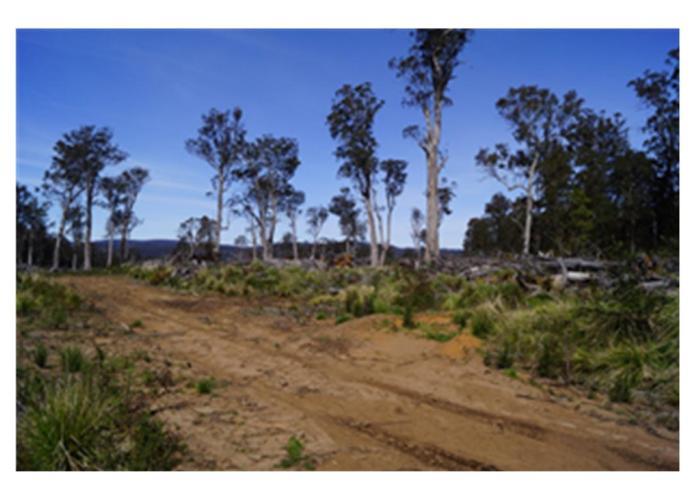
Example of temporary in coupe road used for timber haulage from Hubadub coupe (892-509-0001).

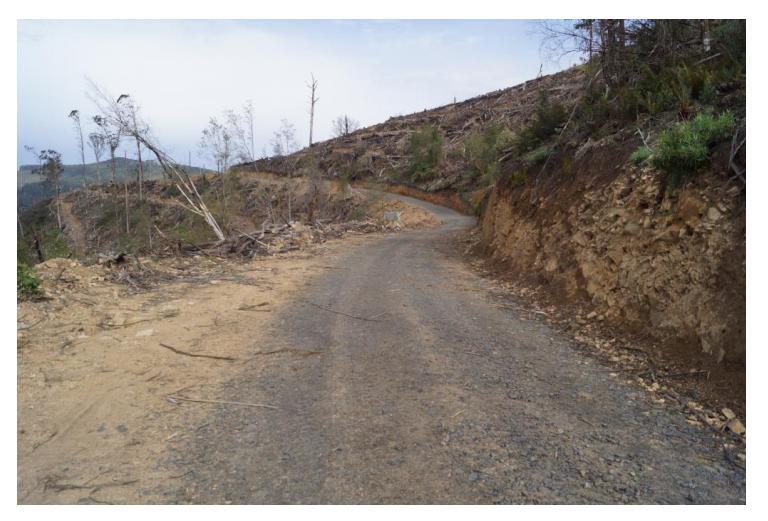
Figure 4.1 Road (Class 5C) in Saxtons Bend coupe located in wet, mountain forests and used to access multiple coupes. The road was surfaced with gravel and had a variety of effective constructed drainage structures (although no culverts).

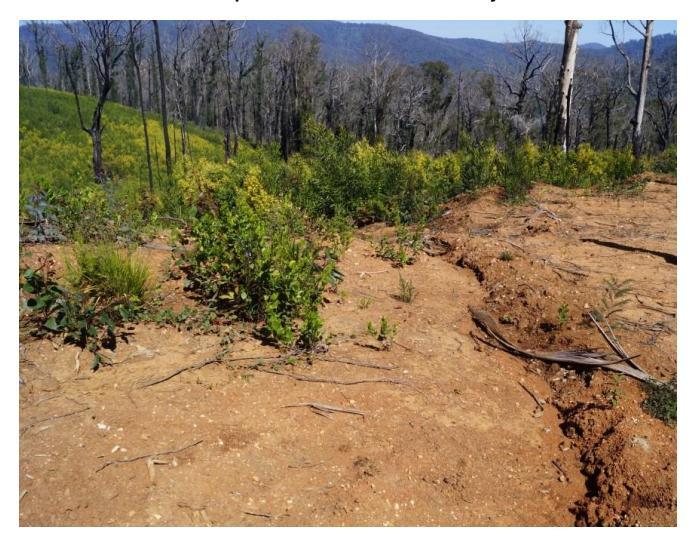
Figure 4.2 Temporary in-coupe road (Class 5D) constructed to access Dancer coupe over a harvest period of 1-2 months. The road was constructed from local materials. Cross drainage was constructed following harvesting and prevents uncontrolled water movement along the road surface while regeneration takes place on the road and coupe.

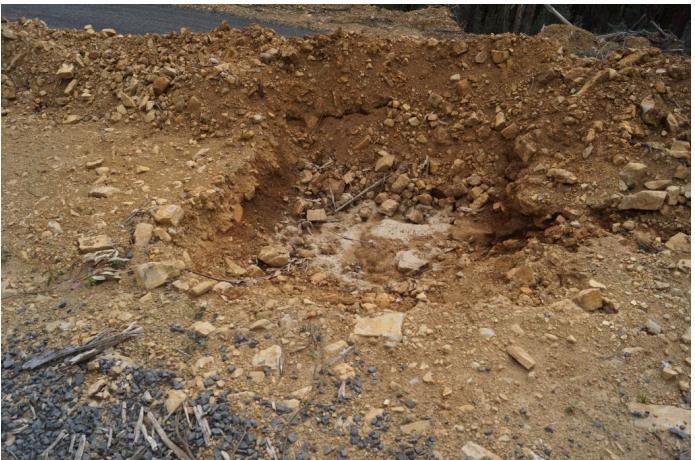
A good practice example of avoiding discharge of drainage onto a road was observed on Saxtons Bend coupe. A silt trap was successfully used above a road switchback to capture road drainage and sediment, rather than allow it to discharge onto the segment of road below (Figure 4.9).

Figure 4.9 An example of a silt trap being used to capture drainage from one side of a road to avoid direct discharge onto a lower segment of the same road (Saxtons Bend coupe).

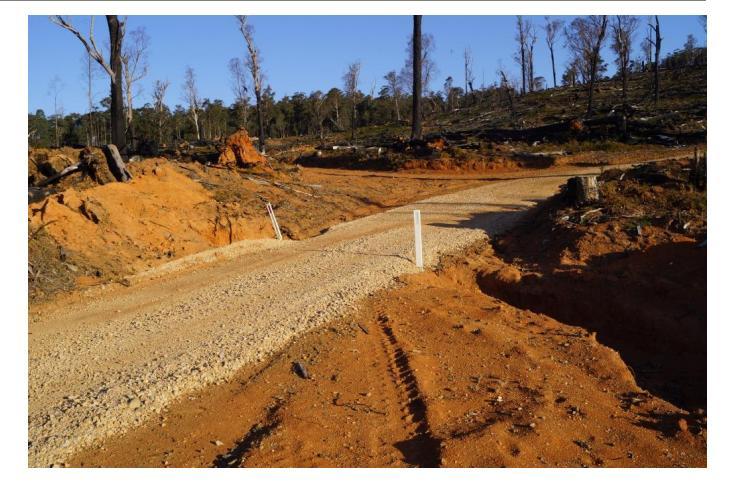
Culverts were only used for cross drainage in six of the 35 audited coupes and were generally constructed in a manner which was compliant with the MSP. One exception was in Billy Goat coupe, where a 100 mm culvert was used to drain a small depression adjacent to the in-coupe road. This was not consistent with the MSP, which requires culverts to be a minimum of 300 mm in diameter.

Figure 4.14 Example of culvert used for cross drainage of the road in Billy Goat coupe.

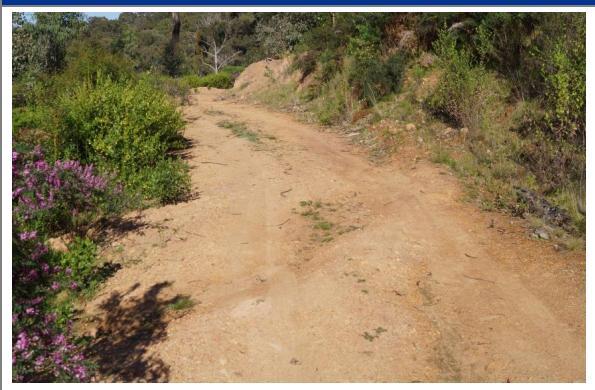
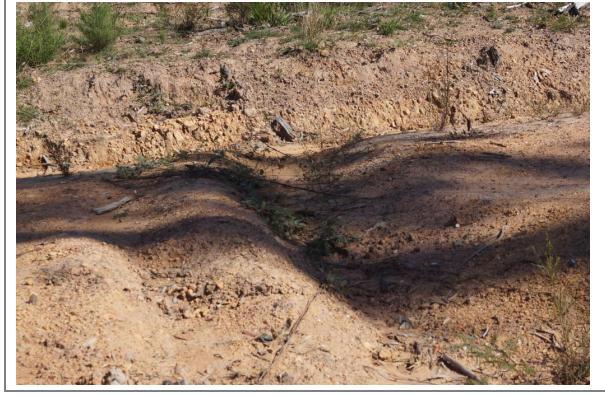
Rollover (above) and invert (below) along in-coupe roads within regenerating coupes which are subject to firewood collection traffic. They both operate effectively as cross drains and are trafficable, but are not usually damaged by that traffic.
