Report

Environmental Audit - Forest Audit Program Module 6 - Harvesting Performance

1 APRIL 2011

Prepared for Department of Sustainability and Environment 8 Nicholson Street Melbourne Victoria

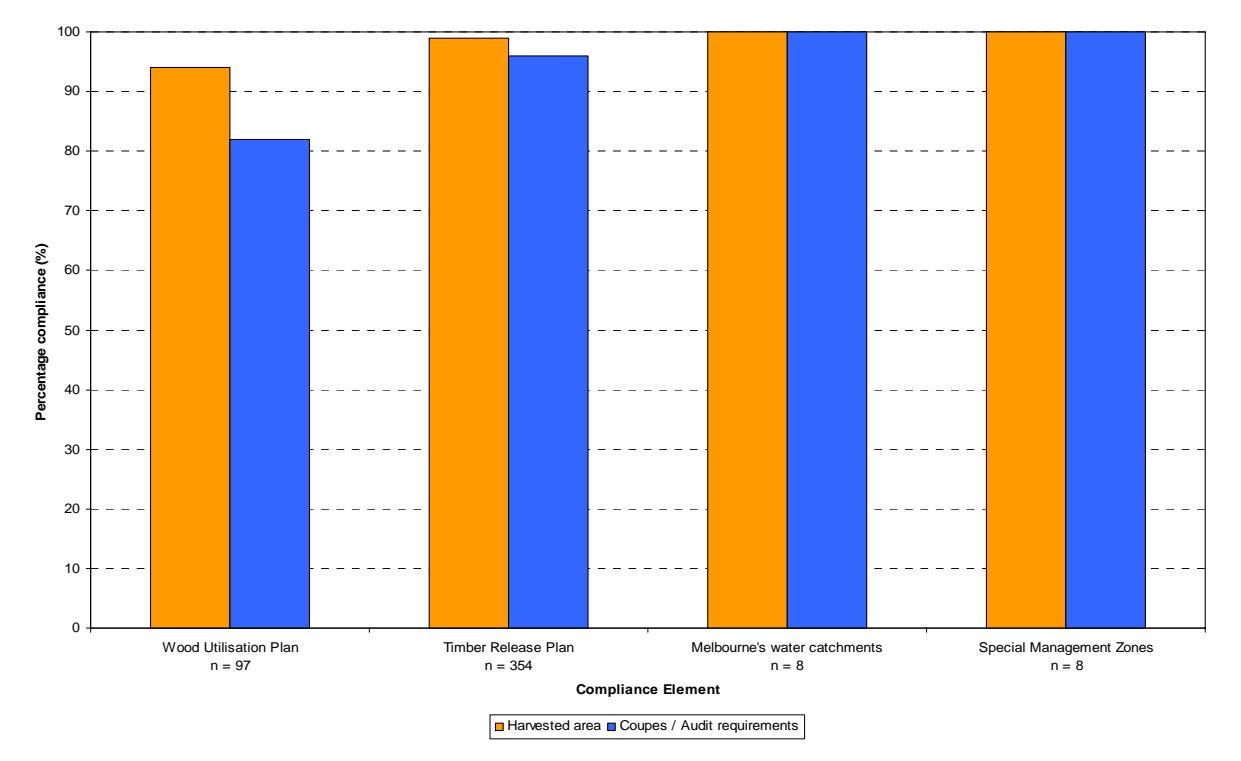
Figure 1 Summary of compliance for each Compliance Element

n = total number of coupes / audit requirements for each Compliance Element

The *Wood Utilisation Plan* Compliance Element, which addresses the compliance of timber harvesting operations with the spatial limits established in the WUPs, had a high proportion of compliant harvested area with 94% of the harvested area found to be compliant with the WUPs. Of the 97 coupes harvested on WUP areas, the audit found that 81% of the coupes were compliant with the WUP areas spatial limits including 76 coupes managed by DSE and three coupes managed by VicForests. With an error margin applied to account for Global Positioning System (GPS) accuracy limitations, the audit identified 18 non-compliant coupes, six of which were not on an approved WUP at the time of harvest. The total area of non-compliance was 199 hectares representing 6% of DSE harvested area in 2008/09. The audit also identified a large number of coupes with small areas located outside of the respective WUP areas, suggesting systemic limitations in the accuracy of the WUP mapping. This may be due to the WUP mapping data being generated through large scale digital analysis based on modelling, aerial photography and other mapping sources. These coupes

The *Timber Release Plan* Compliance Element, which addresses the compliance of timber harvesting operations with the spatial limits established in the TRPs, had a high proportion of harvested area in compliance with 99.9% of the harvested area found to be compliant with the TRPs. Of the 354 coupes harvested on TRP areas, the audit found that 96% of the coupes were compliant with the TRP areas spatial limits. With an error margin applied to account for GPS accuracy limitations, the audit identified 13 coupes that did not comply with the TRP spatial limits or the procedural allowances. The total area of non-compliance was four hectares representing less than 0.1% of VicForests' harvested area in 2008/09. The audit also identified a large proportion of harvested coupes with small areas located outside of the respective TRP boundaries but within the procedural limits, suggesting systemic limitations in the accuracy of the TRP mapping. This may be due to the TRP mapping data being generated through large scale digital analysis based on modelling, aerial photography and other mapping sources. These coupes were not recorded as non-compliances since they were assessed as having been located in accordance with procedural allowances. The non-compliant areas and coupes were attributed to 13 instances of incorrect application of the Management Procedures.

The *Harvest Limits in Melbourne's water supply catchments* Compliance Element addresses the compliance of timber harvesting operations in four water supply catchments with the spatial limits established in the Forest Management Plans (FMPs) and Management Procedures. This Compliance Element had relatively few requirements with eight spatial harvest limits defined in the Management Procedures tested to assess compliance. The audit found that harvesting operations did not exceed the harvest limits in all four water supply catchments. As such this Compliance Element achieved 100% compliance in both the harvested area and against the number of requirements.

The *Harvest limits in Special Management Zones* Compliance Element addresses the compliance of timber harvesting operations with the spatial harvest limits established in the FMPs and the *Flora and Fauna Guarantee Act 1988* (FFG Act) Action Statements. The audit found that only eight FMPs and six FFG Action Statements prescribed spatial harvest limits and as such the audit criteria did not allow for a complete assessment within the intended scope and scale of the audit. However, an assessment of the total area harvested in SMZs for each Forest Management Area (FMA) provided an indication of compliance with the FMP harvest limits. Of the 12 FMPs, eight FMPs defined *approximate* spatial harvest limits. These eight requirements were used to assess compliance. No non-compliances were recorded for the SMZ Compliance Element, noting that four FMAs were unable to be assessed due to lack of information in the FMPs. As such this Compliance Element achieved 100% compliance in both the harvested area and against the number of requirements.

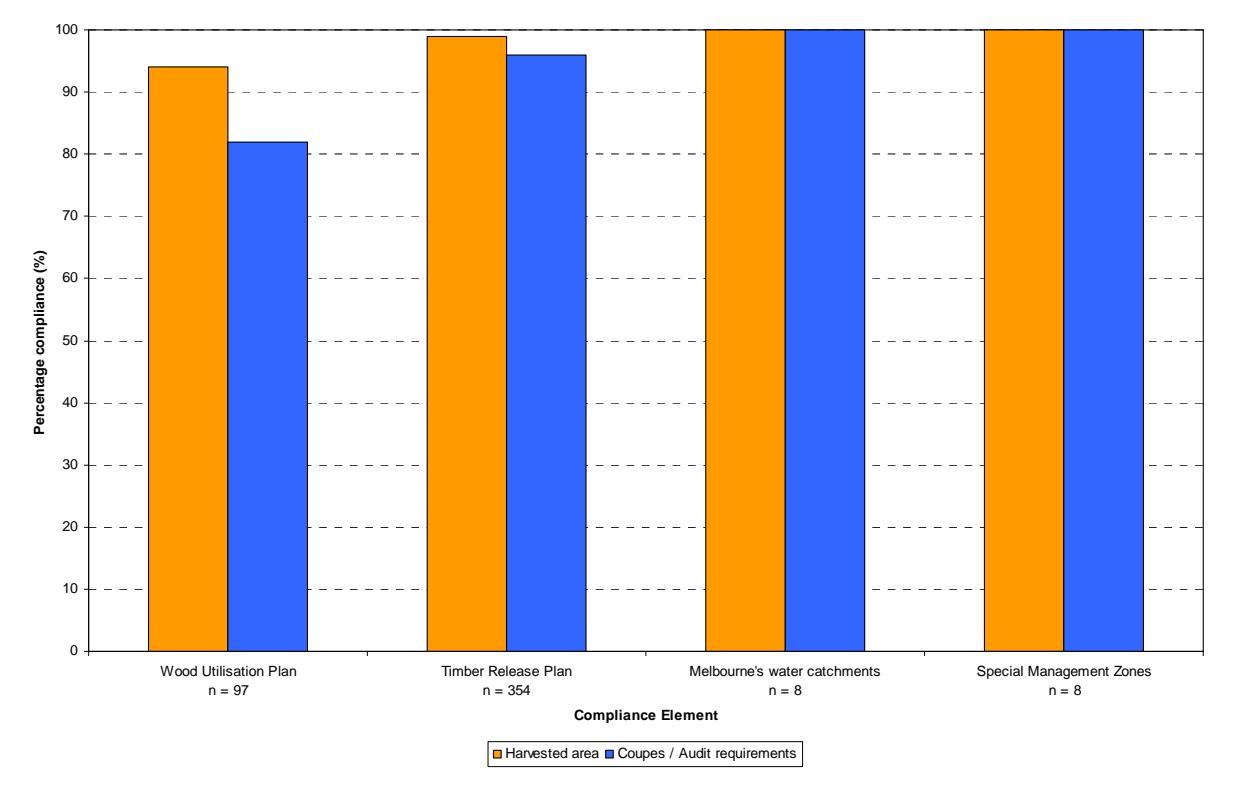
Figure 5-1 Summary of compliance for each Compliance Element

n = total number of coupes or audit requirements for each Compliance Element

The Wood Utilisation Plan Compliance Element, which addresses the compliance of timber harvesting operations with the spatial limits established in the WUPs, had a high proportion of compliant harvested area with 94% of the harvested area found to be compliant with the WUPs. Of the 97 coupes harvested on WUP areas, the audit found that 81% of the coupes were compliant with the WUP areas spatial limits including 76 coupes managed by DSE and three coupes managed by VicForests. With an error margin applied to account for Global Positioning System (GPS) accuracy limitations, the audit identified 18 non-compliant coupes, six of which were not on an approved WUP at the time of harvest. The total area of non-compliance was 199 hectares representing 6% of DSE harvested area in 2008/09. The audit also identified a large number of coupes with small areas located outside of the respective WUP areas, suggesting systemic limitations in the accuracy of the WUP mapping. This may be due to the WUP mapping data being generated through large scale digital analysis based on modelling, aerial photography and other mapping sources. These coupes were not recorded as non-compliances since they were assessed as having been located in accordance with procedural limits. However, 18 coupes with area harvested greater than 50 metres (m) outside of the WUP boundaries including the six coupes that have been harvested on areas not listed on an approved WUP indicate that in these instances the Management Procedures for timber harvesting, roading and regeneration in Victoria's State forests 2007 (Management Procedures) have not been applied correctly.

The *Timber Release Plan* Compliance Element, which addresses the compliance of timber harvesting operations with the spatial limits established in the TRPs, had a high proportion of harvested area in compliance with 99.9% of the harvested area found to be compliant with the TRPs. Of the 354 coupes

harvested on TRP areas, the audit found that 96% of the coupes were compliant with the TRP areas spatial limits. With an error margin applied to account for GPS accuracy limitations, the audit identified 13 coupes that did not comply with the TRP spatial limits or the procedural allowances. The total area of non-compliance was four hectares representing less than 0.1% of VicForests' harvested area in 2008/09. The audit also identified a large proportion of harvested coupes with small areas located outside of the respective TRP boundaries but within the procedural limits, suggesting systemic limitations in the accuracy of the TRP mapping. This may be due to the TRP mapping data being generated through large scale digital analysis based on modelling, aerial photography and other mapping sources. These coupes were not recorded as non-compliances since they were assessed as having been located in accordance with procedural allowances. The non-compliant areas and coupes were attributed to 13 instances of incorrect application of the Management Procedures.

The Harvest Limits in Melbourne's water supply catchments Compliance Element addresses the compliance of timber harvesting operations in four water supply catchments with the spatial limits established in the Forest Management Plans (FMPs) and Management Procedures. This Compliance Element had relatively few requirements with eight spatial harvest limits defined in the Management Procedures tested to assess compliance. The audit found that harvesting operations did not exceed the harvest limits in all four water supply catchments. As such this Compliance Element achieved 100% compliance in both the harvested area and against the number of requirements.

The Harvest limits in Special Management Zones Compliance Element addresses the compliance of timber harvesting operations with the spatial harvest limits established in the FMPs and the *Flora and Fauna Guarantee Act 1988* (FFG Act) Action Statements. The audit found that only eight FMPs and six FFG Action Statements prescribed spatial harvest limits and as such the audit criteria did not allow for a complete assessment within the intended scope and scale of the audit. However, an assessment of the total area harvested in SMZs for each FMA provided an indication of compliance with the FMP harvest limits. Of the 12 FMPs, eight FMPs defined *approximate* spatial harvest limits. These eight requirements were used to assess compliance. No non-compliances were recorded for the SMZ Compliance Element, noting that four FMAs were unable to be assessed due to lack of information in the FMP. As such this Compliance Element achieved 100% compliance in both the harvested area and against the number of requirements.

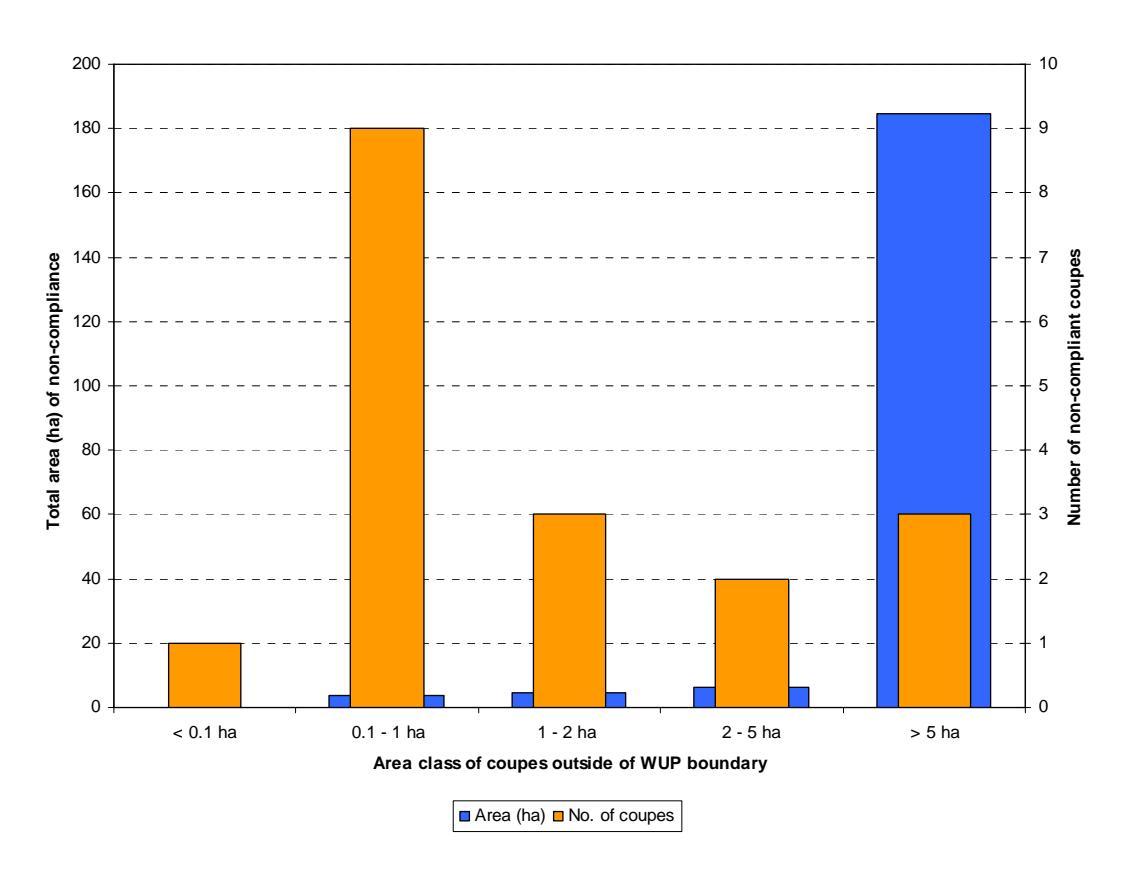
Of the 18 non-compliant DSE coupes where area has been partially harvested outside of a WUP, none were found to have exceeded the total approved WUP area (ha). The 18 non-compliant coupes are made up of 13 thinning from below coupes, three single tree selection coupes, one clearfelling coupe and one group/gap selection coupe. The majority of the area of non-compliance is therefore of a relatively low environmental risk in terms of the less intensive silviculture systems used.

The Auditor considers that the 18 non-compliances do not present imminent environmental hazards or unacceptable risks to the beneficial uses of the environment, noting that the scope of the audit was limited to desktop review.

Figure 5-2 below depicts the audit findings graphically illustrating that the majority of the non-compliant coupes have small areas harvested outside of the WUP and that the area of non-compliance is largely due to three non-compliant coupes representing 93% of the total area harvested outside of the WUP.

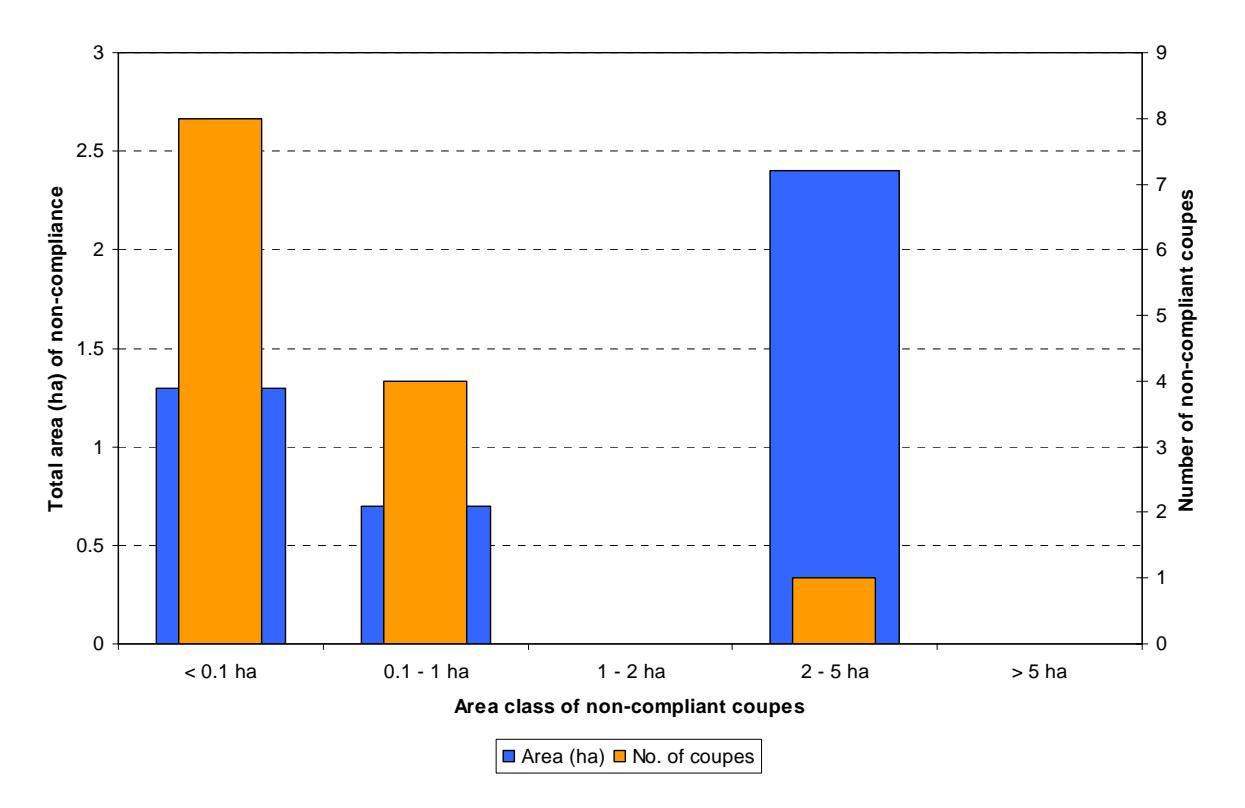
The Auditor considers that the 13 non-compliances do not present imminent environmental hazards or unacceptable risks to the beneficial uses of the environment, especially in terms of the small areas of individual non-compliant areas, noting that the scope of the audit was limited to desktop review.

Figure 5-3 depicts the audit findings graphically illustrating that the majority of the coupes have small areas that are outside of the TRP and that approximately half of the total area, or 4 ha, harvested outside of a TRP boundary was less than one hectare.

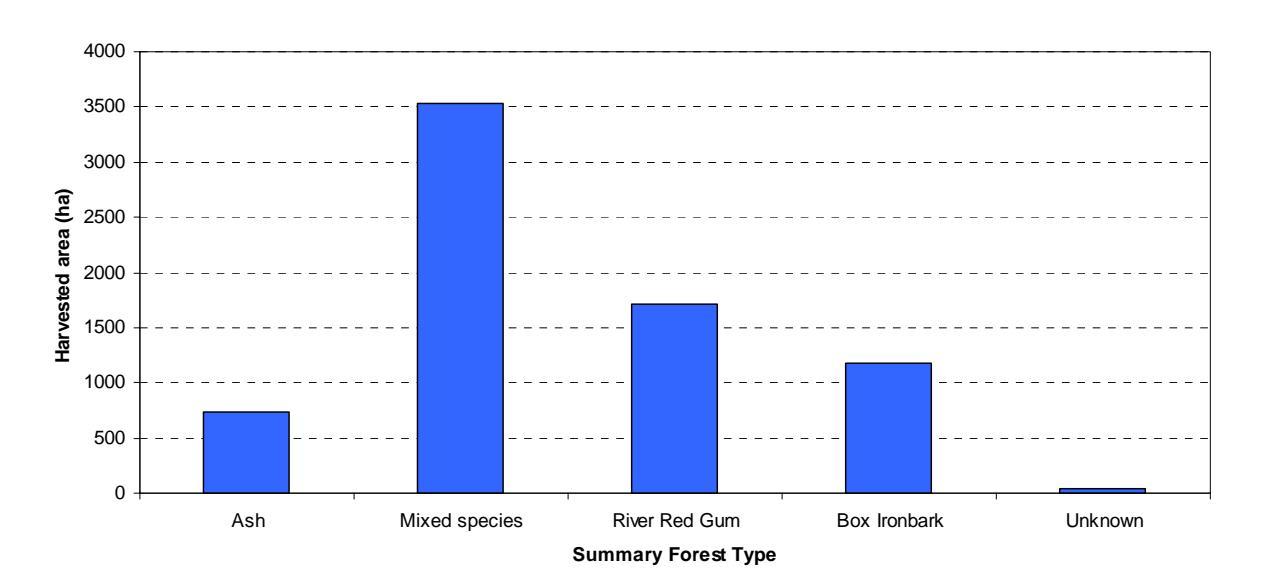
Figure L-1 below illustrates Table L-3 showing the summarised forest types of the areas harvested within the SMZs over the 10 year period 1999/00 - 2008/09.

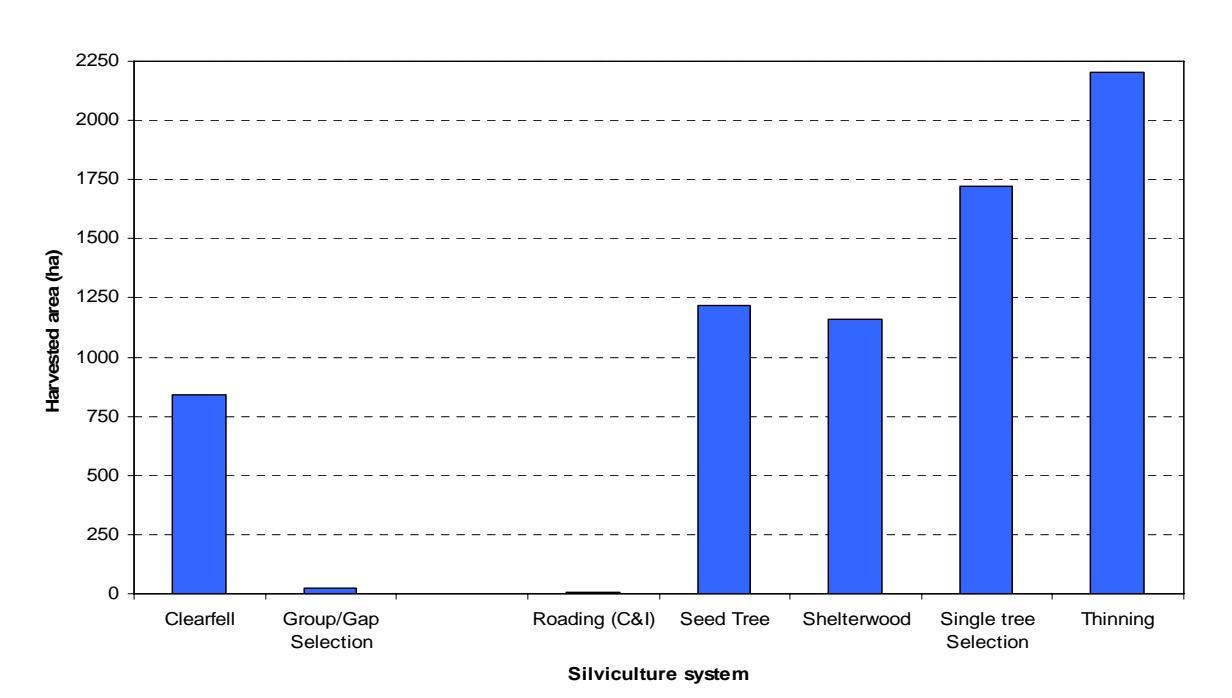
Figure L-2 below provides the areas harvested within the SMZs by the silviculture system over the 10 year period 1999/00 - 2008/09. It shows that more than 50% of the total area harvested within SMZs over the ten year period were thinning and single tree selection harvesting operations. 16% were shelterwood (1 & 2) harvesting systems and a further 16% were seed tree harvesting operations.
