Direl (Lake Tyrrell)

Cultural Landscape Conservation Management Plan

'Direl' (VAHR 7427-0187)

PUBLIC REPORT

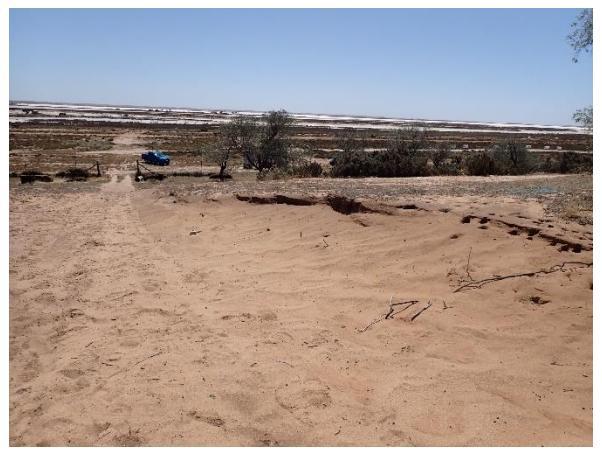
Photograph 11: Survey Area 1, wind erosion on vehicle track on the loose sandy deposit of the lunette. Facing west. A. Garamszegi (4/2/2020).

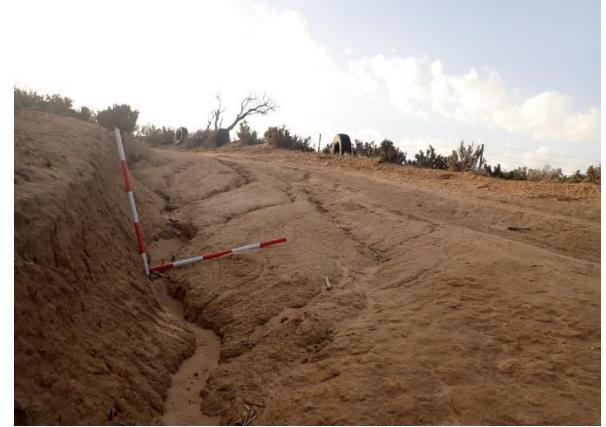
Photograph 12: Survey Area 1, deep erosion channel (water flow, wind, vegetation stripping) due to vehicular use. Facing southeast. A. Garamszegi (6/2/2020).

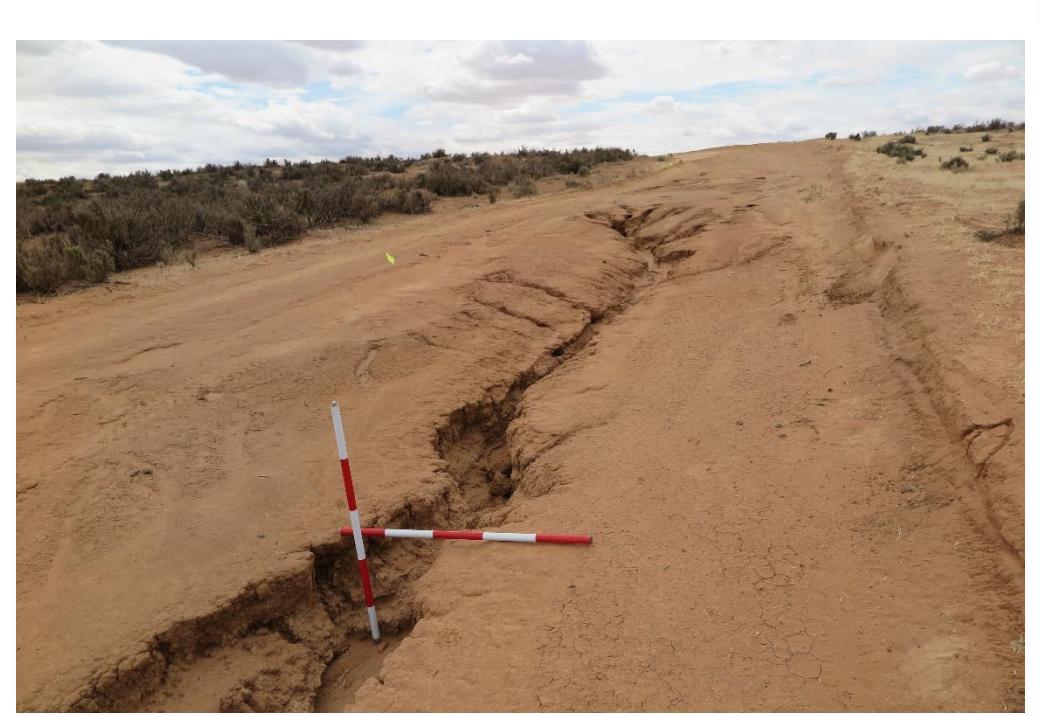
Photograph 25: Survey Area 2, extreme water erosion along Mallee Rally track. Facing north. A. Garamszegi (10/2/2020).

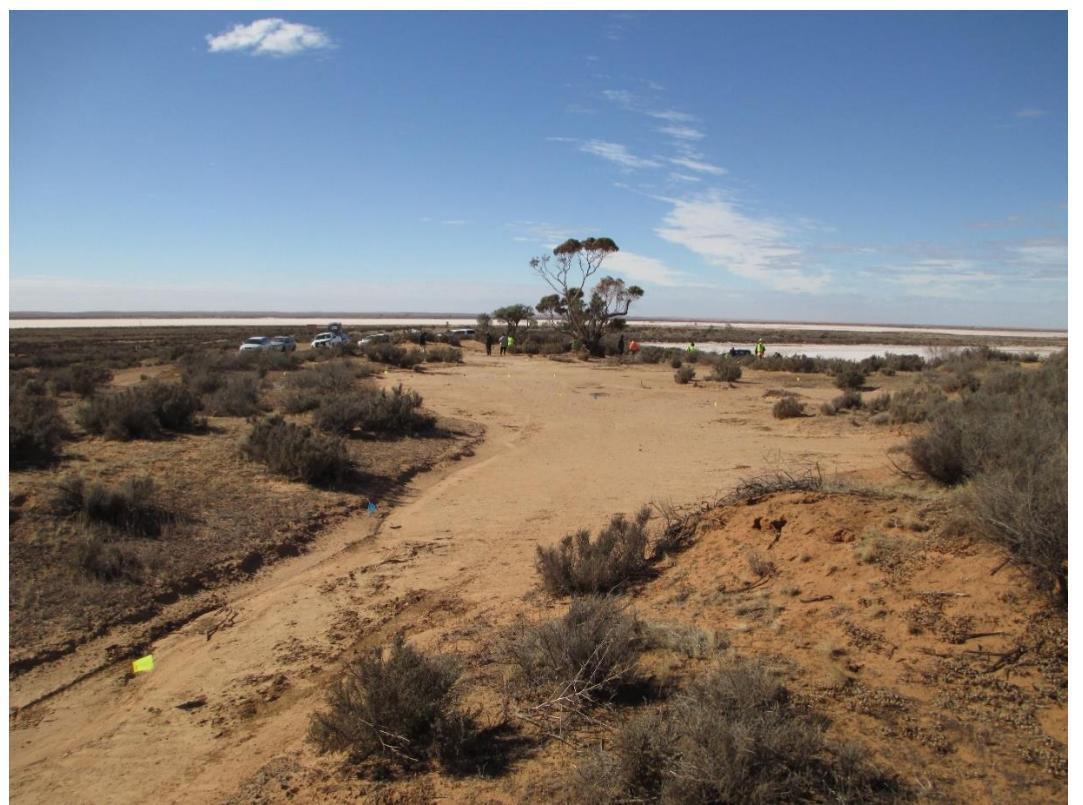
Photograph 42: Survey Area 4, view of the terrace from its western end, showing the offshoot vehicle track and surface artefacts (marked by flags) in the eroded area. Facing southeast. P. Kucera (20/4/2021).

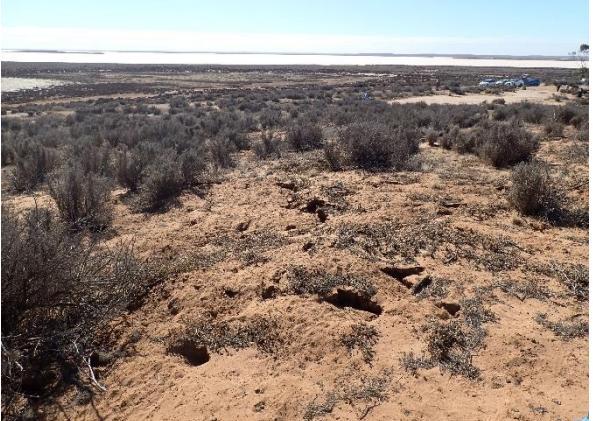
Photograph 49: Survey Area 4, ground disturbance caused by rabbits in the upper slope of the dune. Facing north-northeast. S. Cath-Garling (20/4/2021).

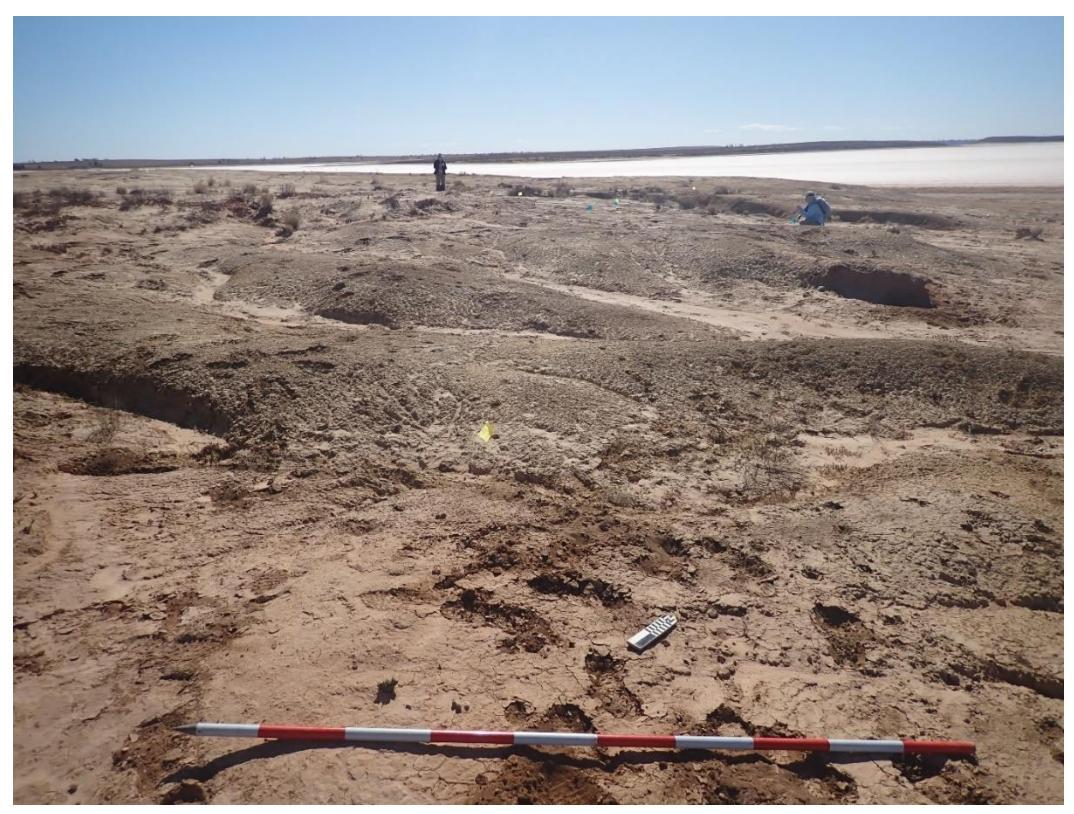
Photograph 55: Survey Area 5, erosion scour with deep gullies on the northeast side of the promontory at VAHR 7427-0179. Facing northwest. I. Bilbao Malave (21/4/2021).

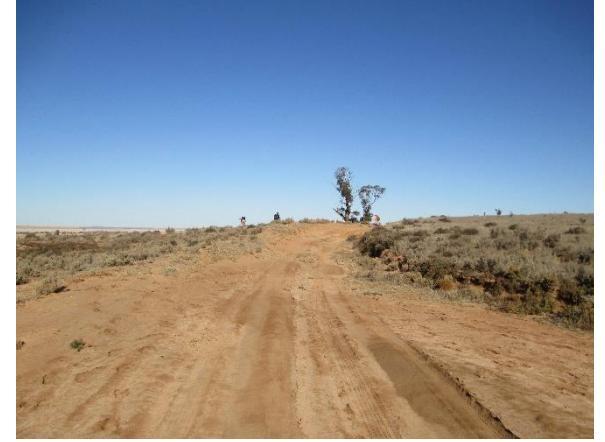
Photograph 73: Survey Area 6, view of the main vehicle track and impact to vegetation, north of the ridge and terrace. Facing southeast. P. Kucera (21/4/2021).

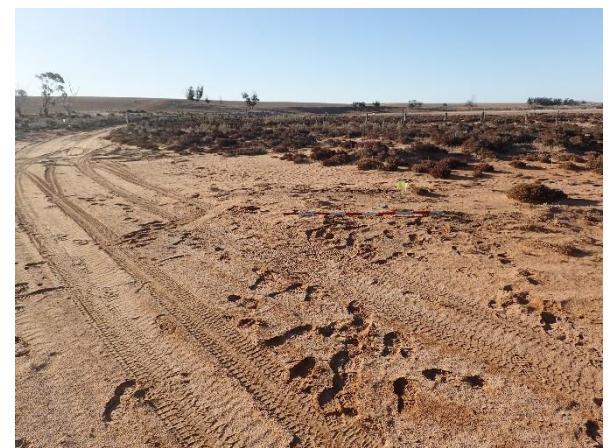
Photograph 74: Survey Area 6, view along the secondary vehicle track, showing impacts to vegetation in the low-lying area. Facing north. S. Cath-Garling (21/4/2021).

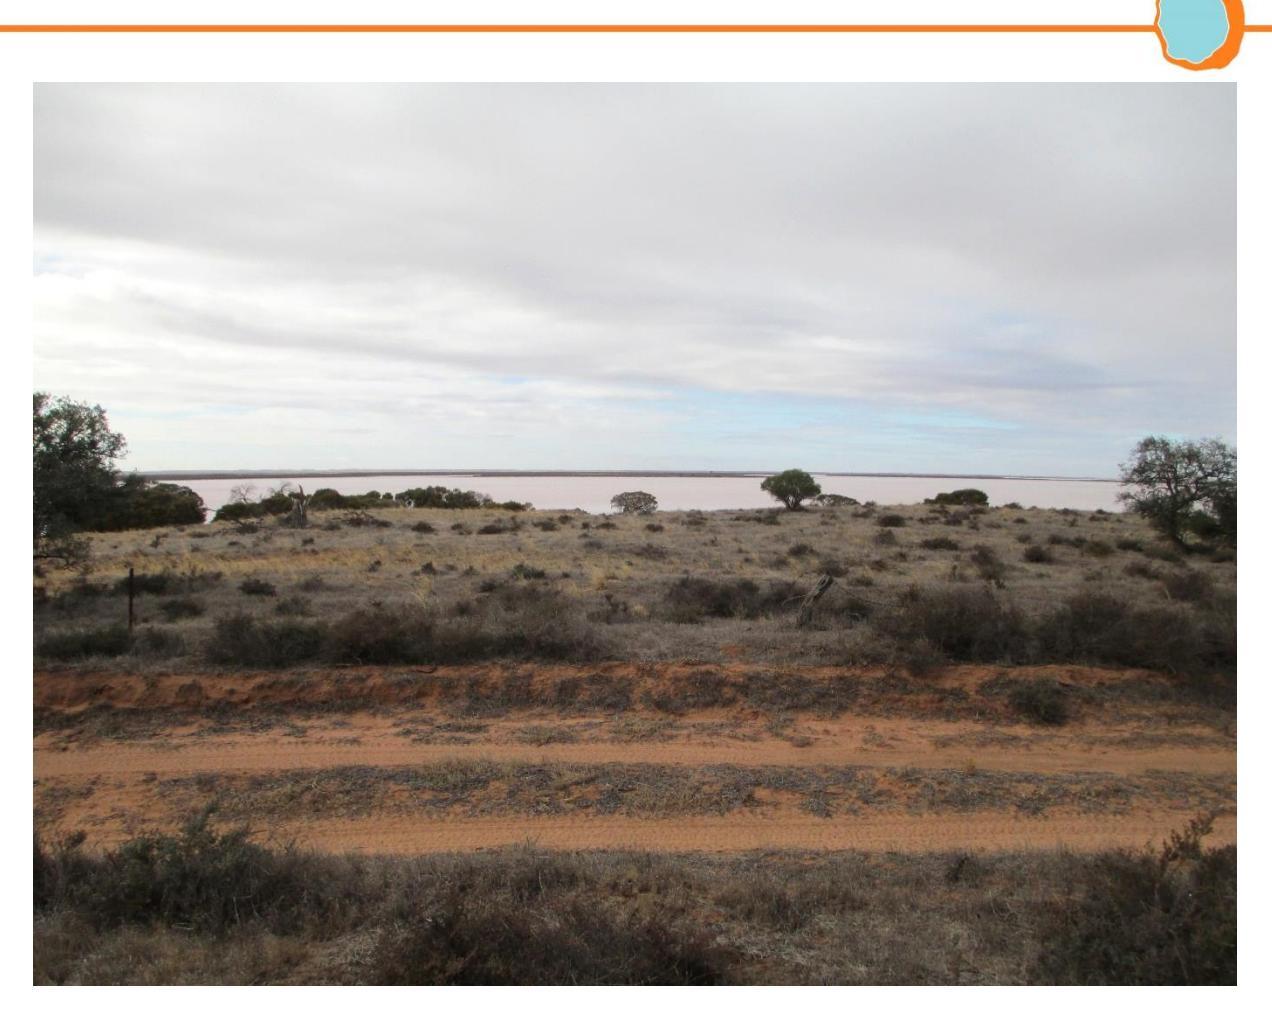
Photograph 83: Survey Area 7, conditions along the vehicle track in the central part of the terrace. Facing east. P. Kucera (22/4/2021).

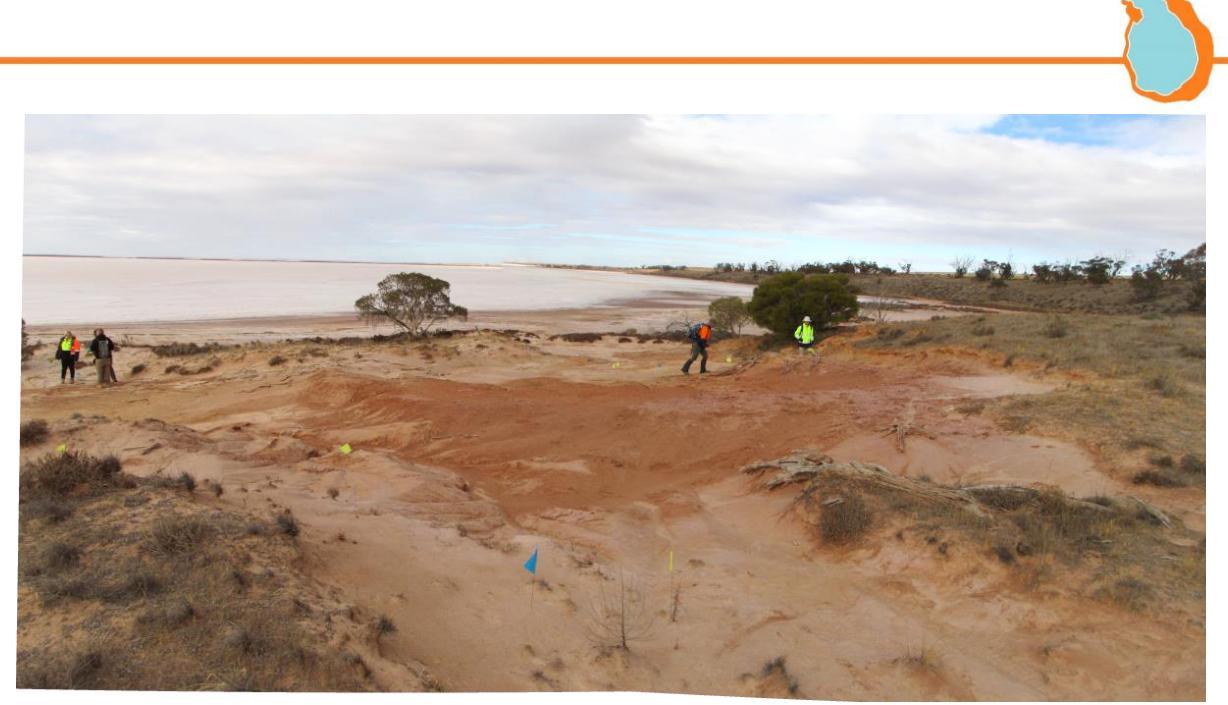
Photograph 86: Survey Area 7, severe erosion and loss of landform in the east end of the terrace, also showing the distribution of artefacts. Facing southeast. Composite photo, P. Kucera (22/4/2021).

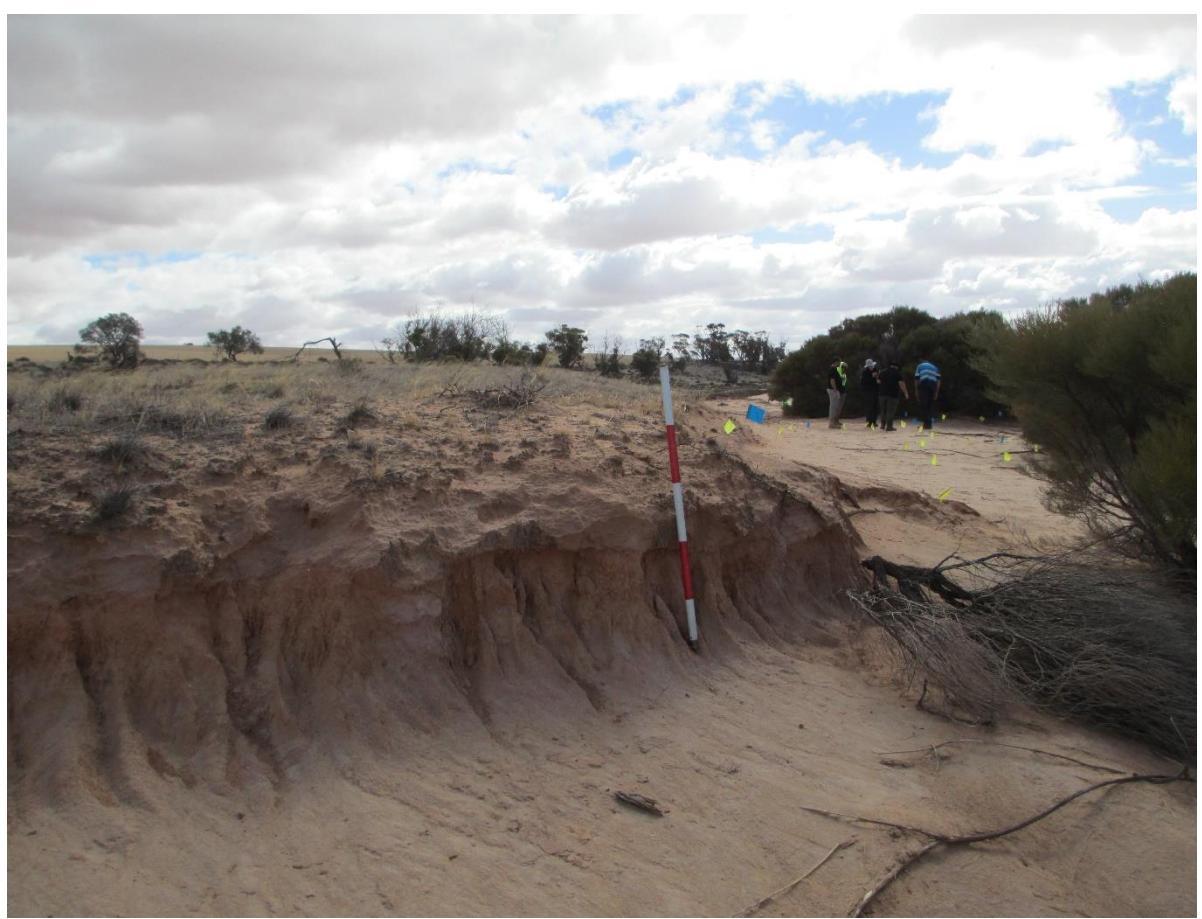
Photograph 87: Survey Area 7, severe erosion of the terrace along the sandy shelf in the east/northeast area. Facing northwest. P. Kucera (22/4/2021).

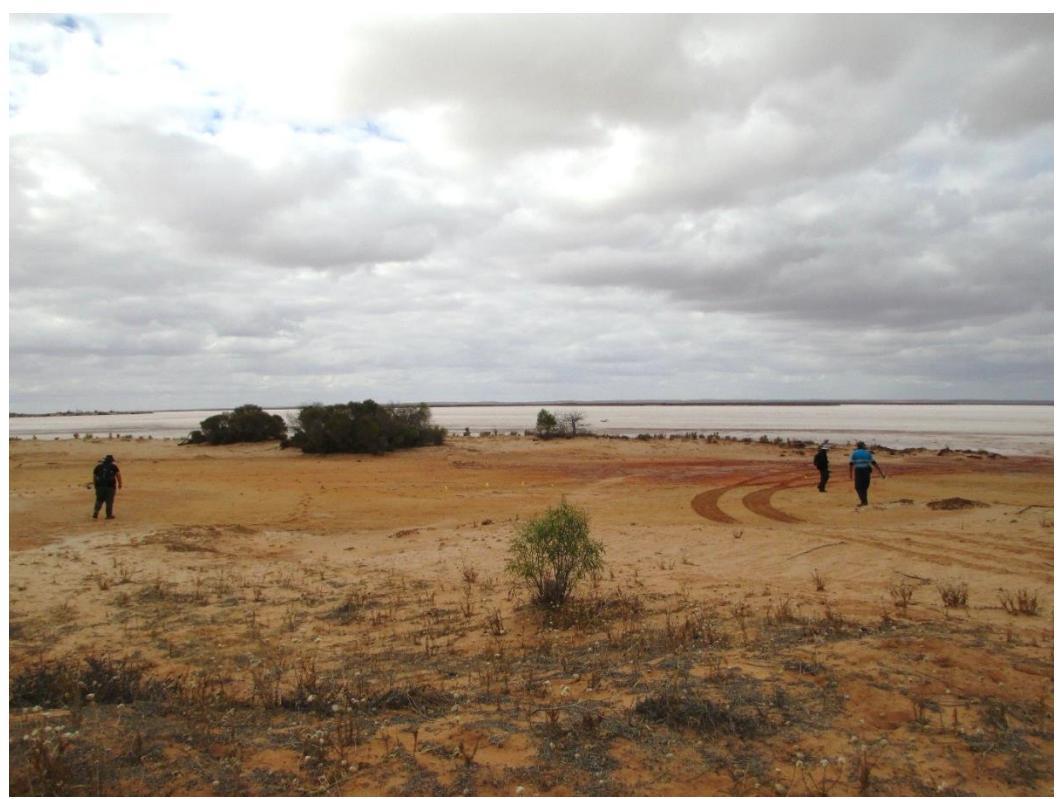
Photograph 92: Survey Area 8, view across the claypan-like depression on the east side of the terrace, showing locations of stone artefacts and recent tyre marks (centre right). Facing east. P. Kucera (22/4/2021).

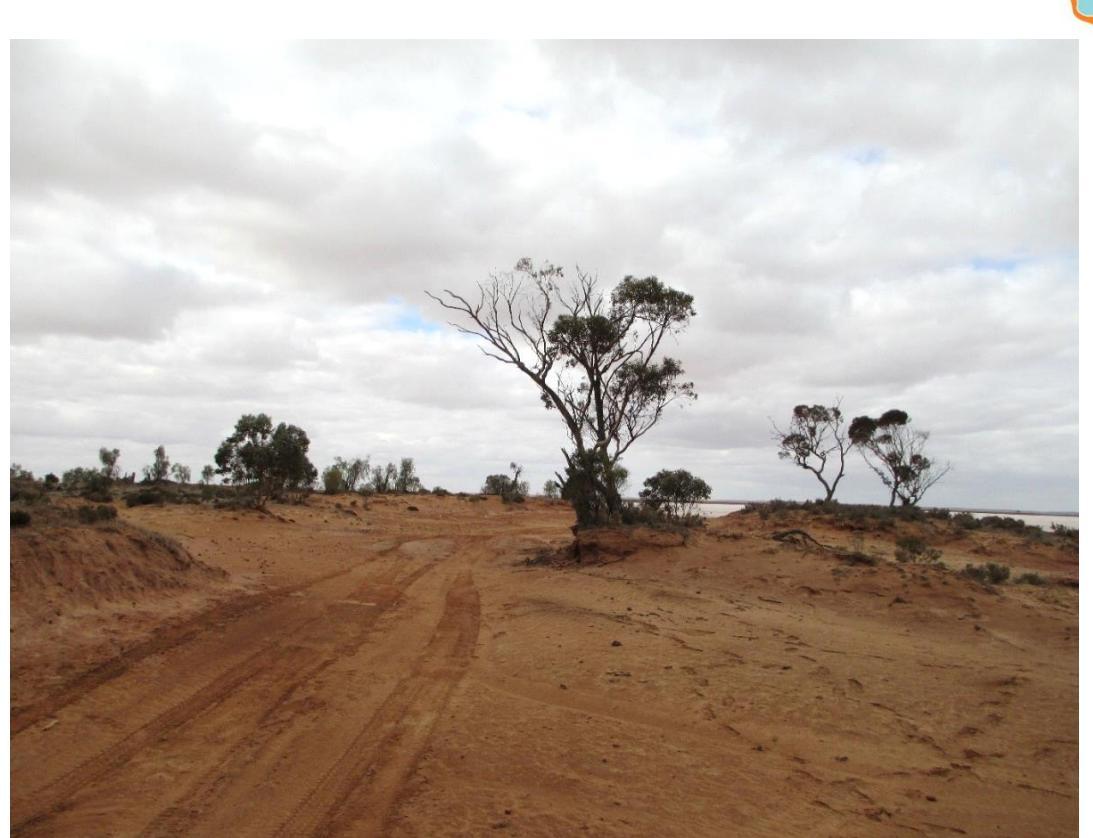
Photograph 93: Survey Area 8, view of the hummocks (centre right) on the southeast side of the terrace (centre left), showing the vehicle track and surrounding degraded areas. Facing northeast. P. Kucera (22/4/2021).

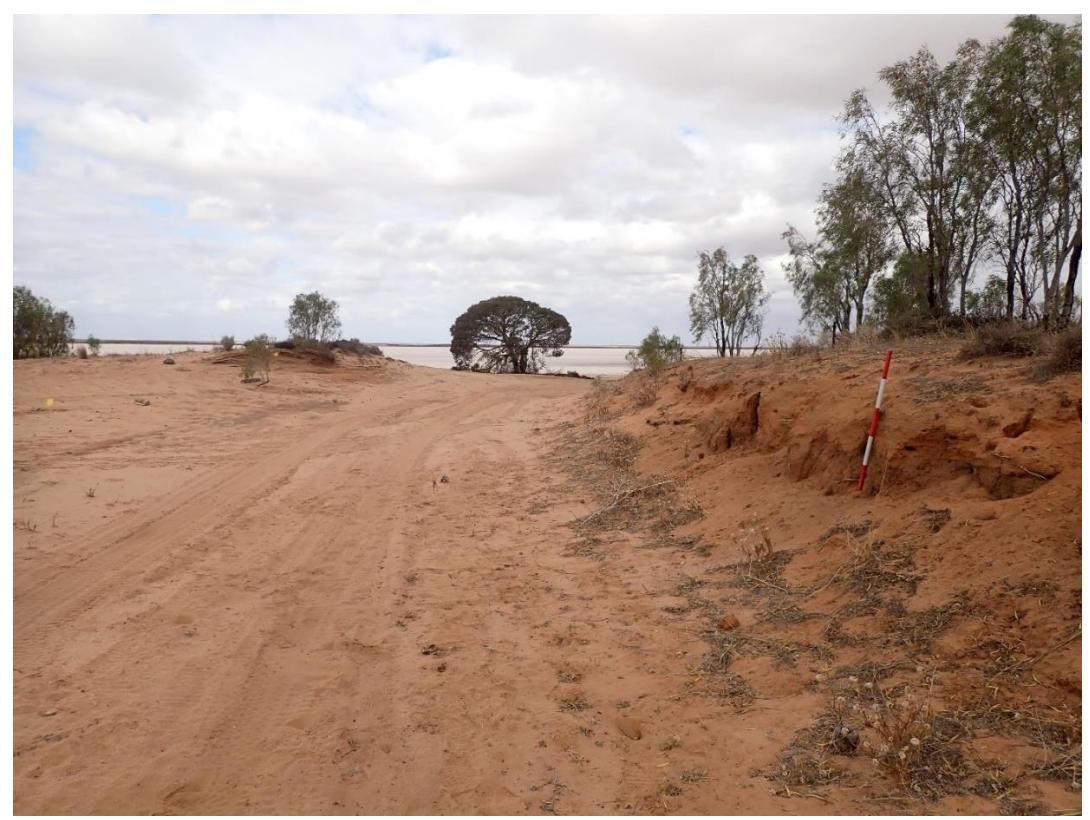
Photograph 94: Survey Area 8, view along the main vehicle track through the centre of the terrace, demonstrating the significant loss of landform. Facing southeast. I. Bilbao Malave (22/4/2021).

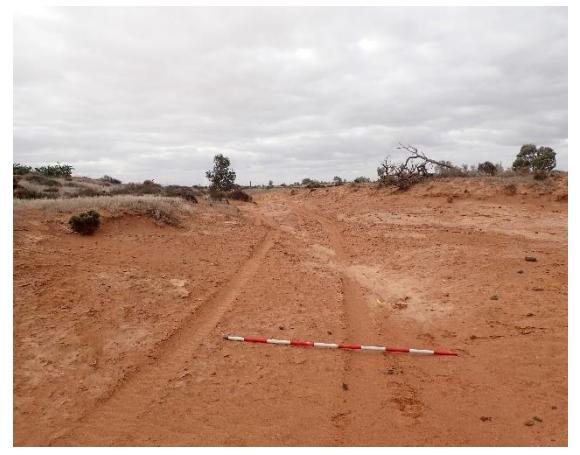
Photograph 95: Survey Area 8, southwest end of the terrace where the former vehicle track continues, showing vegetation loss and significant damage to the landform. Facing northwest. I. Bilbao Malave (22/4/2021).

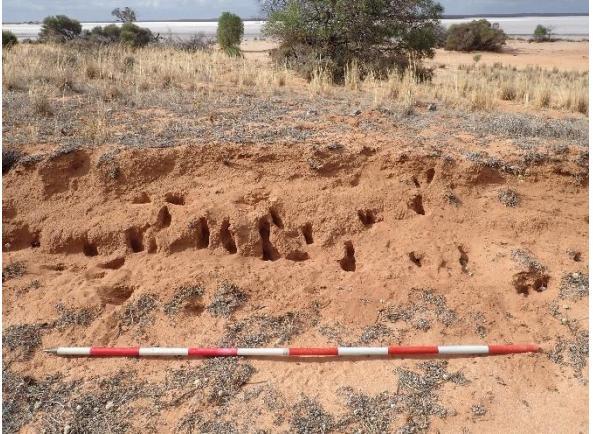
Photograph 96: Survey Area 8, rabbit digging activity along the main vehicle track. Facing northeast. I. Bilbao Malave (22/4/2021).

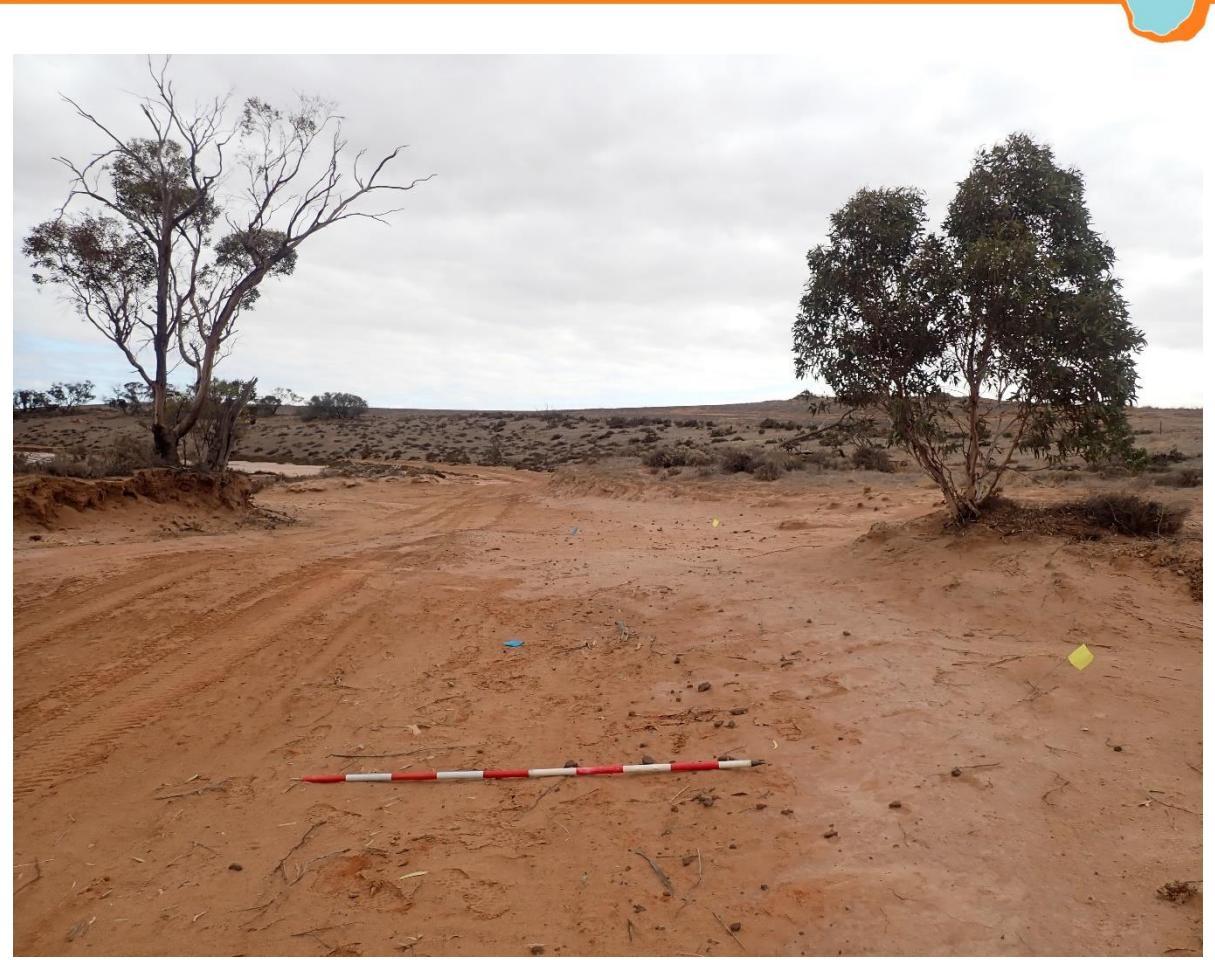
Photograph 101: Survey Area 8, view of artefact distribution beside the vehicle track at the southern end of the terrace in the vicinity of the hummocks, showing the erosional impacts (centre left in particular) to landform. Facing southwest. I. Bilbao Malave (22/4/2021).
